EC12-009

ECM REPLACEMENT PROCEDURES WITH CONSULT III PLUS

APPLIED VEHICLES: All 2004 and later

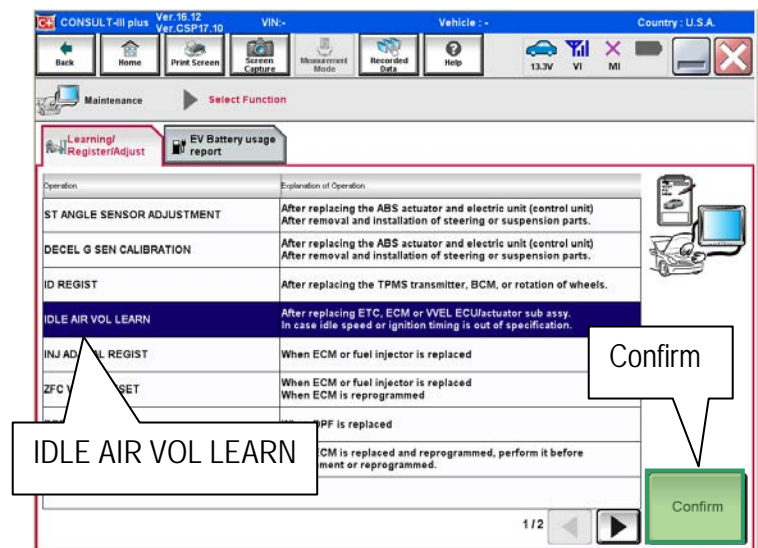
Figure 2

- c. In the CIII plus "Maintenance mode", select "IDLE AIR VOL LEARN" and then "Confirm". See Figure 2.

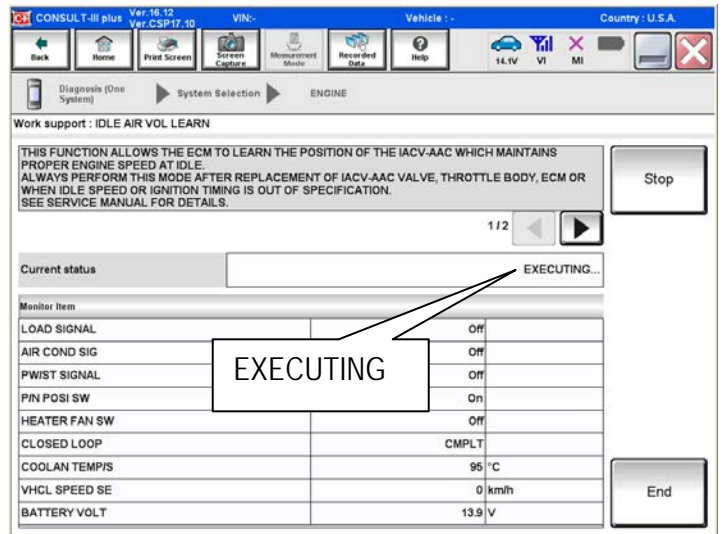
Figure 4

- The IAVL procedure will take several minutes to complete.
- CIII plus will display "EXECUTING" in the "Current status" box while the IAVL procedure is in process. See Figure 4.
