# SERVICE BULLETIN

## MIL ON WITH DTC P0101

**APPLIED VEHICLES:** 2011-2012 Altima Coupe (CL32)  
2011-2012 Altima Sedan (L32)  
2013 Altima Sedan (L33) with **QR25DE engine only**  
2015 Altima Sedan (L33) with **QR25DE engine only**  
2011-2012 cube<sup>®</sup> (Z12)  
2011-2012 Frontier (D40) with **VQ40DE engine only**  
2011-2012 Maxima (A35)  
2011-2012 Pathfinder (R51) with **VQ40DE engine only**  
2011-2012 Sentra (B16) with **MR20DE engine only**  
2011-2012 Xterra (N50)

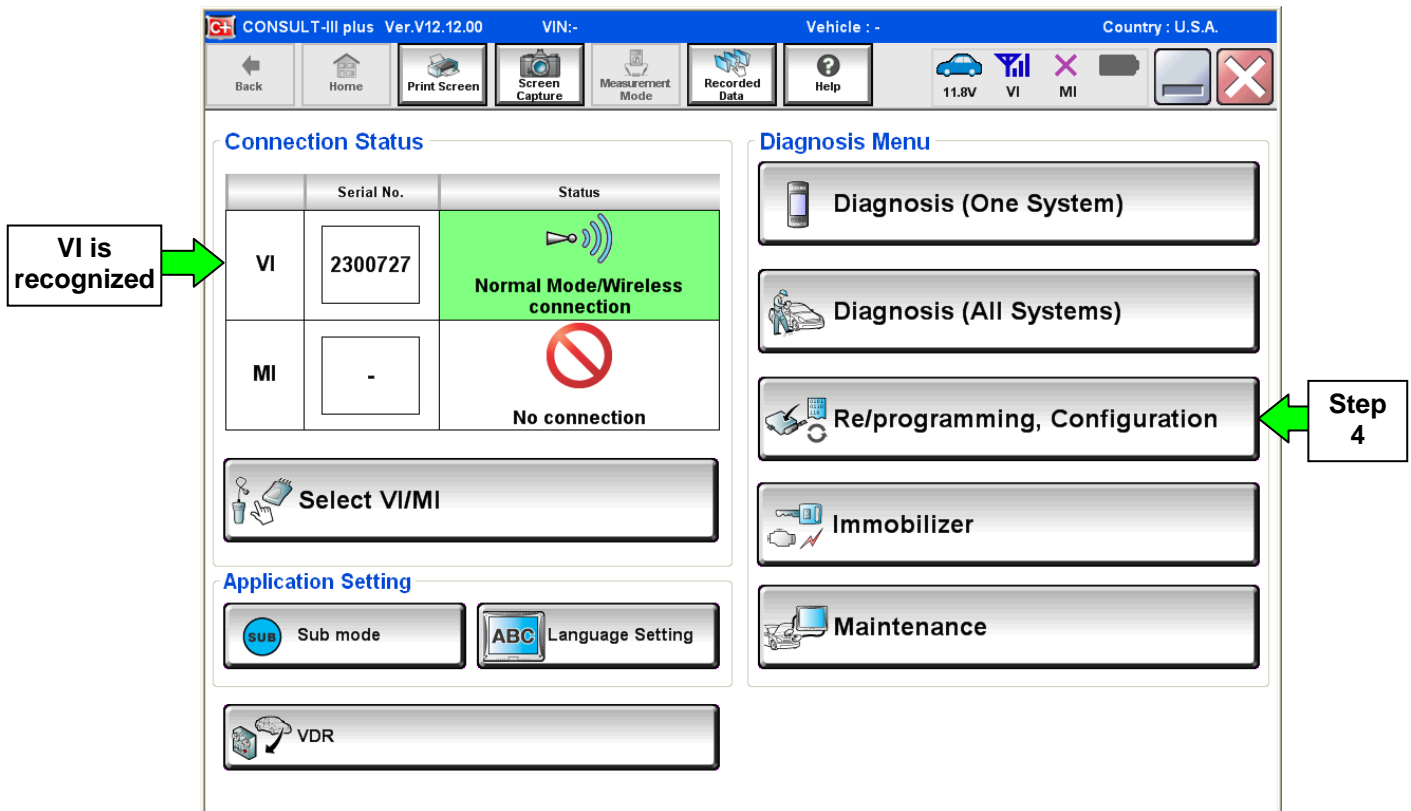
Figure 1

1. Connect the CONSULT PC to the vehicle to begin the reprogramming procedure.
2. Start C-III plus.
3. Wait for the plus VI to be recognized / connected.
  - The serial number will display when the plus VI is recognized / connected.
4. Select **Re/programming, Configuration**.
