ITB12-044a

## VOLUNTARY SERVICE CAMPAIGN 2013 JX35 INTELLIGENT BRAKE ASSIST

**CAMPAIGN I.D. #:** P2540**APPLIED VEHICLE:** 2013 JX35 (L50)

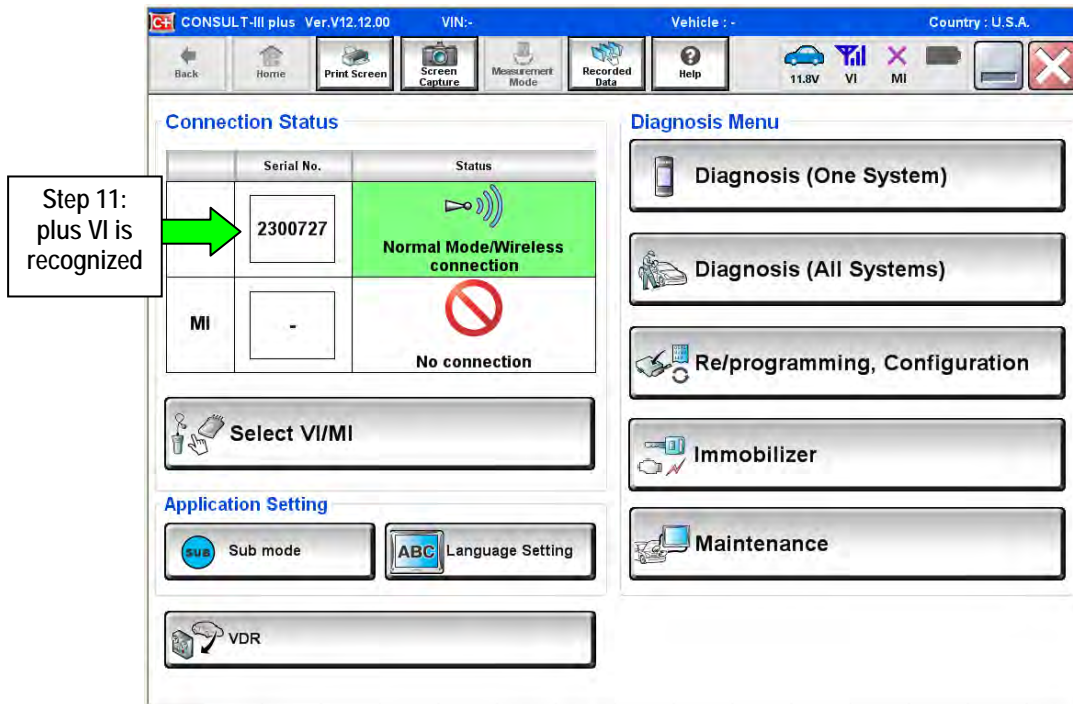
Figure 1

8. Turn ON the CONSULT PC.
9. Turn OFF all software (programs), including ASIST.
10. Select CONSULT-III plus (open C-III plus).
11. Wait for the plus VI to be recognized / connected.
  - Serial number will display when the plus VI is recognized / connected.

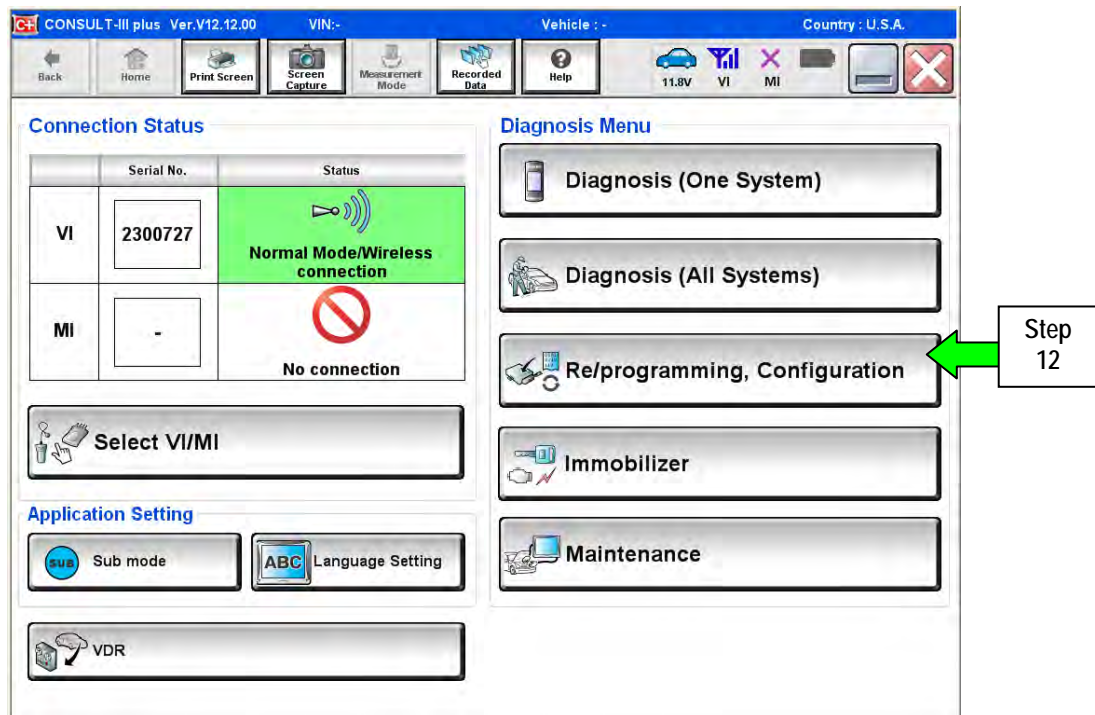
Figure 2

12. Select Re/programming, Configuration.

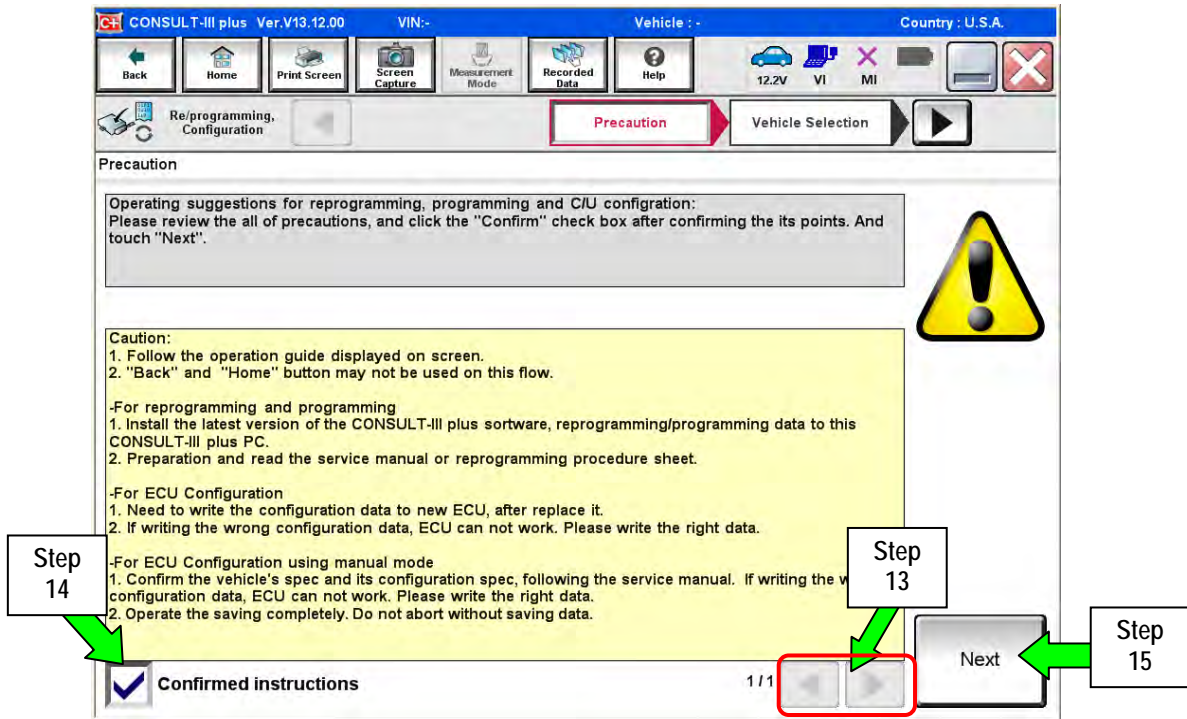
Figure 3

13. Use arrows (if needed) to view and read all precautions.
14. Check the box confirming the precautions have been read.
15. Select **Next**.

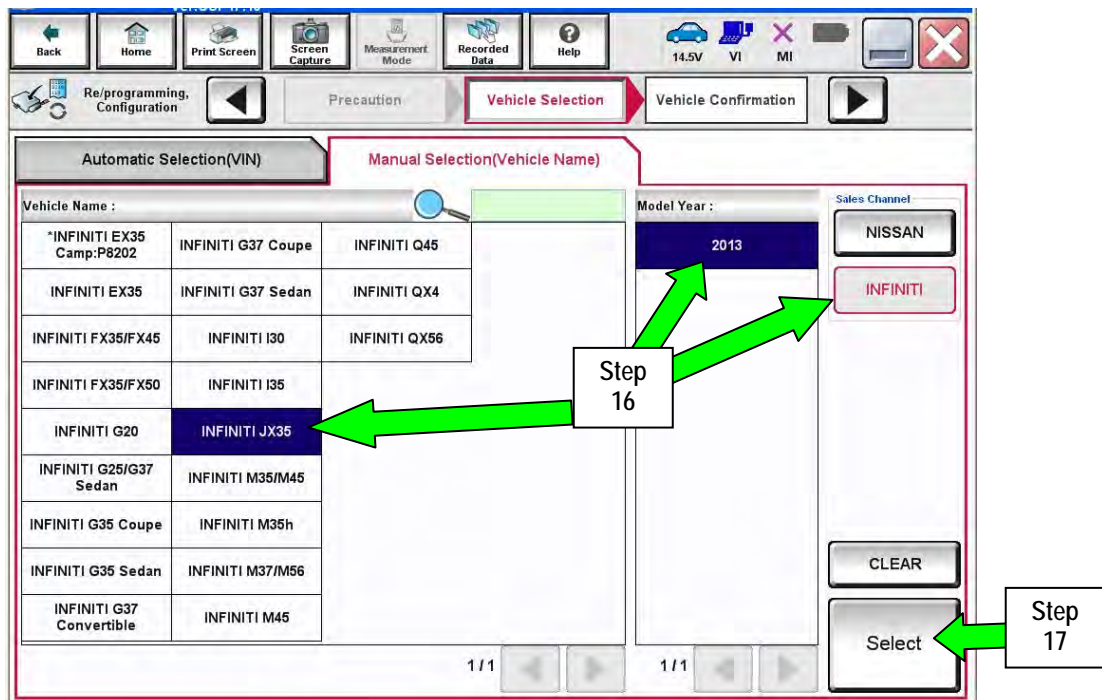
16. Select **INFINITI**, **INFINITI JX35**, and **2013**.
  - If the screen in Figure 4 does not display, skip to step 20.

17. Click **Select**

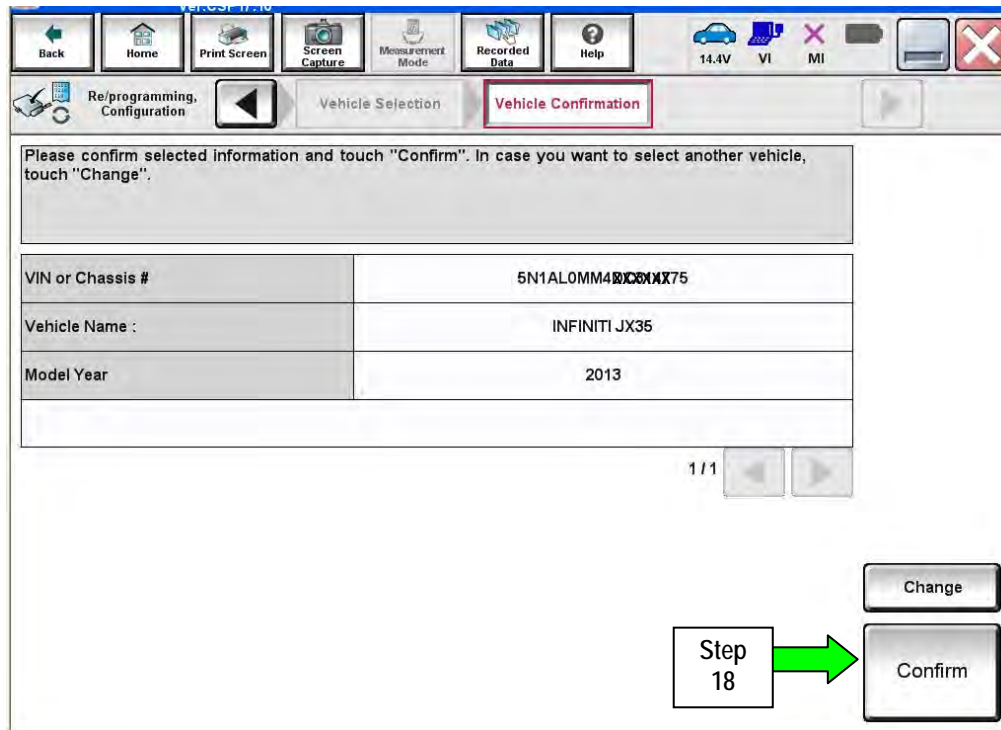
Figure 5

18. Verify all information is correct, and then select **Confirm**.

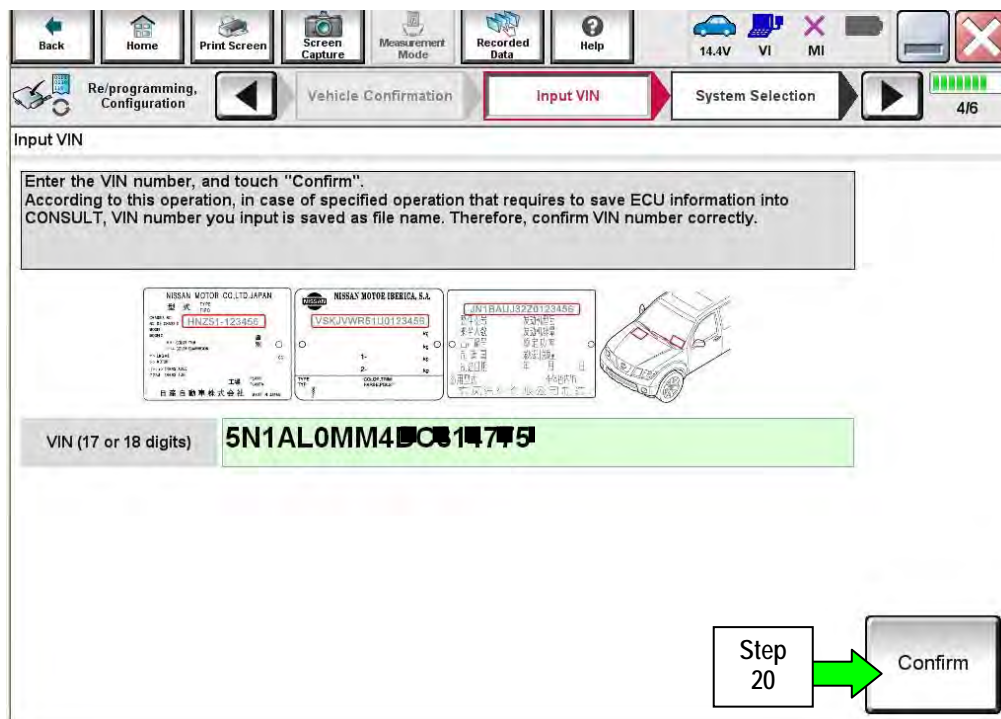
Figure 6

20. Verify the VIN is correct, and then select **Confirm**.

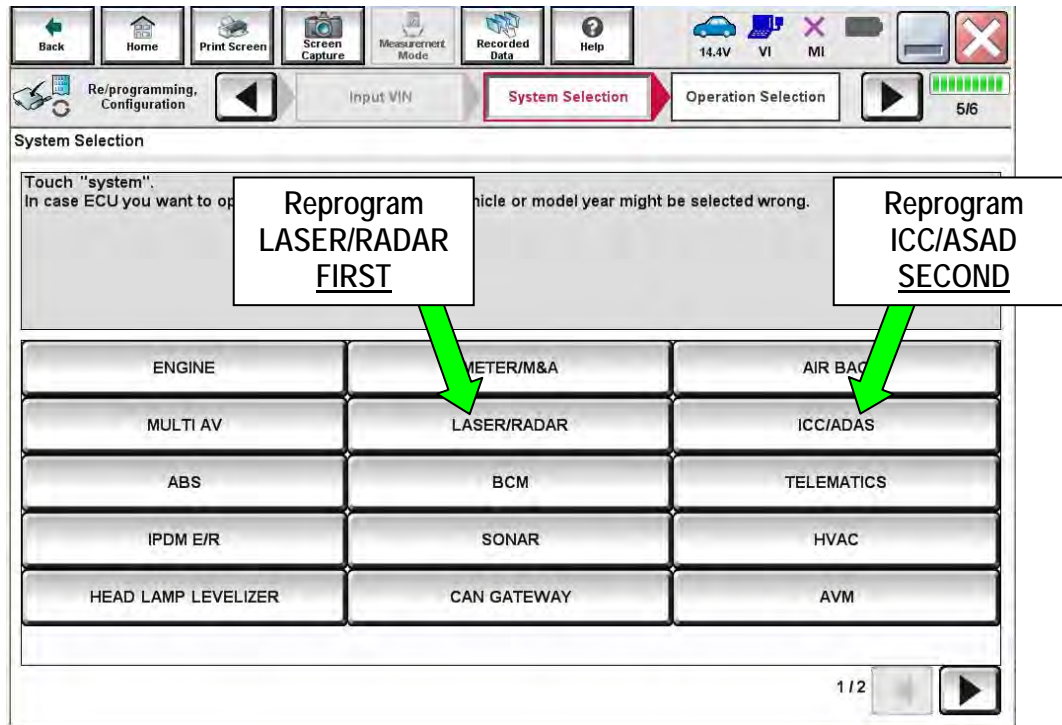
Figure 7

21. Select LASER/RADAR first – Reprogram RADAR first.

For second reprogram, select ICC/ADAS – Reprogram ADAS second.

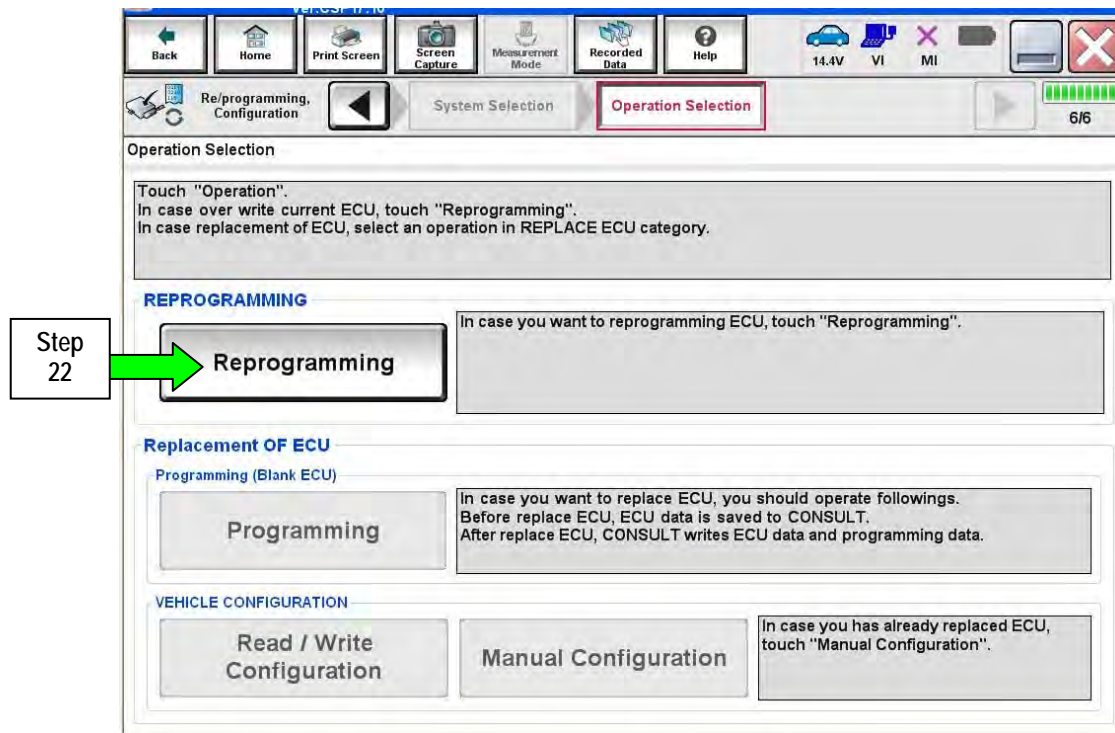
Figure 8

22. Select Reprogramming.

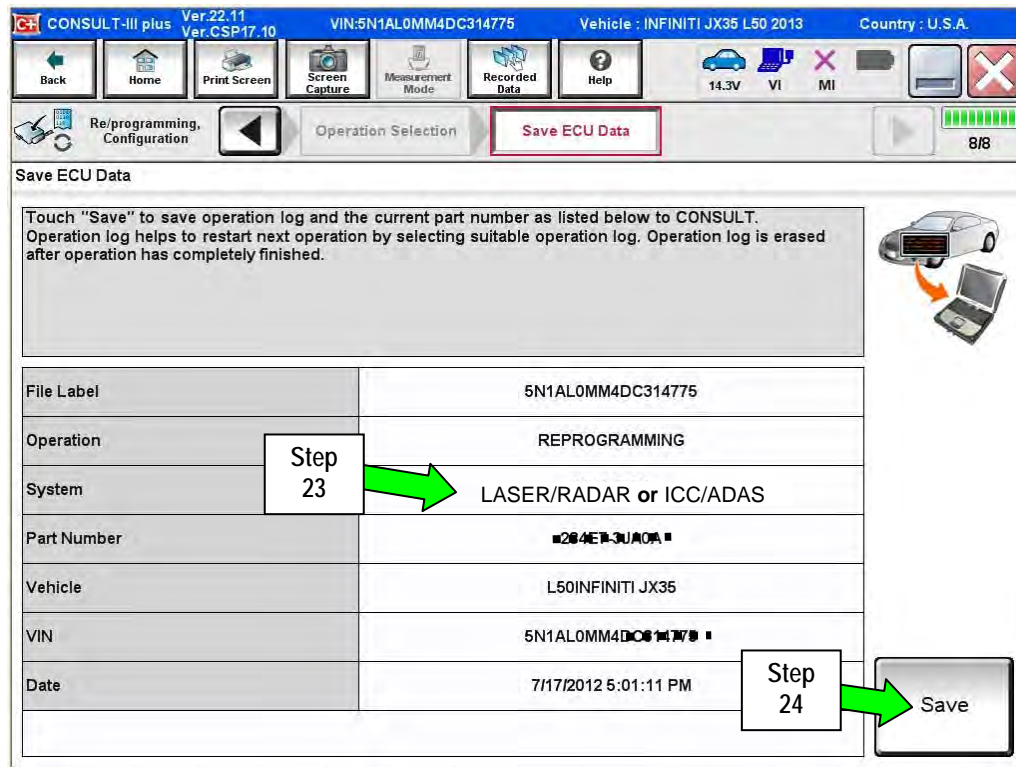
Figure 9

23. Confirm System is LASER/RADAR or ICC/ADAS.

24. Select Save

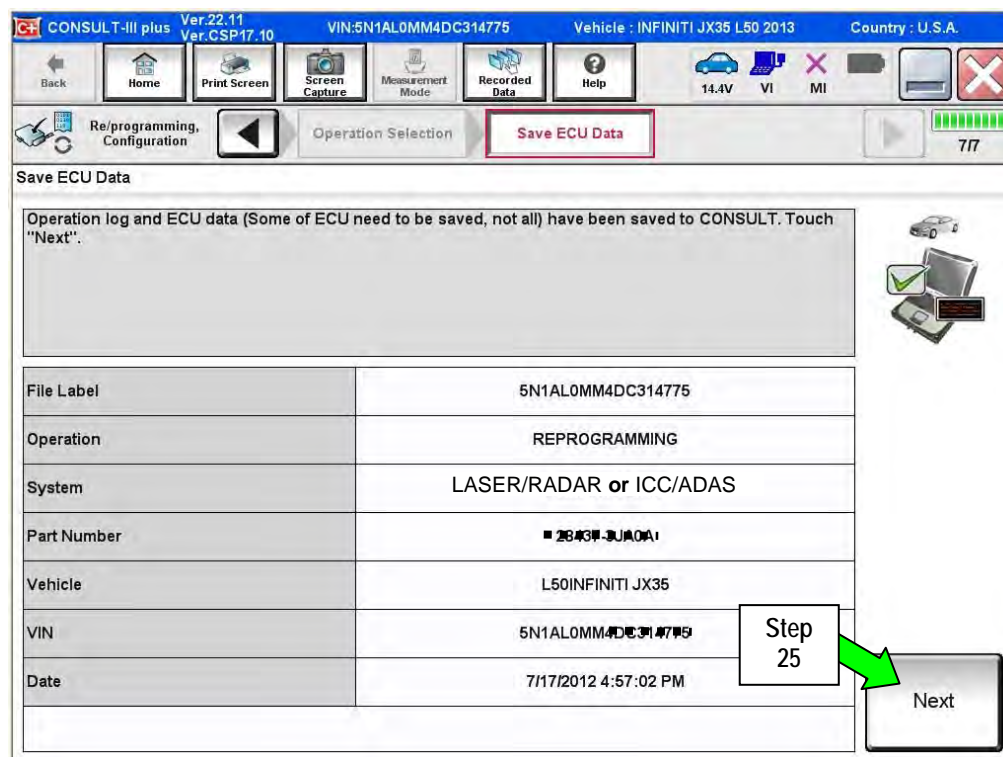
Figure 10

25. Select Next

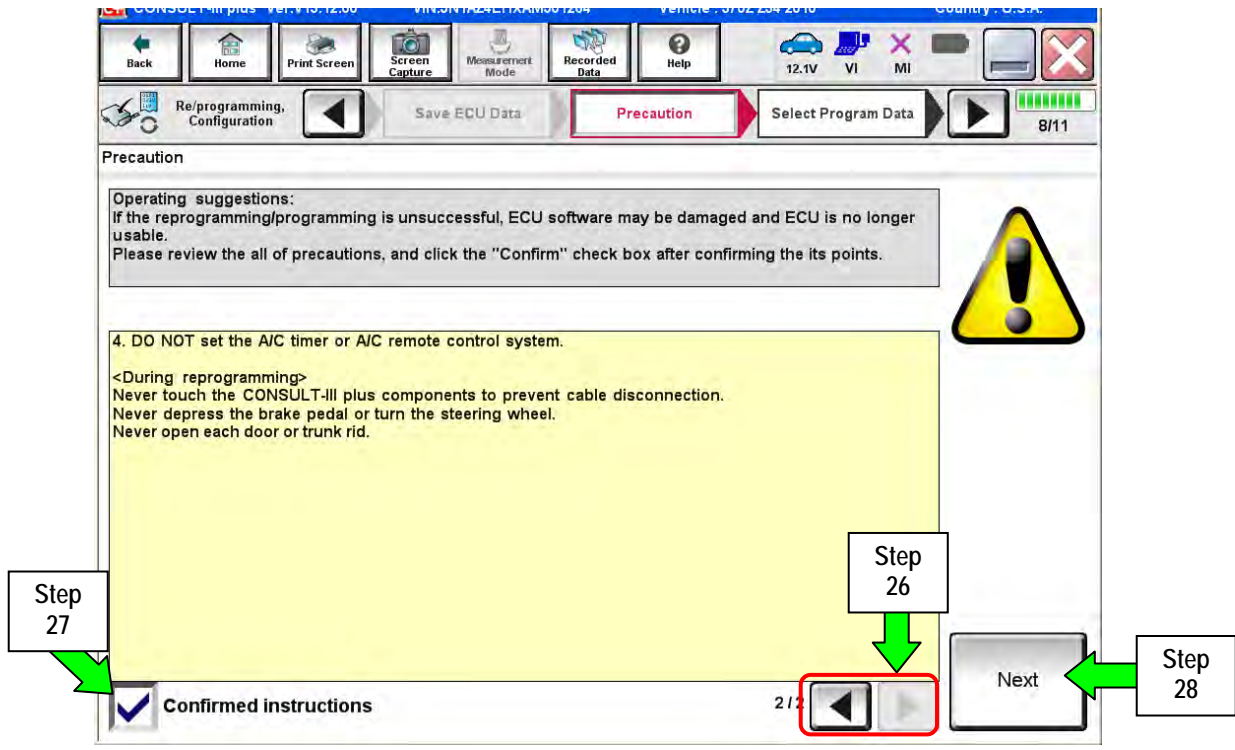
Figure 11

26. Use arrows (if needed) to view and read all precautions.

27. Check the box confirming the precautions have been read.

28. Select Next

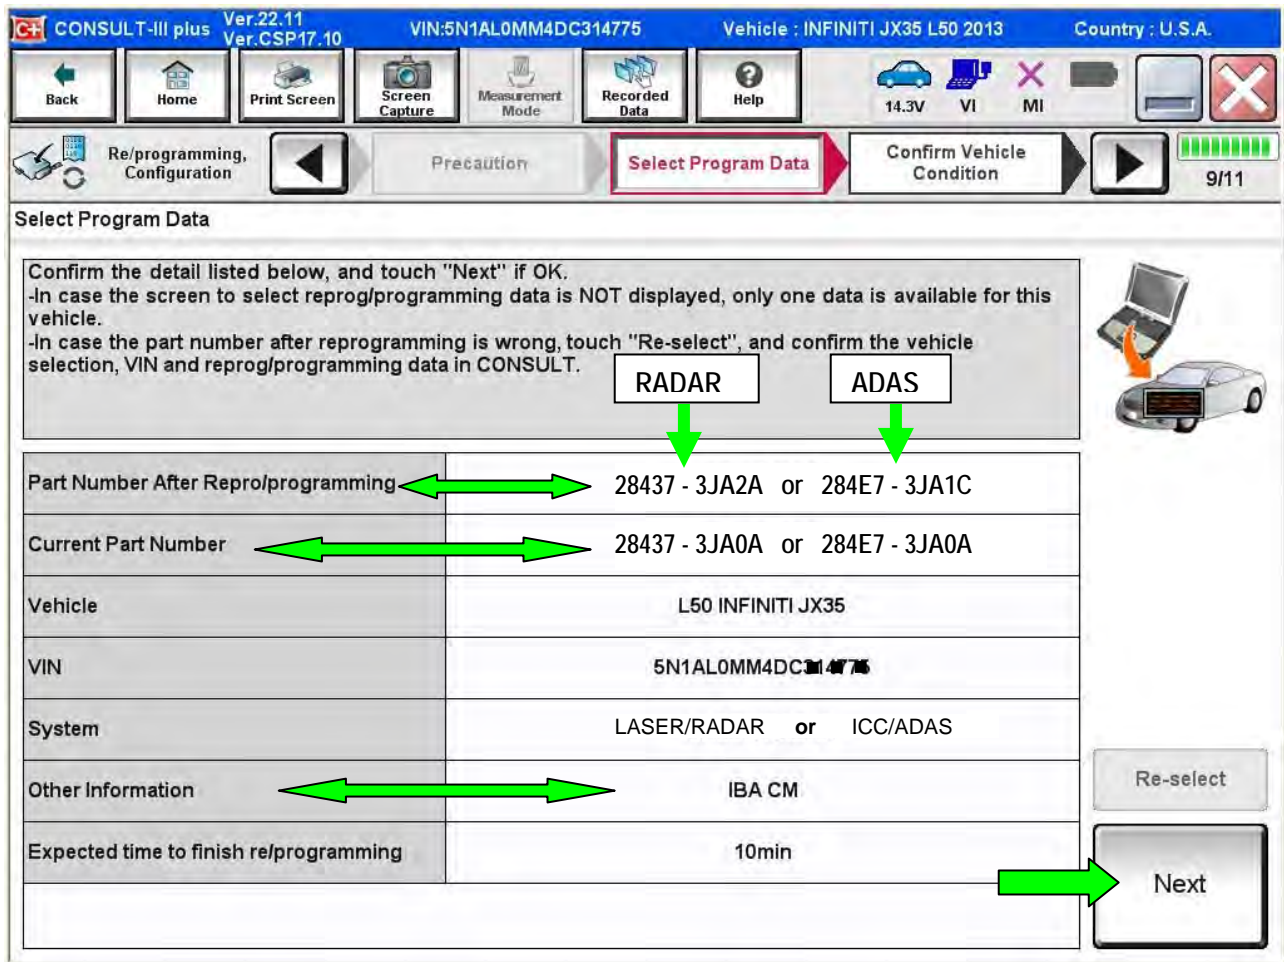
**Step 29 for RADAR** - Check the following:

- Part Number After Repro/programming --- 28437 - 3JA2A
- Current Part Number --- 28437 - 3JA0A
- Other Information --- IBA CM
- Select **Next** if above are correct.

**Step 29 for ADAS** - Check the following:

- Part Number After Repro/programming --- 284E7 - 3JA1C
- Current Part Number --- 284E7 - 3JA0A
- Other Information --- IBA CM
- Select **Next** if above are correct.

This bulletin has been amended to correct Figure 12 and add the Owner's Letter.  
Please discard previous versions of this bulletin.

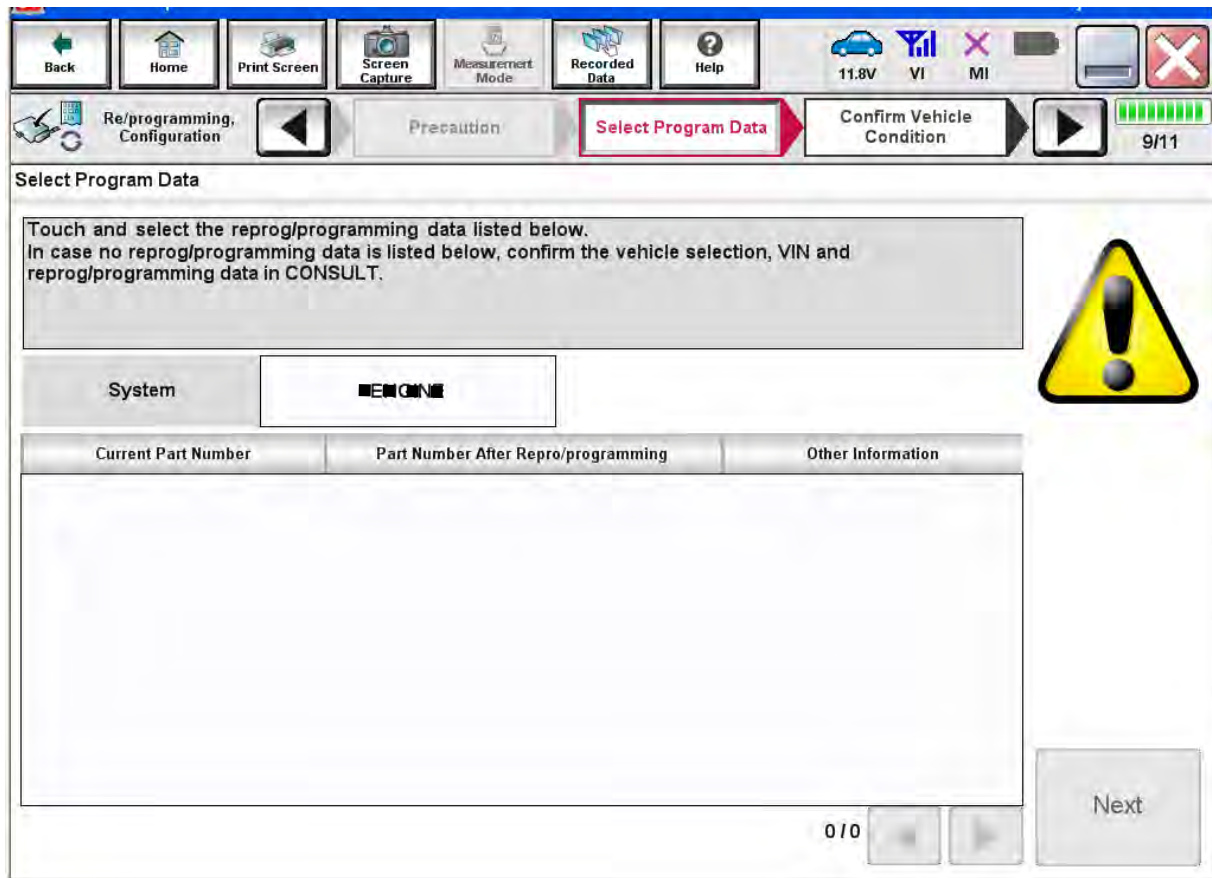
Figure 13

NOTE:

- If you get this screen and it is blank (no reprogramming listed), it means there is no RADAR or ADAS C/U reprogramming available for this vehicle.

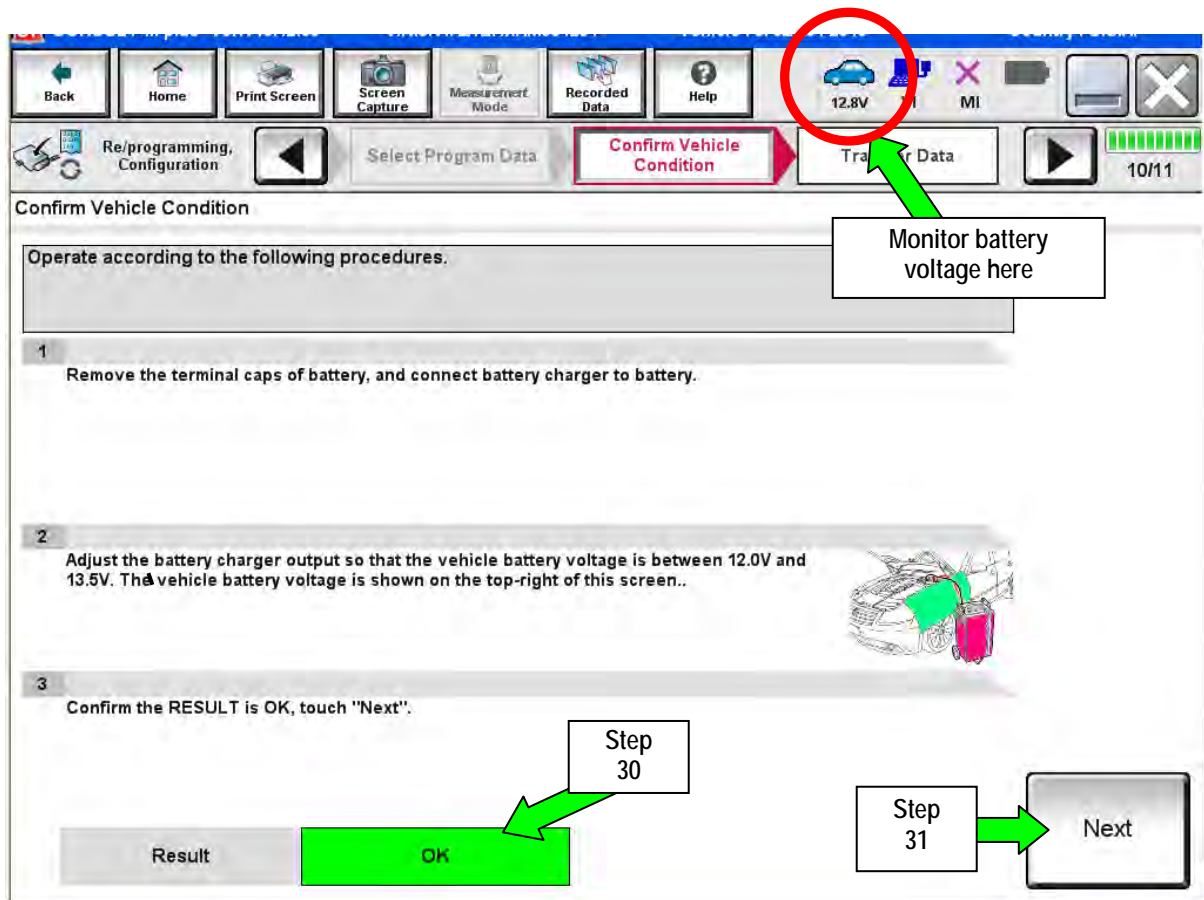
Figure 14

30. Make sure OK is highlighted green (battery voltage must be between 12.0 and 15.5 Volts).

31. Select Next.

**IMPORTANT:** Battery voltage must stay between 12.0 and 15.5 Volts during reprogramming or ECM reprogramming may be interrupted and ECM may be damaged.

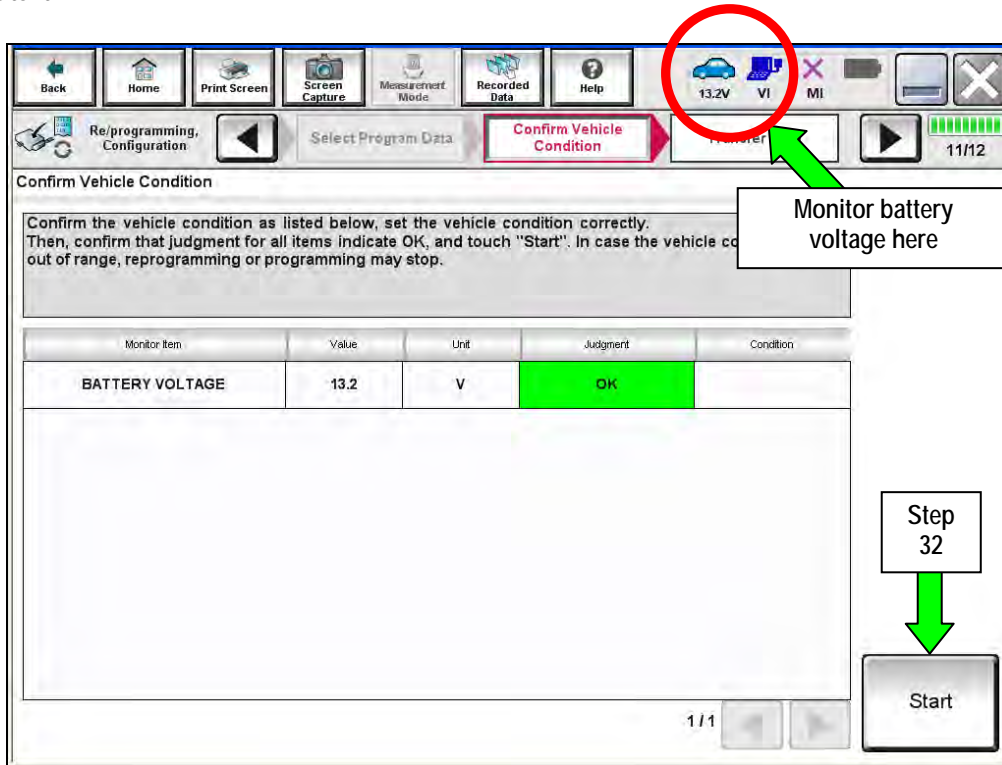
Figure 15

NOTE: In the next step, the reprogramming process will begin when **Start** is selected.

32. Select **Start**.

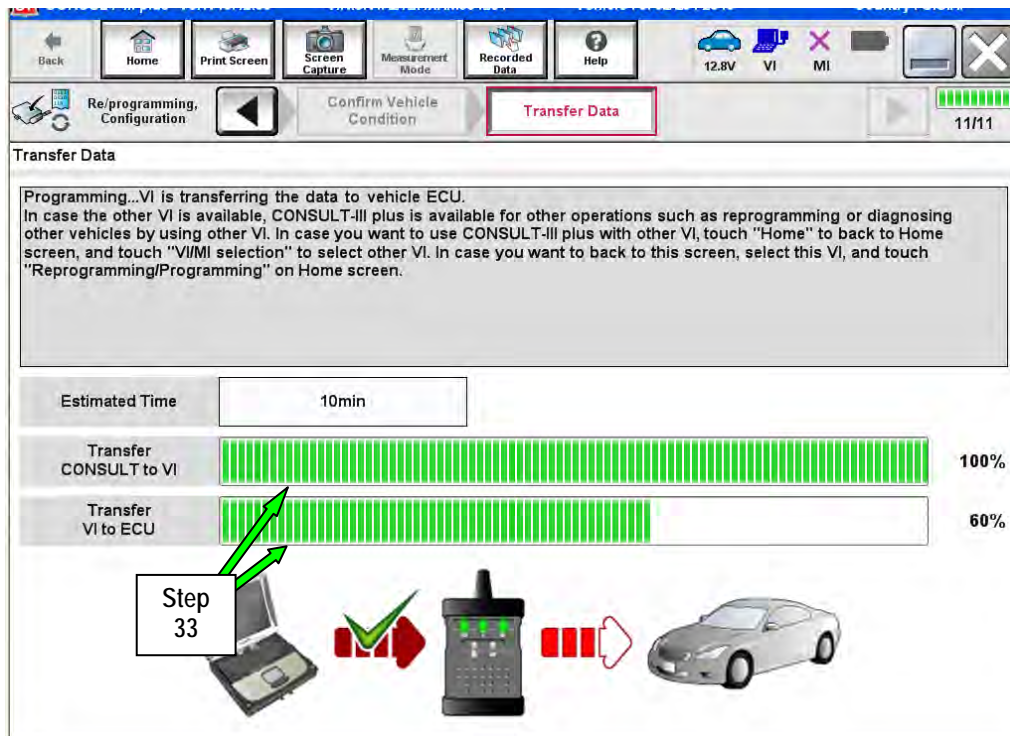
Figure 16

33. Wait for both progress bars to complete.

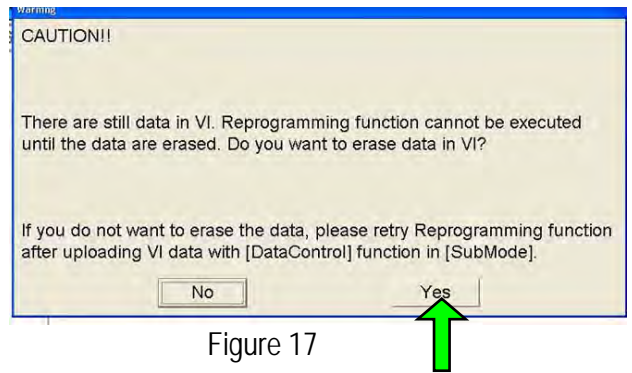
**NOTE:** If the message shown in Figure 17 appears, there is data stored in the plus VI. Select "Yes" to proceed with reprogramming.

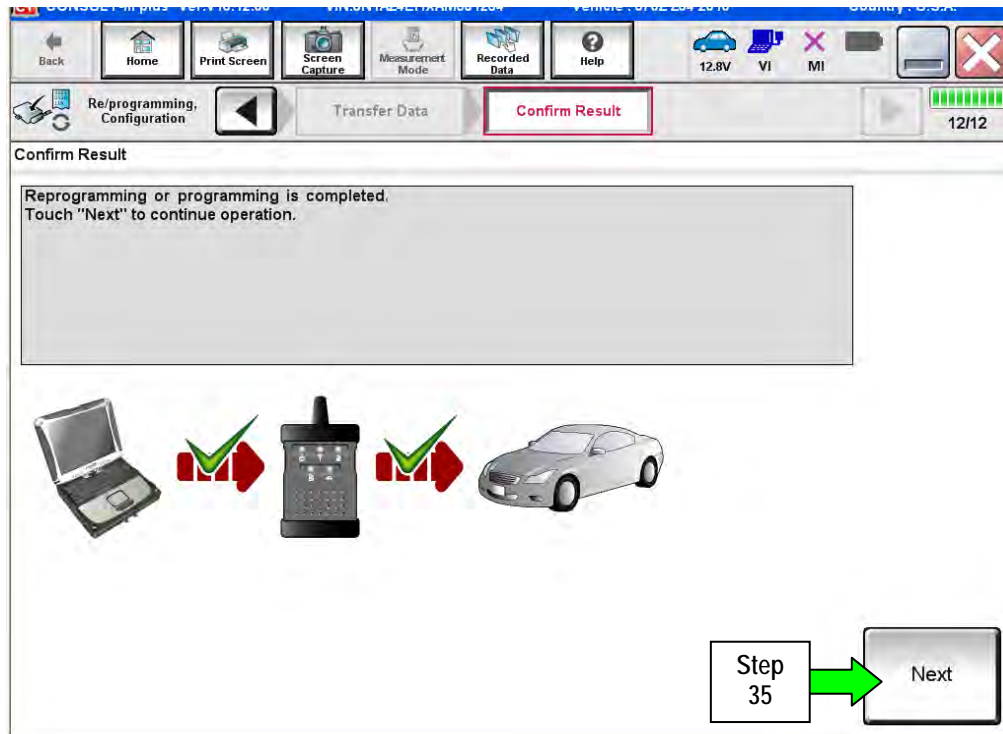
34. When the screen in Figure 18 displays, the reprogramming is complete.

35. Select **Next**.

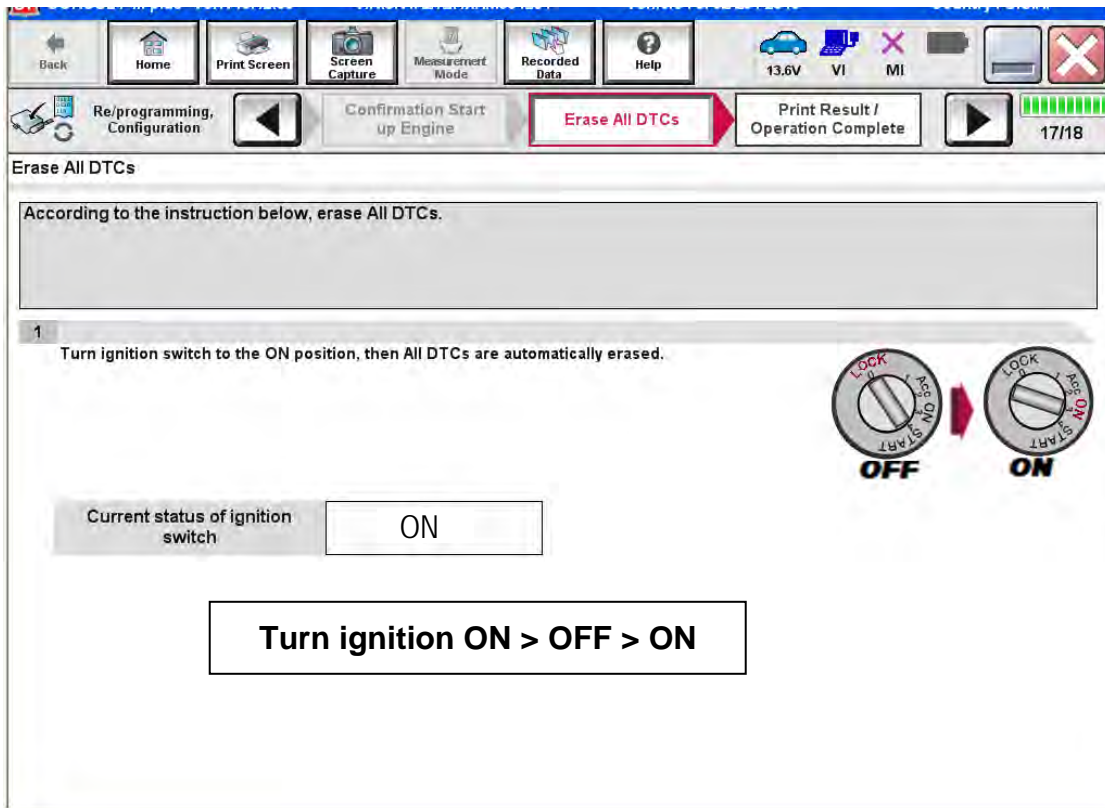
Figure 19

36. Wait for System Call to complete (a progress bar will display).

37. Erase all DTCs as follows:

- a. Turn the ignition OFF.
- b. Turn the Ignition ON (foot off of brake – push button twice).
- c. Wait for DTC erase to complete.

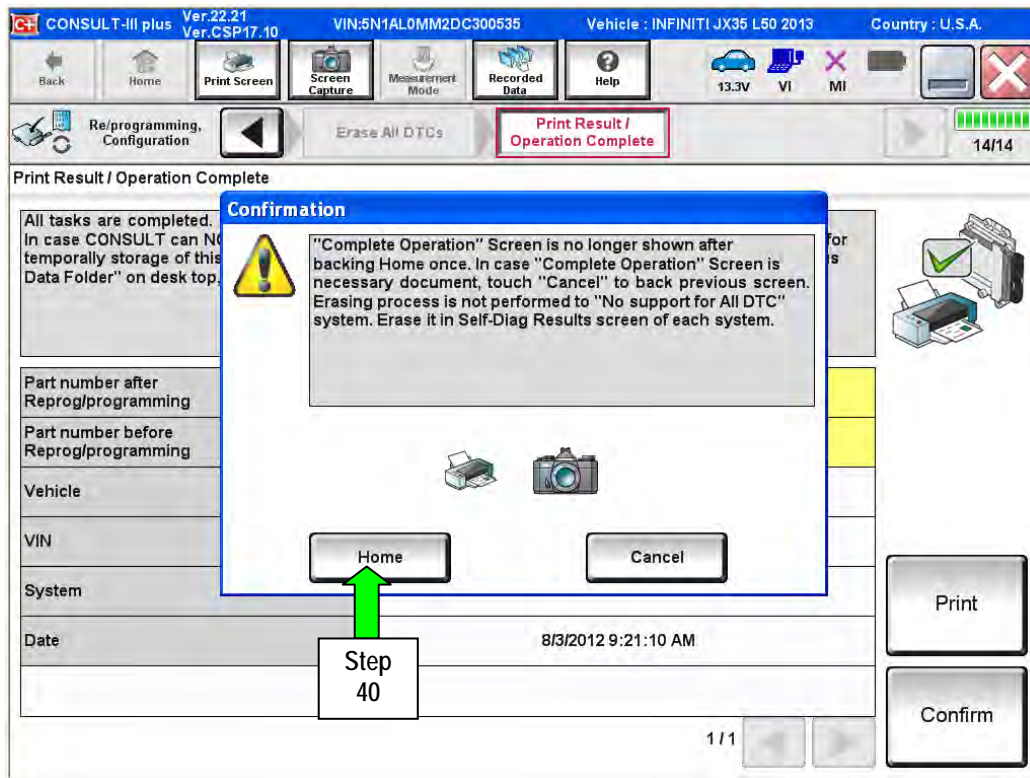
Figure 21

40. Select Home

- Return to step 12 and perform reprogramming for ADAS.
- If both reprograms have been done (RADAR and ADAS), continue with the next step.

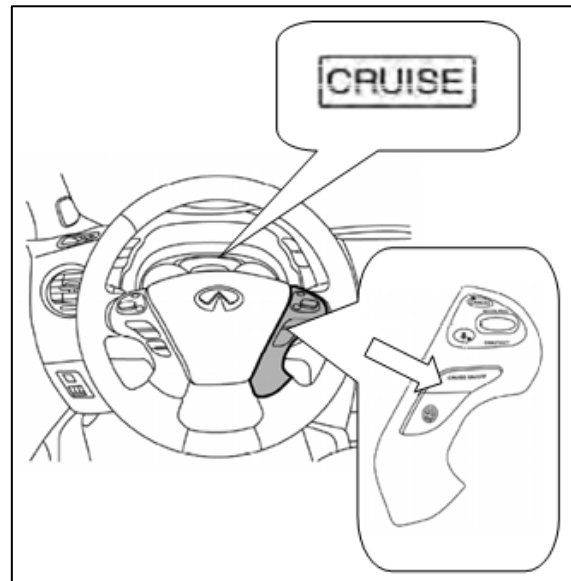
Figure 22

46. Push the CRUISE ON/OFF switch on the steering wheel.

47. Watch the "CRUISE" lamp for one minute.

- If CRUISE lamp is ON steady (normal) after one minute, check is OK.
