## VOLUNTARY SERVICE CAMPAIGN 2013 JX35 INTELLIGENT BRAKE ASSIST

**CAMPAIGN I.D. #:** P2540**APPLIED VEHICLE:** 2013 JX (L50)

Infiniti is conducting a voluntary service campaign on certain 2013 JX35 vehicles to reprogram the RADAR and ADAS Control Units. This procedure will be performed at no charge for parts or labor.

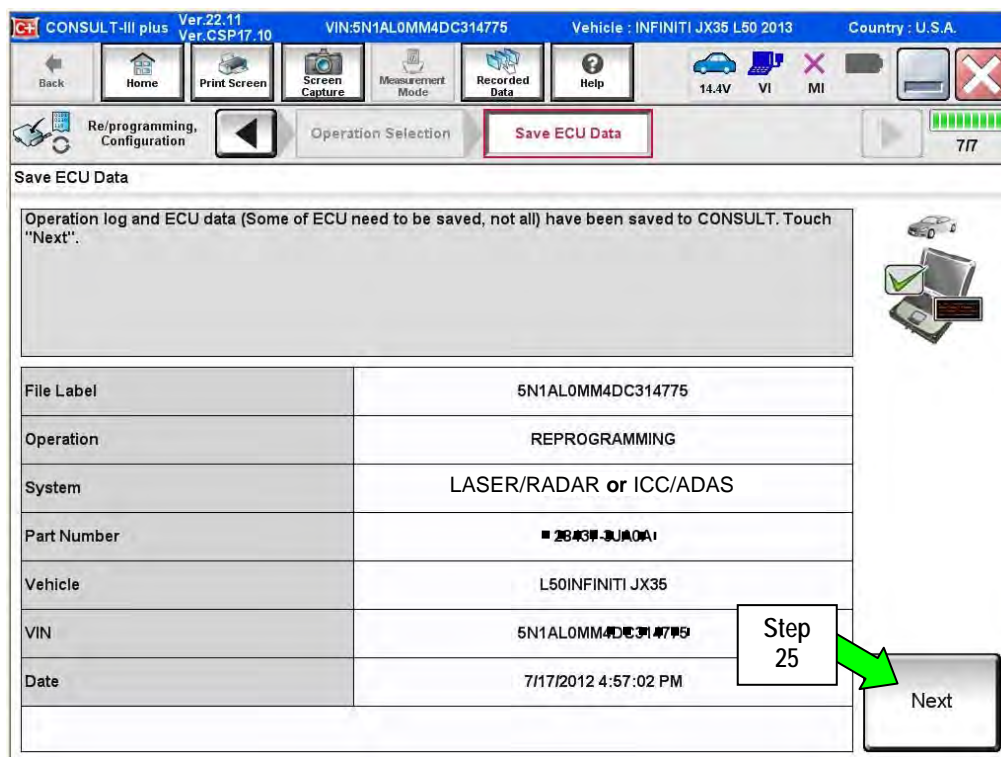
Figure 10

25. Select Next
