**WC34 - Re-programming Front-end Electronics Control Unit and Rear-end Electronics Control Unit (Workshop Campaign)**

**Model Year: As of 2012 up to 2013**

**Vehicle Type: 911 Carrera (991)/911 Carrera S (991)**

**Concerns:** **Front-end electronics control unit**  
**Rear-end electronics control unit**

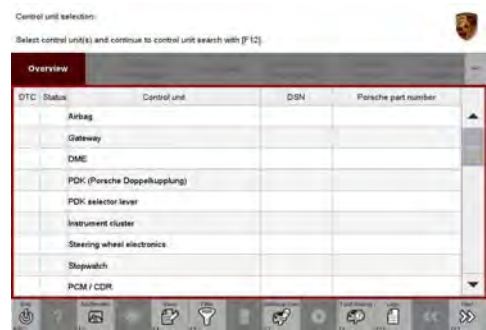
Control unit selection

- 2 In the control unit selection screen (⇒ **'Overview'** menu), press **(F7)** to call up the ⇒ **'Additional menu'** (⇒ *Control unit selection*).

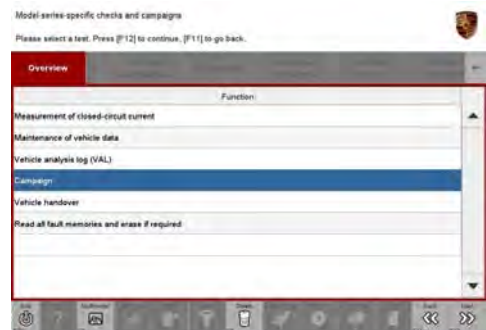
Additional menu – Campaign

- 3 When the question “Create Vehicle Analysis Log (VAL)?” appears, either press **(F12)** to create a VAL or press **(F11)** if you do not want to create a VAL.
- 4 Press **(>>)** to acknowledge the message informing you that campaigns for the vehicle are stored in the PIWIS information system.
- 5 Select the ⇒ **'Campaign'** function and press **(>>)** to confirm your selection ⇒ *Additional menu – Campaign*.

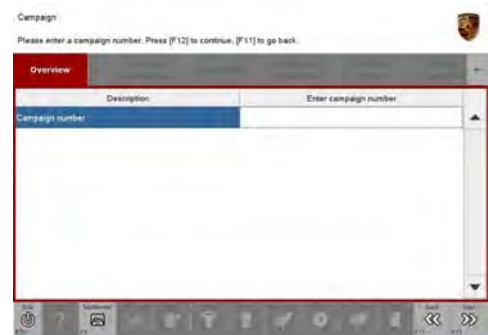
*Programming number input field*

- 6 To enter the programming number, click in the relevant text box so that the cursor starts to flash ⇒ *Programming number input field.*

- 7 Enter the programming number **WC34\_991** and press **Enter** to confirm.
