SERVICE CAMPAIGN BULLETIN

NTB12-100a

VOLUNTARY SERVICE CAMPAIGN 2009 – 2011 VERSA SPEEDOMETER AND ODOMETER REPROGRAMMING

CAMPAIGN ID #: P2508

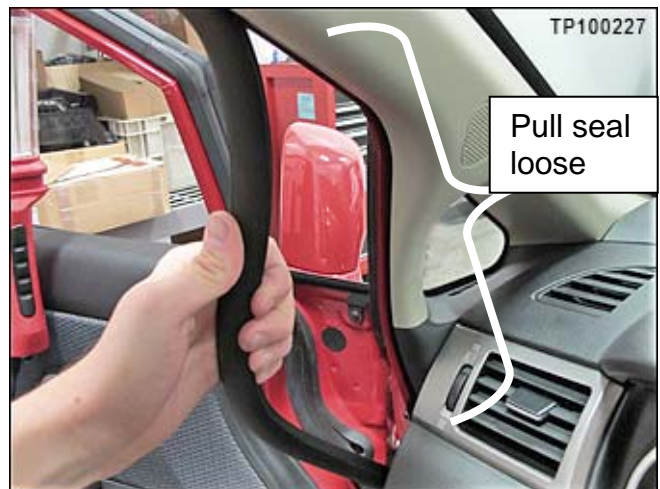
Figure 2

3. Pull the driver's door seal loose in the area shown in Figure 2.

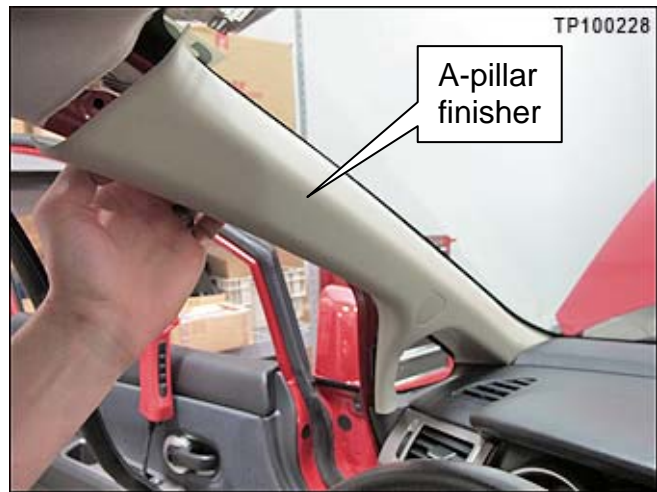
Figure 3

4. Snap loose and remove the A-pillar finisher.
 - Use a plastic trim tool as needed.

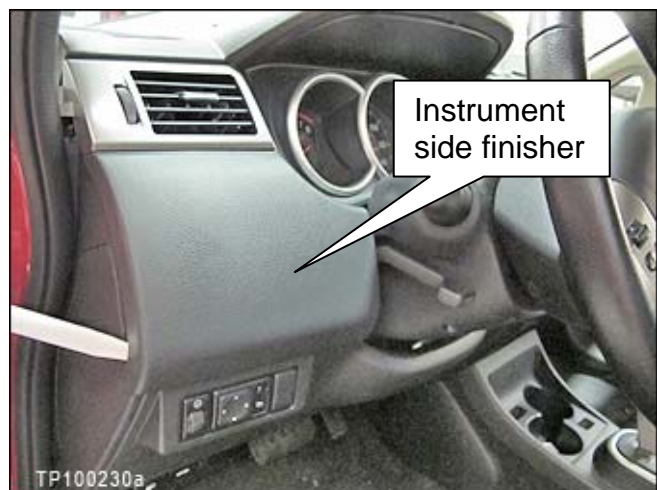
Figure 5

6. Snap loose and remove the instrument side finisher.
 - Use a plastic trim tool as needed.

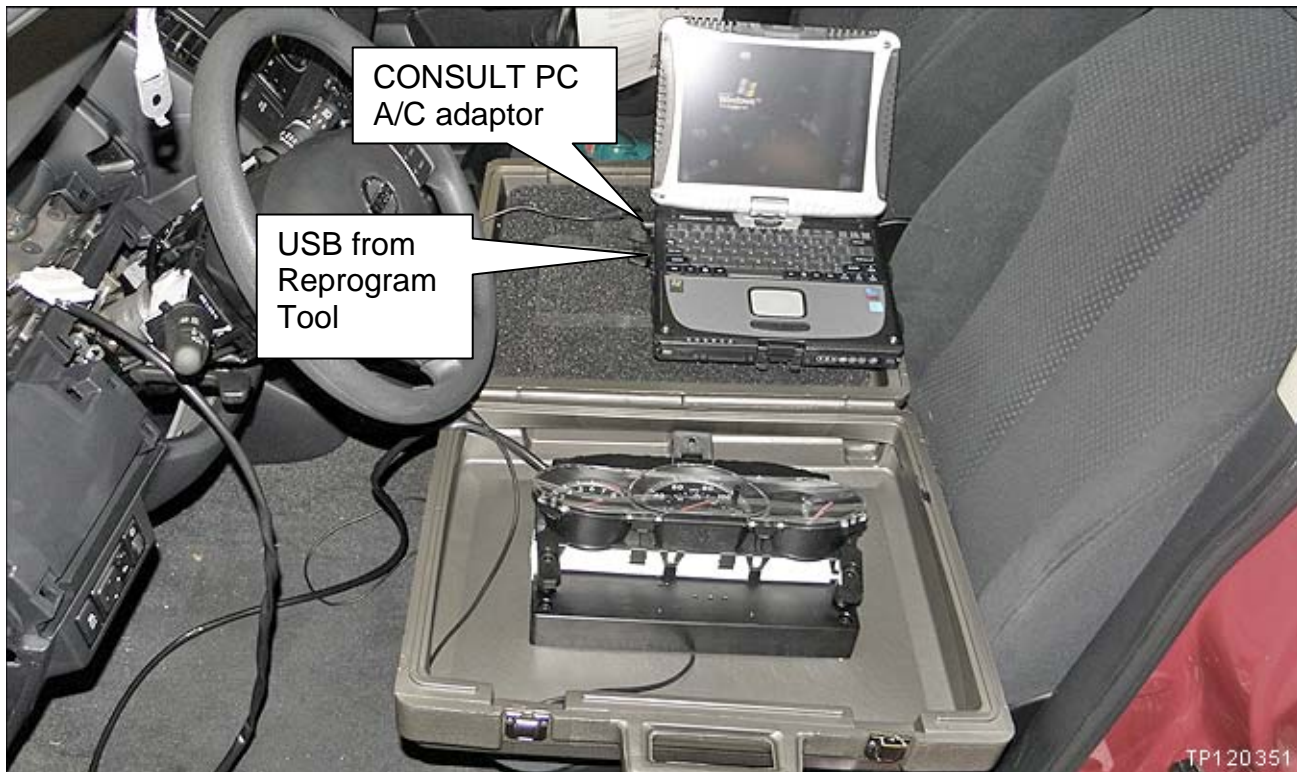
Figure 19

2. Connect the USB cable from the Reprogramming Tool to the CONSULT PC (see Figure 19).
3. Connect the AC Adapter to the CONSULT PC (see Figure 19).

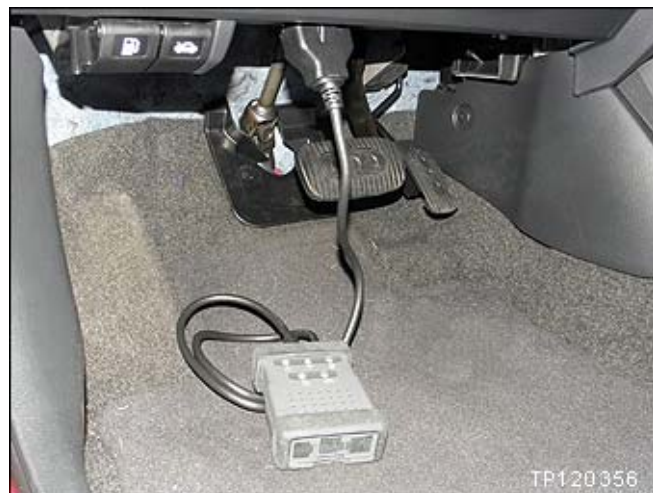
Figure 20

4. Connect the C-III plus VI to the vehicle.
