SUBJECT: **DEMONSTRATION / DELIVERY HOLD - Application Performance Upgrade 12A04**
- Supplement #2

Certain 2011-2013 Model Year Vehicles Equipped with SYNC® and MyFord/MyLincoln Touch™
Application Performance Upgrade

This program is intended to make the latest level MyFord/MyLincoln Touch™ software (BB/12285/V.3.5.1) available for all non-Electrified Vehicles produced, or previously serviced, with earlier levels of software. The latest level software is currently in production at all affected assembly plants.

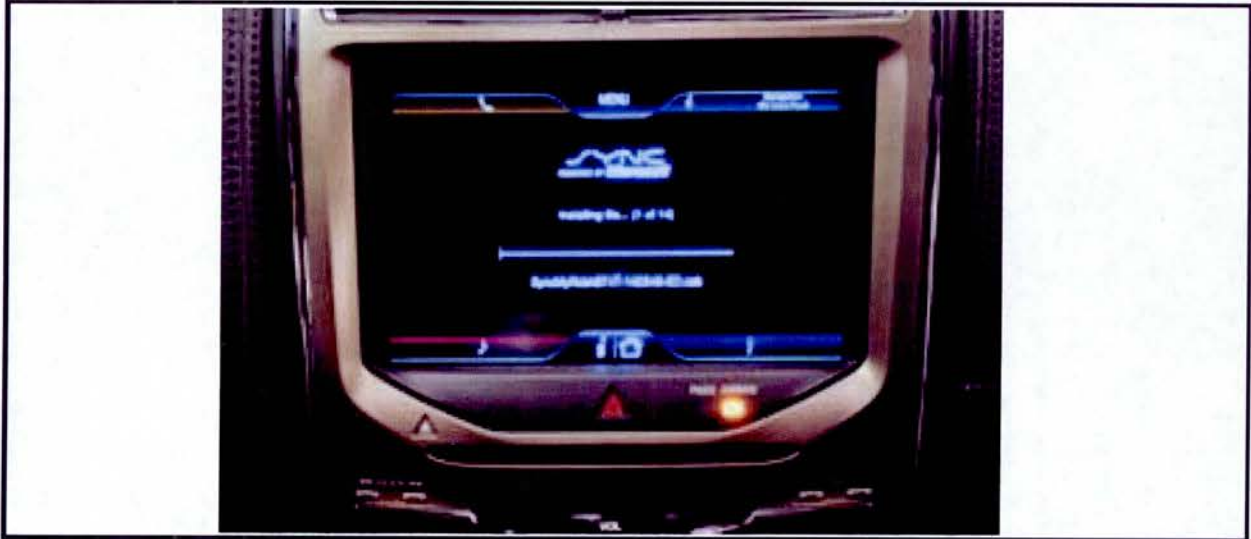
FIGURE 2

3. Install the USB drive containing BB/12285/V3.5.1 software level into one of the vehicle's USB ports. The reprogramming procedure will start automatically. See Figure 2.

NOTE: This installation procedure may cause the system to reboot several times and/or cause the screen to go dark/blank for a period of time, this is normal. The USB drive needs to remain installed during this time and should not be removed until the "Installation Complete!" screen appears.

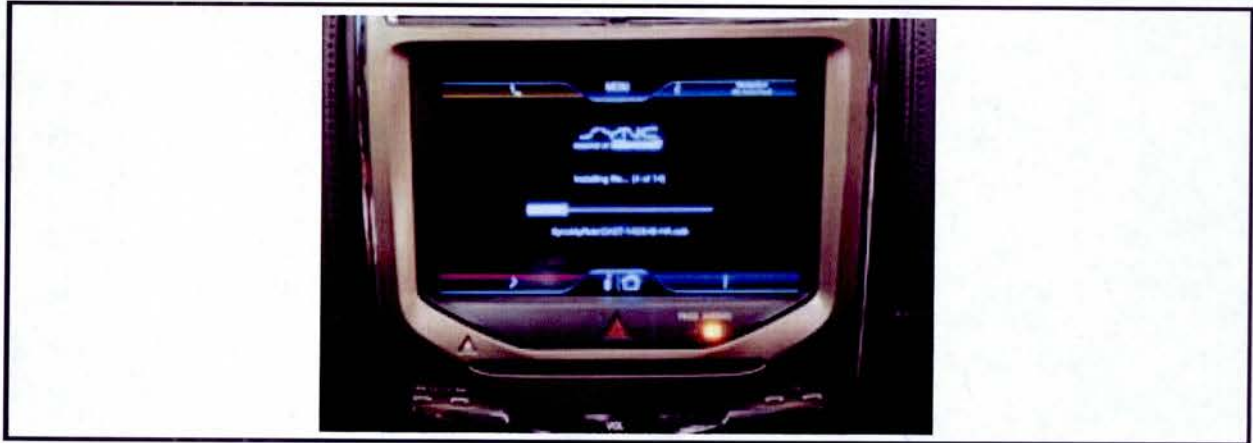
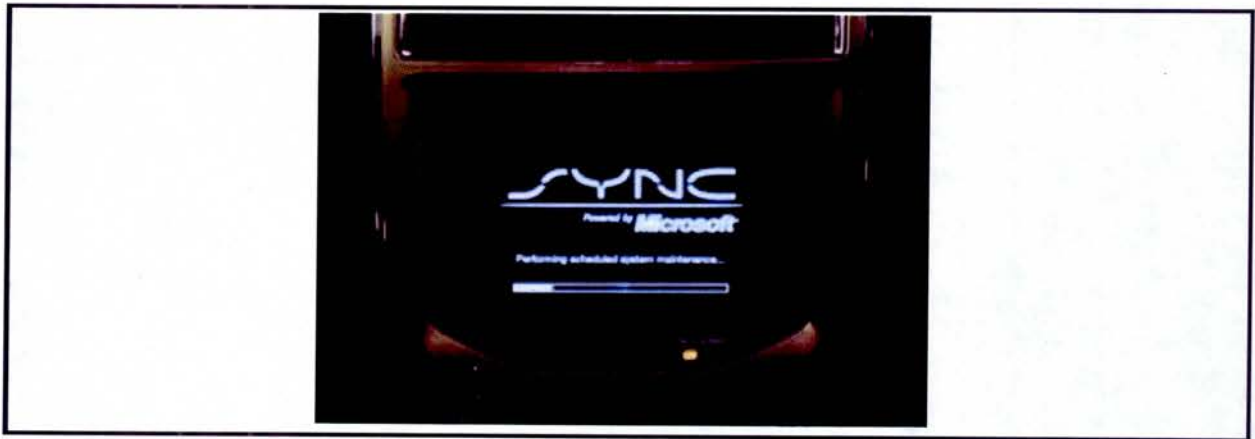
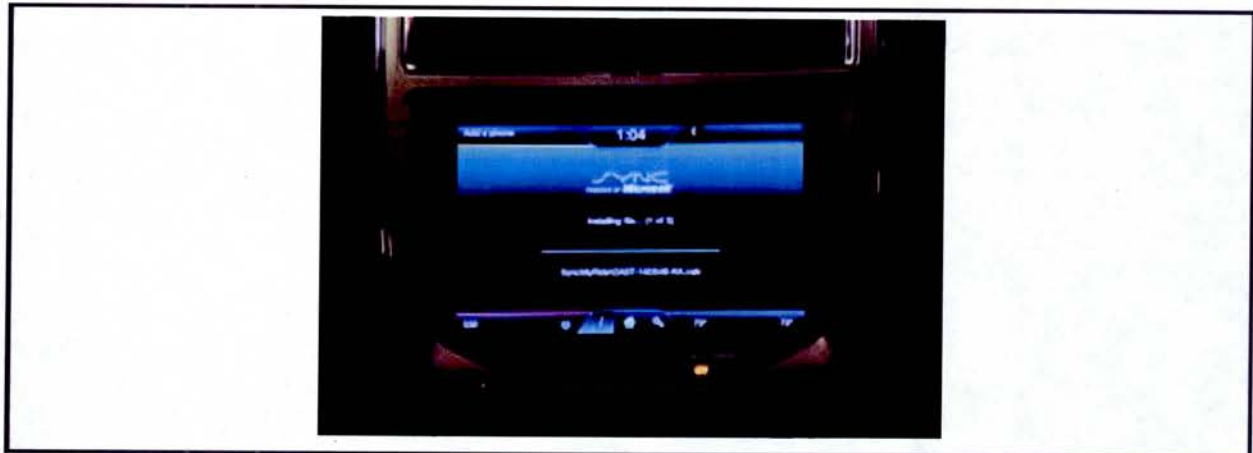
5. During the reprogramming process a series of screens may appear and/or the system will reboot with a blank screen. See Figures 4, 5, and 6.

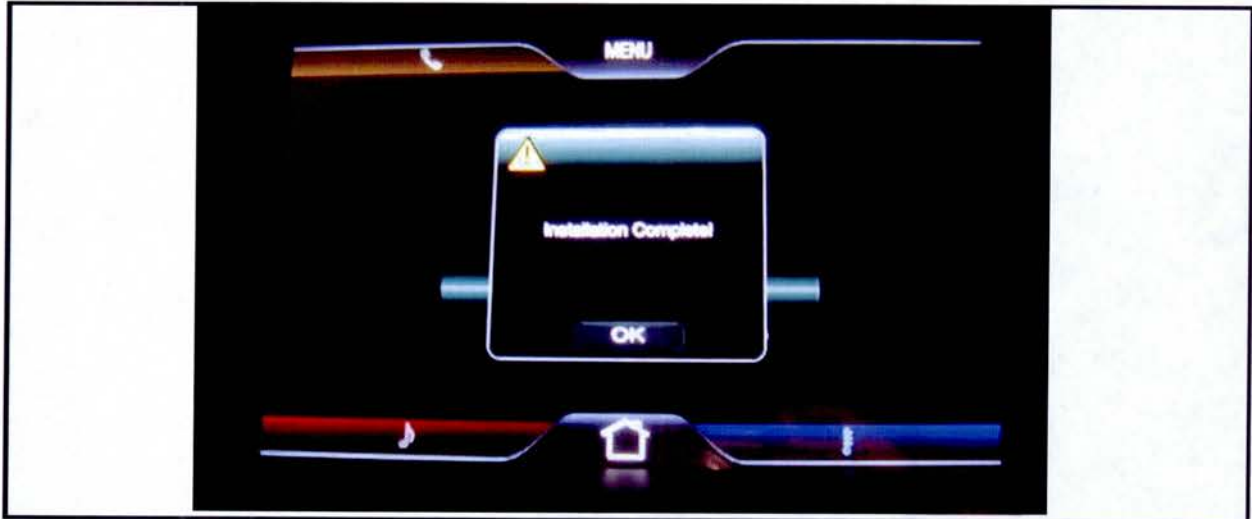
FIGURE 8

7. When the "Installation Complete!" screen appears tap "OK". See Figure 8.

NOTE: The entire upgrade is complete when you see an "Installation Complete!" message and you press "OK" on the center screen or when the home screen appears.

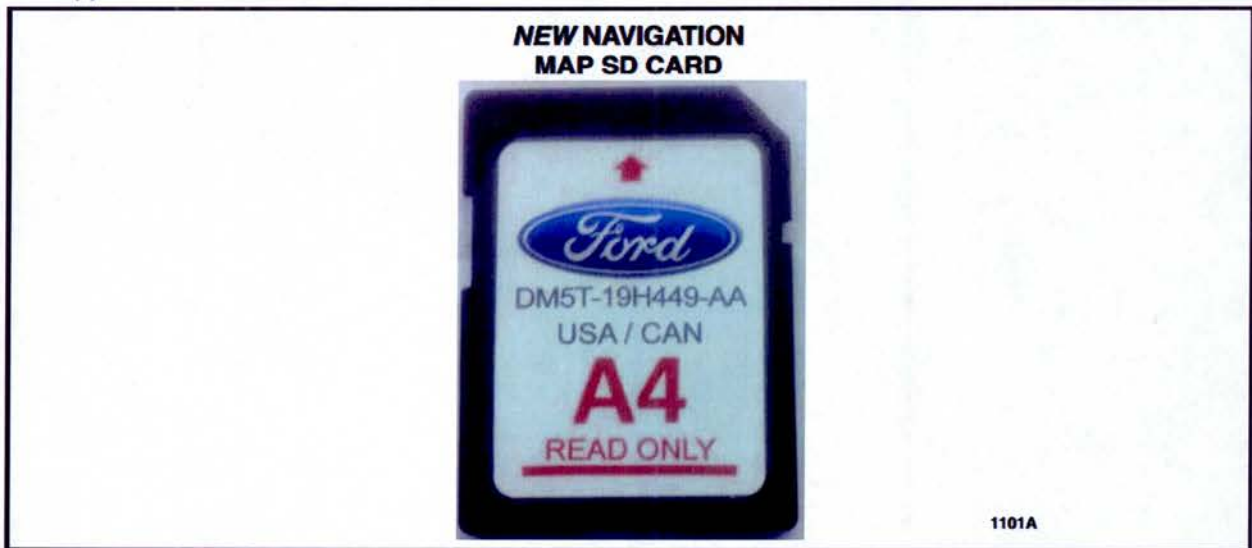
FIGURE 9

NOTE: After the reprogramming procedure has completed, an SD card fault will appear on the screen. This is normal.

9. Remove the Navigation Map SD Card from the vehicle's map card slot.
10. Tap "SD Nav" on the FDIM to clear the SD card fault.
11. Install the *new* Navigation Map SD Card into the vehicle's map card slot. See Figure 9. Wait for the *new* Navigation Map SD Card to be recognized and tap "OK" when the "SD Card Detected" screen appears on the FDIM.
