Technical Service Bulletin

PSS 37 Transmission warning message in cluster. Gearbox in limp mode, Fault P17E100 stored in TCM

37 13 90 2032971/1 February 11, 2013.

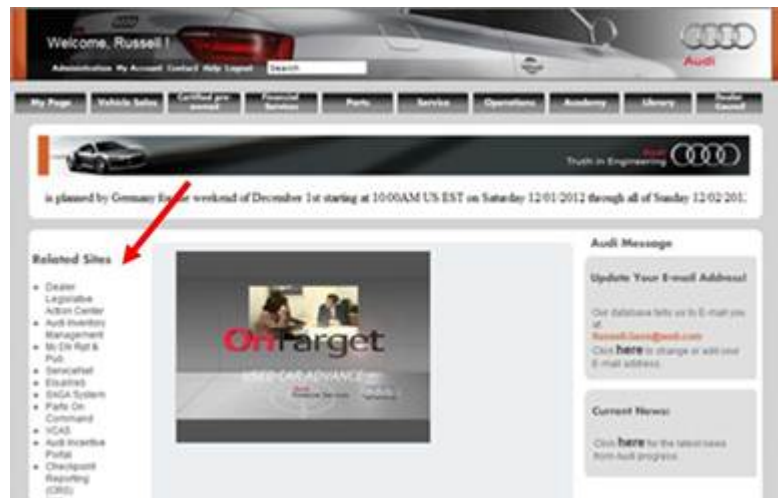
3. Create a PSS record in the PSS application via the hyperlink in Accessaudi.com (Figure 2) or Technical Assistance page in Elsa (Figure 3).

Figure 2. Related Sites section on Accessaudi.com landing page
