Technical Service Bulletin

NUMBER GROUP 13-01-002 CAMPAIGN DATE MODEL(S) SANTA FE (AN) **JANUARY 2013**

SANTA FE MDPS UPDATE (SERVICE CAMPAIGN TN8)

Description: This bulletin describes the procedure to update the MDPS (motor driven power steering) software on some 2013MY Santa Fe (AN) vehicles.

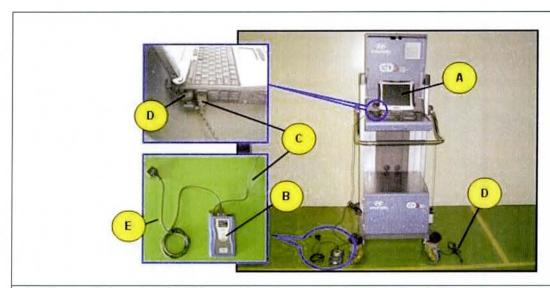
1. GDS INSTALLATION PROCEDURE

A: Diagnostic terminal / B: VCI (Vehicle Communication Interface) / C: USB (Universal Serial Bus) cable / D: Power supply cable / E: DLC cable

Connect the power supply cable to the diagnostic terminal.

Connect the USB cable between the VCI and the diagnostic terminal.

- Connect the 16-pin DLC cable from the VCI into the vehicle's 16-pin connector under the driver side instrument panel.
- Set the ignition to the ON position.

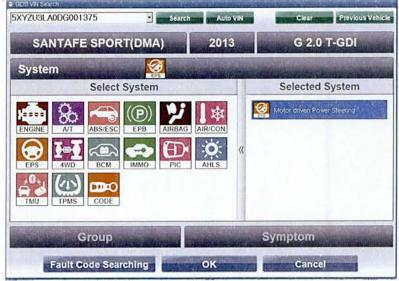
- Choose VIN or ECU Upgrade on the initial screen.
- Enter the vehicle information by pressing the VIN Auto Detect button, entering the vehicle's VIN or selecting the vehicle model, model year, engine/fuel type and EPS (MDPS, Motor Driven Power Steering) as the system and then click OK.

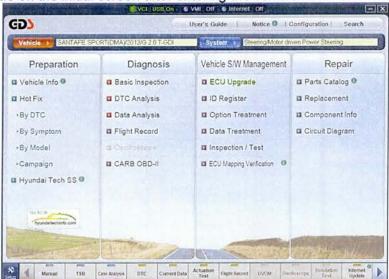
Select ECU Upgrade on the initial screen after entering the vehicle information.

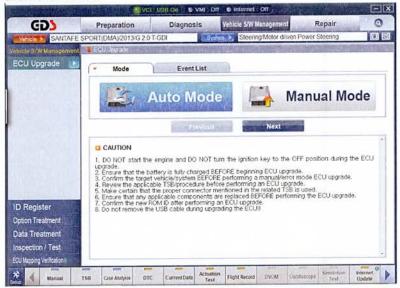
Select Auto Mode then click Next.

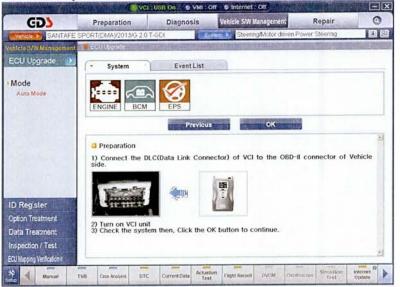
Select EPS, then read the Preparation and click OK.

The GDS will read the vehicle's ROM ID.

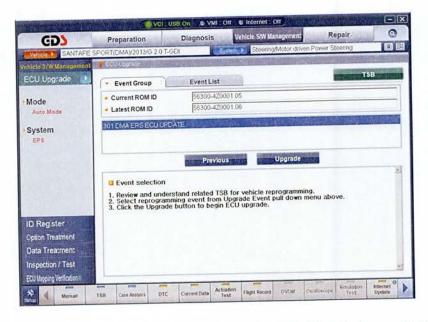
After the Current ROM ID is displayed, select the upgrade event, "301.DMA EPS ECU UPDATE."

Click Upgrade.

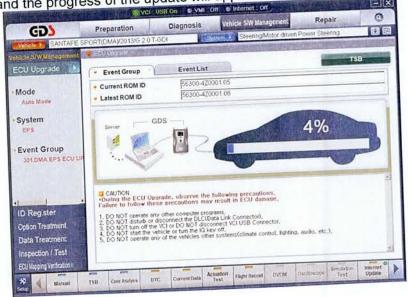
10. Update will begin and the progress of the update will appear on the bar graph.

Update will occur until 100% is reached on the bar graph. Turn the ignition OFF for 10 seconds, and then back ON again. Click OK to continue.

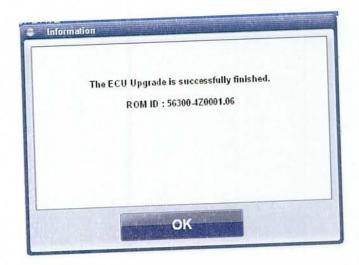
Click **OK** on the final screen, which indicates update is complete.

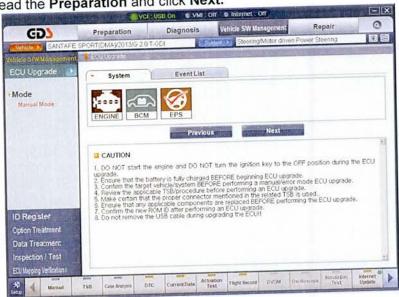
Select EPS, then read the Preparation and click Next. 2.

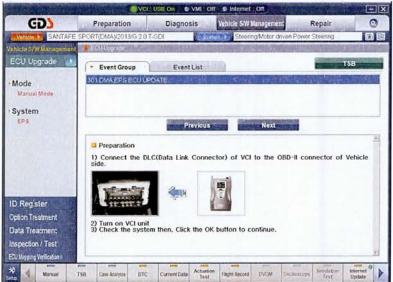
Select the upgrade event, "301.DMA EPS ECU UPDATE" and click Next.

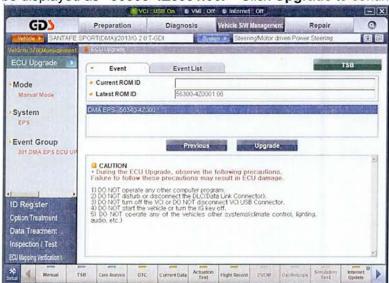
Latest ROM ID will be displayed as "56300-4Z0001.06." Click Upgrade to continue.

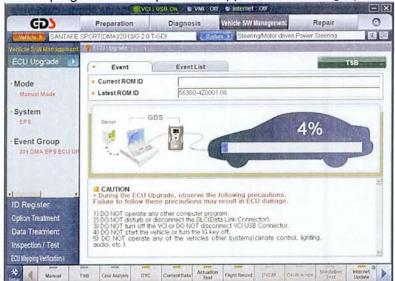
8. Update will begin and the progress of the update will appear on the bar graph.

Update will occur until 100% is reached on the bar graph. Turn the ignition OFF for 10 seconds, and then back ON again. Click OK to continue.

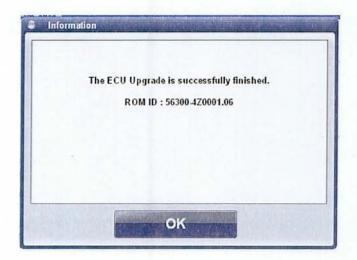
Click **OK** on the final screen, which indicates update is complete.
