Technical Service Bulletin

SUBJECT:		No: TSB-13-13-005REV	
ECM REPROGRAMMING FOR FALSE MIL (P2100) OR HARD TO START WITH ENGINE COLD – REV.		DATE: May, 2013	
		MODEL: 2010-2012 Outlander	
CIRCULATE TO:	<input type="checkbox"/> GENERAL MANAGER	<input checked="" type="checkbox"/> PARTS MANAGER	<input checked="" type="checkbox"/> TECHNICIAN
<input checked="" type="checkbox"/> SERVICE ADVISOR	<input checked="" type="checkbox"/> SERVICE MANAGER	<input checked="" type="checkbox"/> WARRANTY PROCESSOR	<input type="checkbox"/> SALES MANAGER

This TSB provides field fix information on hard-to-start engine conditions or DTC P2100 detection (P2100: Disconnection on throttle valve control servo circuit). New ECM software modifies the EGR intake air activation temperature to avoid freezing the ETV and false P2100 detection.

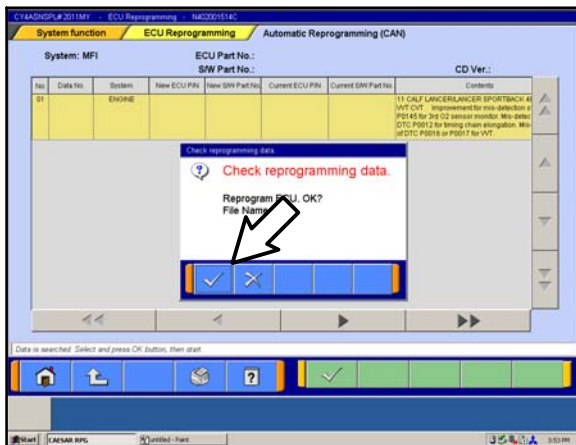
- m. A message will ask you to “Check reprogramming data.”
- n. Click on the check mark to begin reprogramming.

It will take up to 5 minutes for reprogramming to complete.
