Emissions Service Action

Code: 24Y7

**Subject: 2011-2012 Routan with 3.6L engine
PCM Software Update**

May 01, 2013

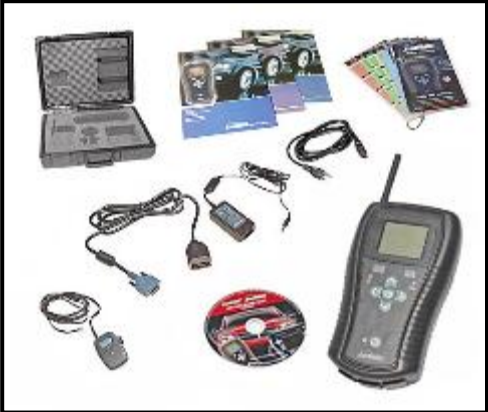
<ul style="list-style-type: none">• StarMOBILE Diagnostic Tool
---	--

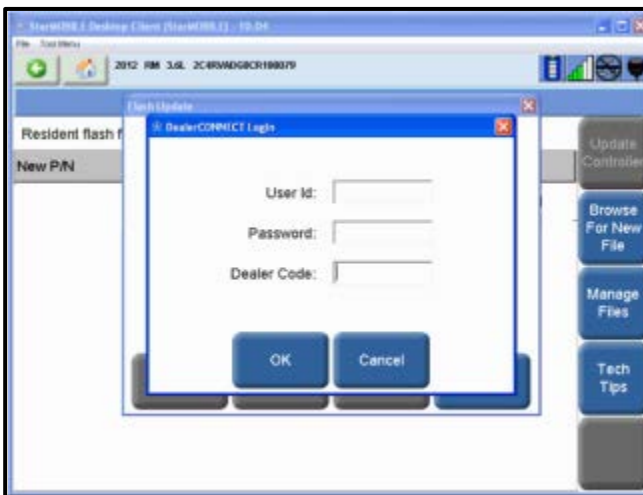
- ⇐ If this screen is displayed, Select "Download from DealerCONNECT".
- ⇐ Select "Next" <arrow>.

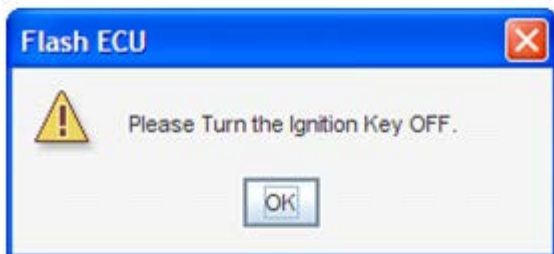
- If this message is displayed, select “OK”.

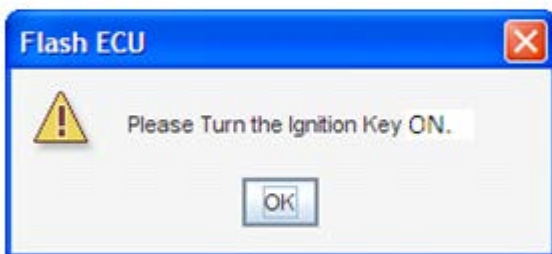
← Cycle the ignition off, then back on following the on-screen prompts.

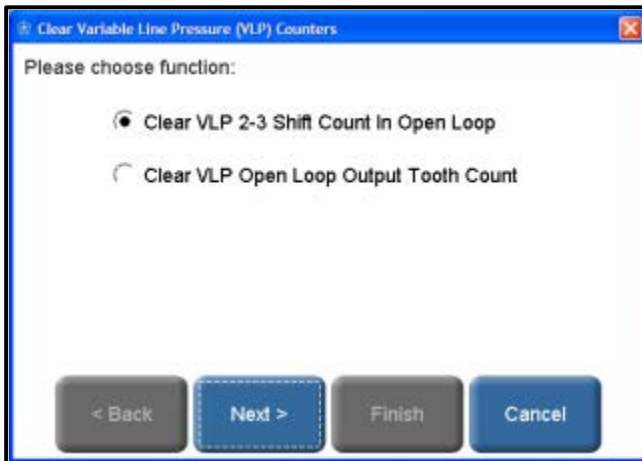
- Select "Next".

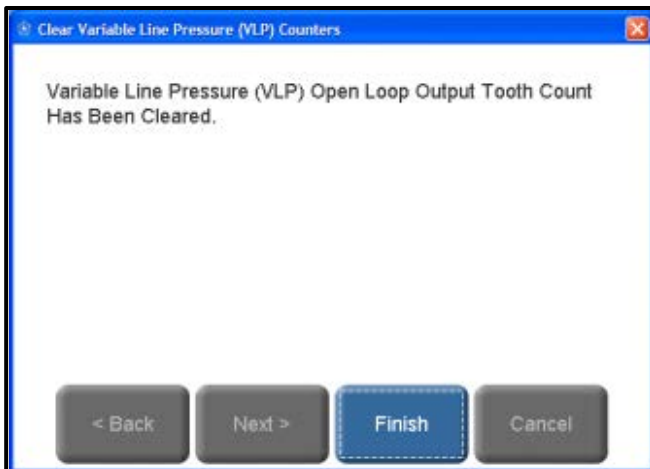
Note: It will be necessary to follow this test plan for each option listed.

- Select "Next".
- Follow the screen prompts to "Clear VLP 2-3 Shift Count In Open Loop".
- Repeat the procedure to "Clear VLP Open Loop Output Tooth Count".

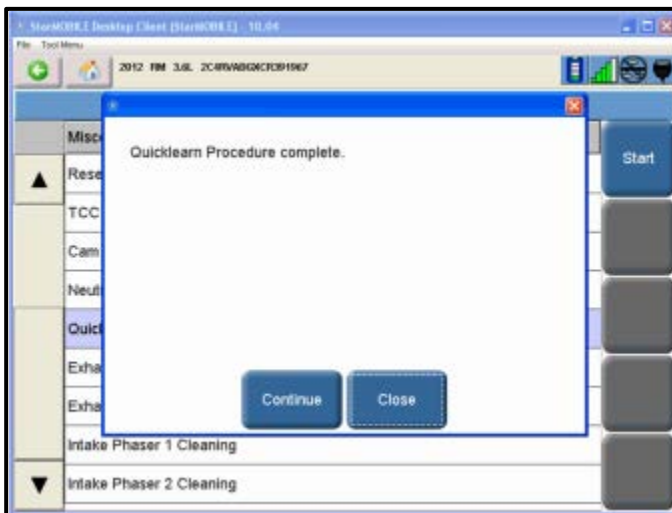
- Start the engine.
- ⇐ Select “Quicklearn (62TE)” <arrow> and press the “Start” button.
- Follow the screen prompts to complete the Quicklearn procedure.

Note: The Quicklearn procedure must be performed while sitting in the vehicle.

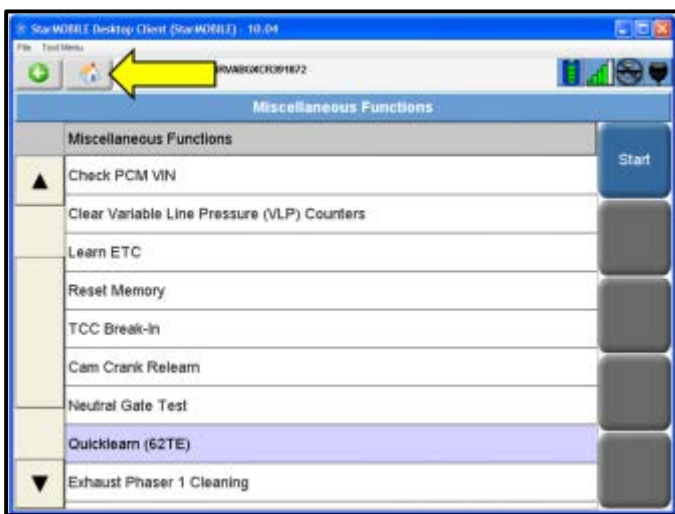
Note: The test plan may not properly display the confirmation message.

- If this screen is displayed (left) for more than 60 seconds with no change, Quicklearn procedure is complete.
- Select "Close".

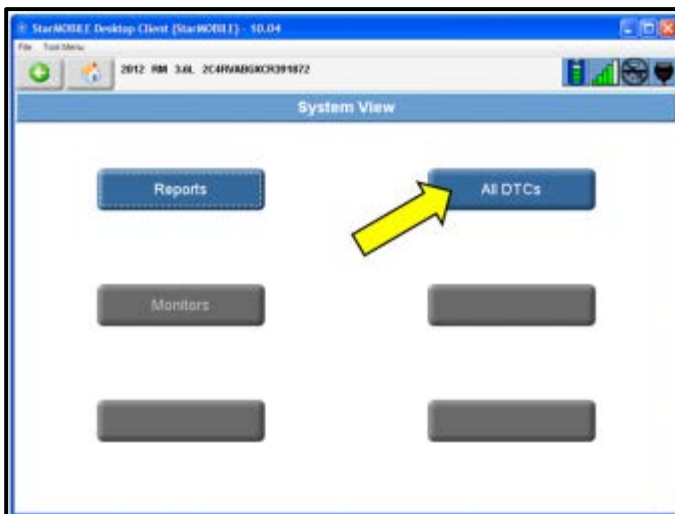
← Select "Home" button <arrow>.
