Classification:
EC13-010a

Reference:
ITB13-030a

2012-2013 M HYBRID; MIL "ON" WITH DTC P0300, P0301, P0302, P0303, P0304, P0305, OR P0306 STORED

APPLIED VEHICLES: 2012-2013 M35 Hybrid (HY51)

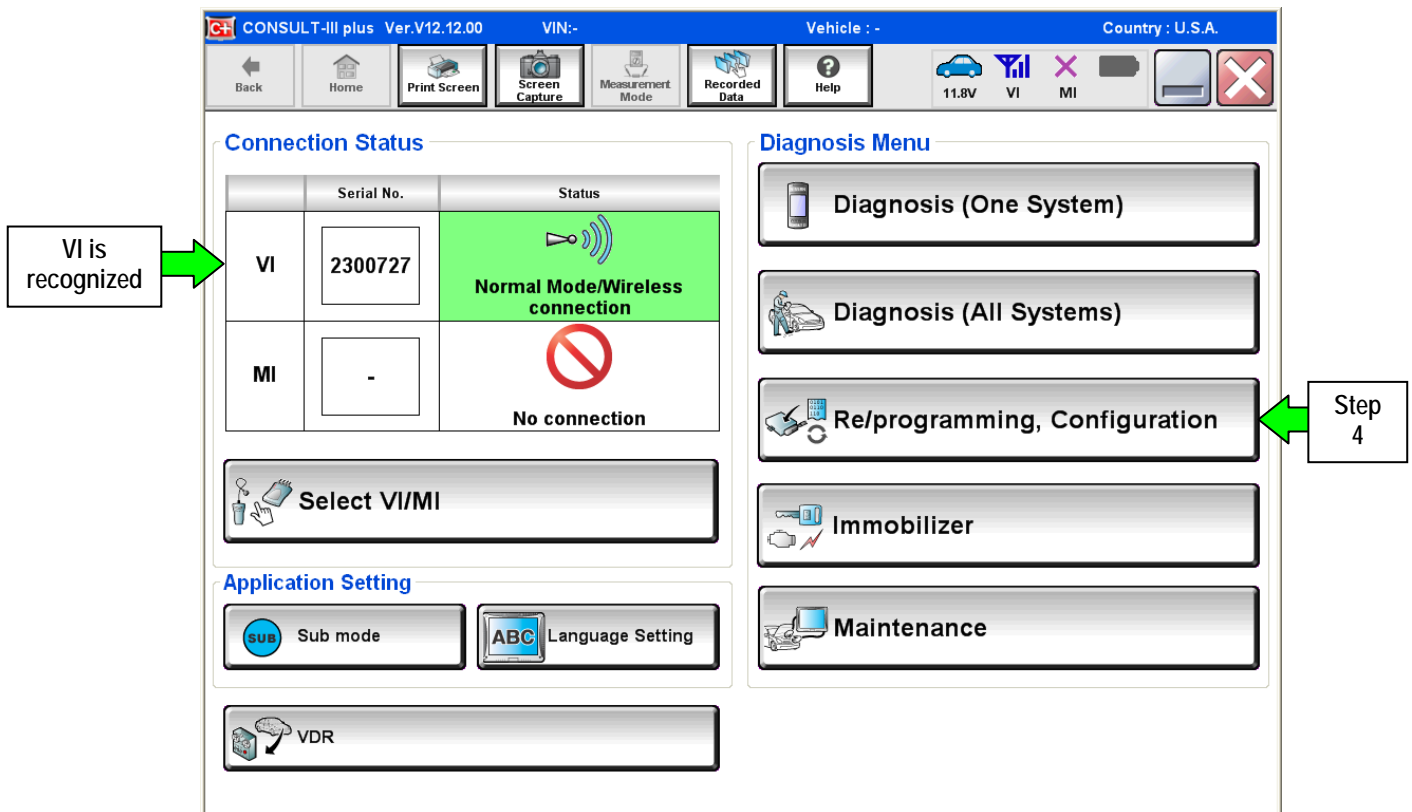
Figure 1

1. Connect the CONSULT PC to the vehicle to begin the reprogramming procedure.
2. Start C-III plus.
3. Wait for the plus VI to be recognized.
 - The serial number will display when the plus VI is recognized.
4. Select Re/programming, Configuration.

- Follow the on-screen instructions and navigate the C-III plus to the screen shown in Figure 2 on the next page.

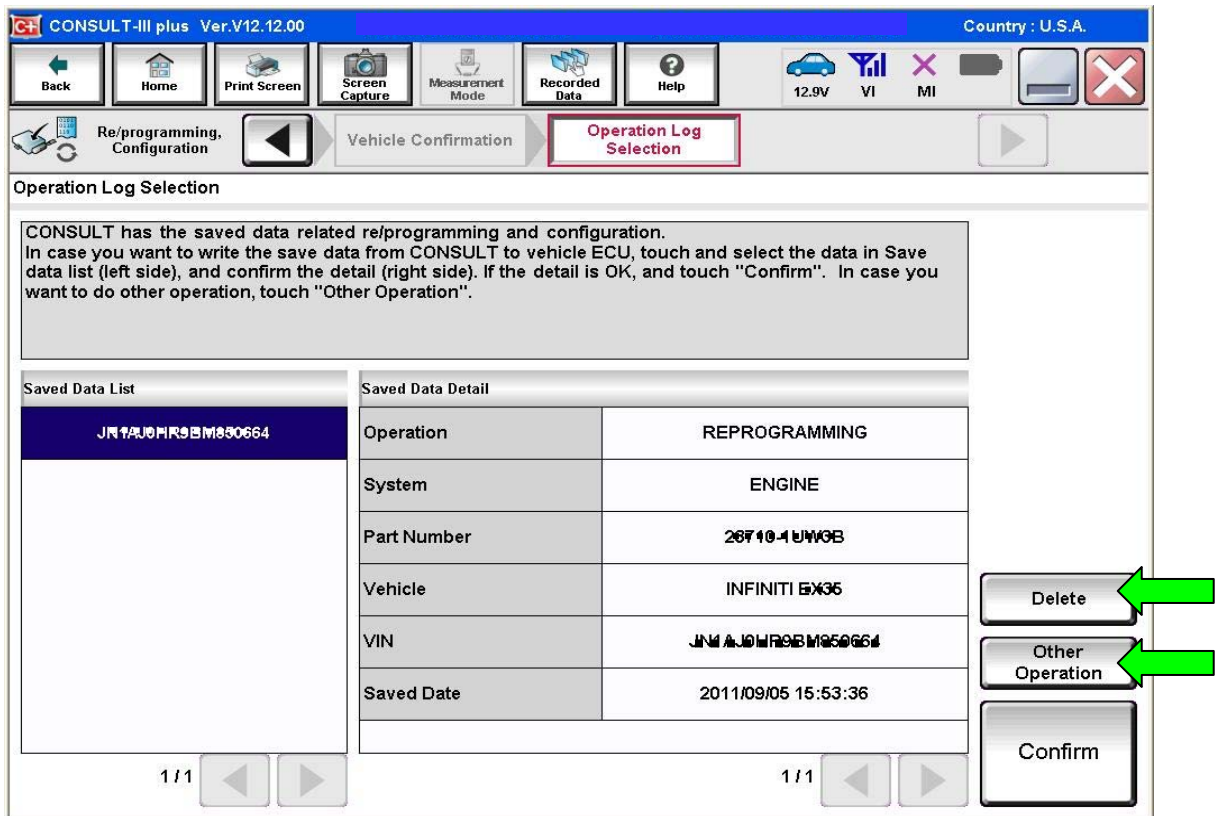
Figure 1a

During the initial "Reprogramming Confirmation" set-up, if you get this screen (Figure 1a):

- Select **Delete**.
- Select **Other Operation**.
- Continue with the reprogramming procedure.

NOTE: If reprogramming does not complete, this screen can display for reprogramming recovery. Do not select Delete if this screen displays during reprogram recovery.

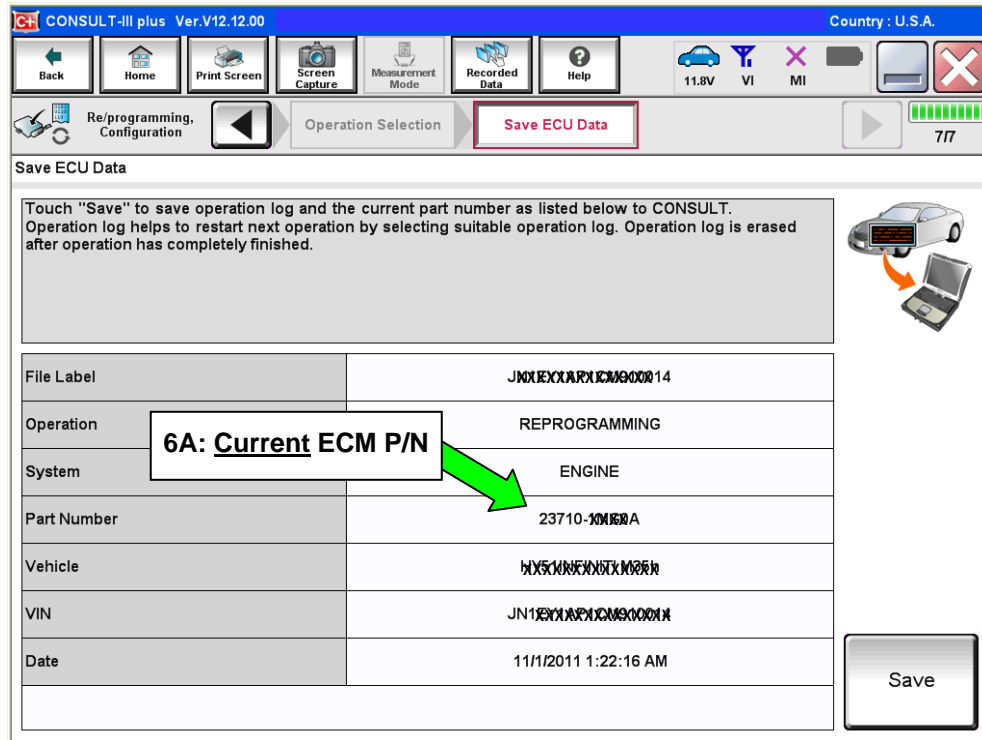
Figure 2

6. When you get to the screen shown in Figure 2, confirm this bulletin applies as follows.

A. Find the ECM **Part Number** and write it on the repair order.

NOTE: This is the current ECM Part Number (P/N).

B. Compare the P/N you wrote down to the numbers in the **Current ECM Part Number** column in **Table A** below.

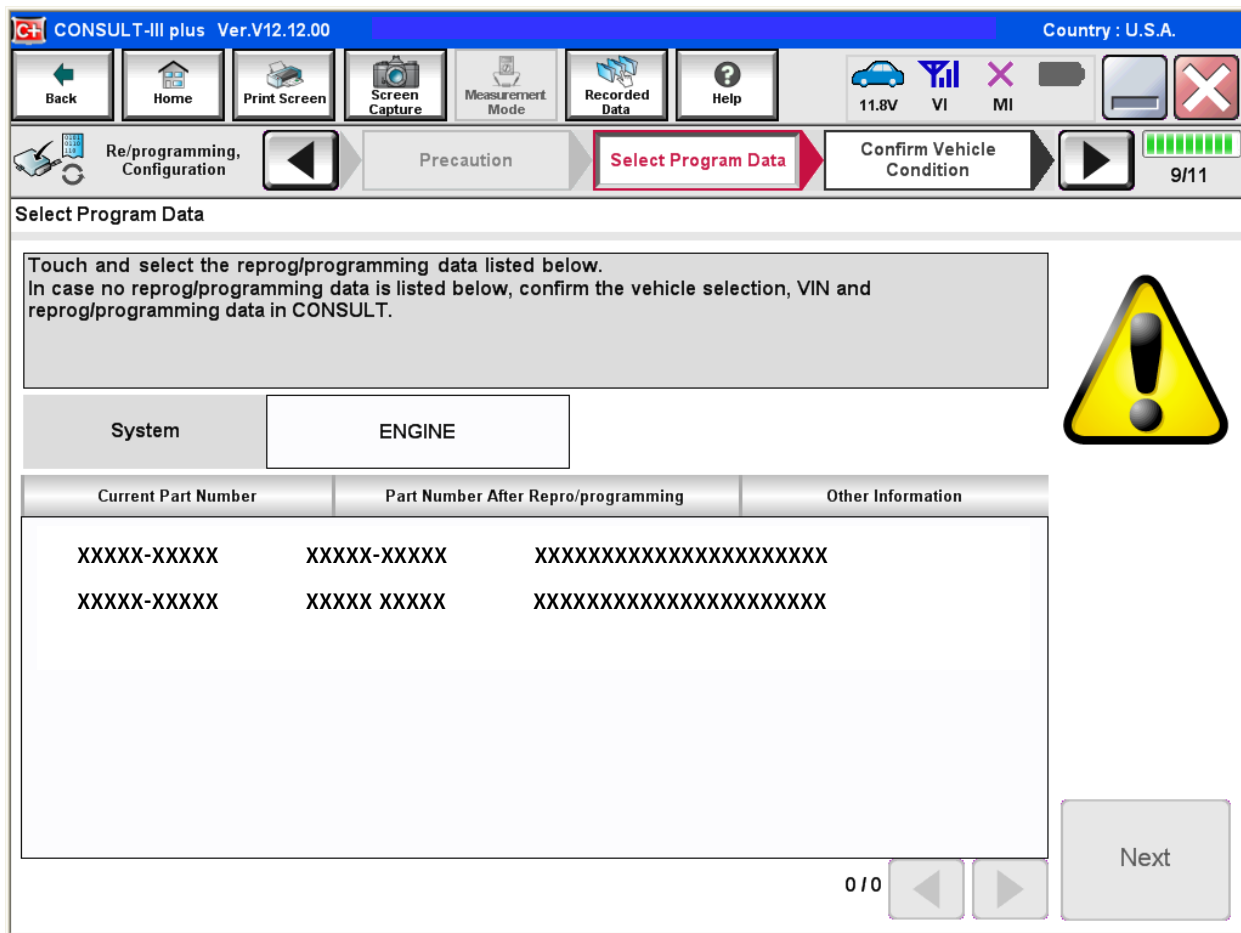
- In some cases, more than one new P/N for reprogramming is available.
 - In this case, the screen in Figure 3 displays.
 - Select and use the reprogramming option that **does not** have the message “Caution! Use ONLY with ITBXX-XXX”.
- If you get this screen and it is blank (no reprogramming listed), it means there is no reprogramming available for this vehicle. Close C-III plus and refer back to ASIST for further diagnosis.

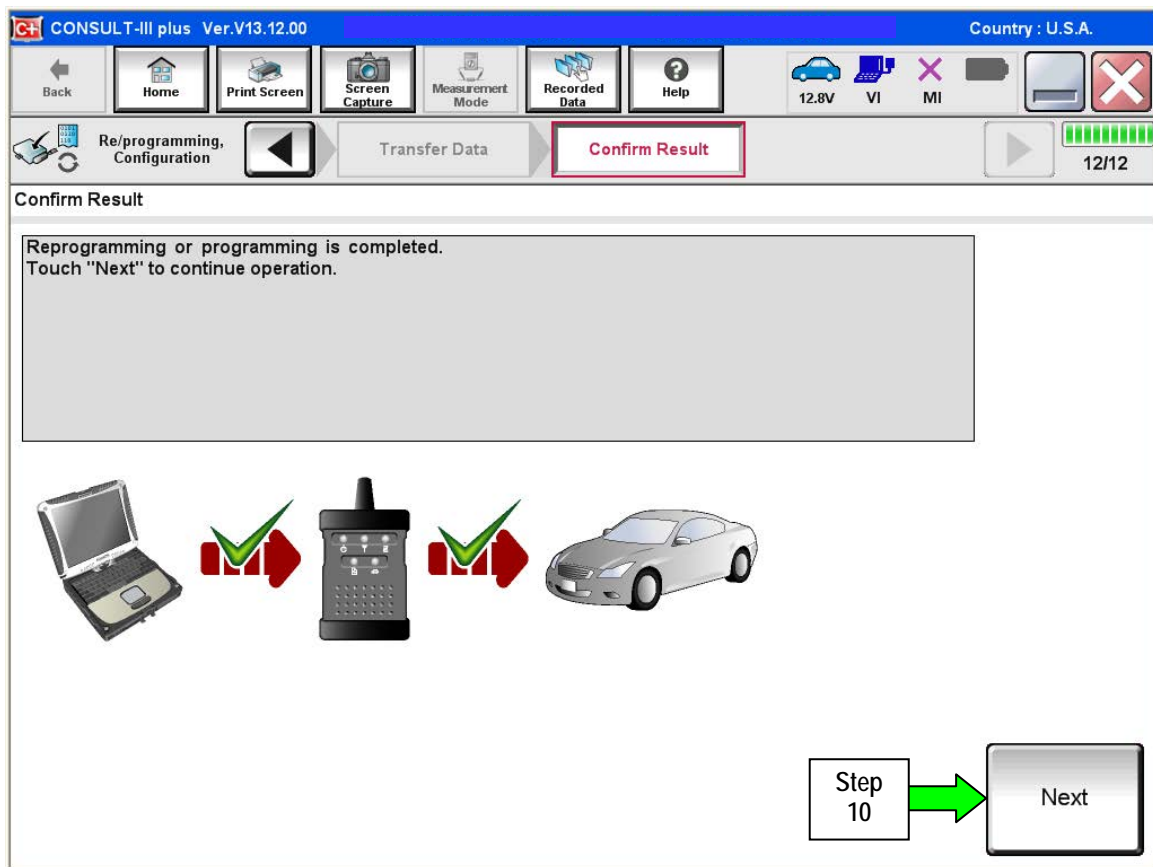
8. When the screen in Figure 4 displays, reprogramming is complete.

NOTE: If the screen in Figure 4 does not display (reprogramming does not complete), refer to the information on the page 8.

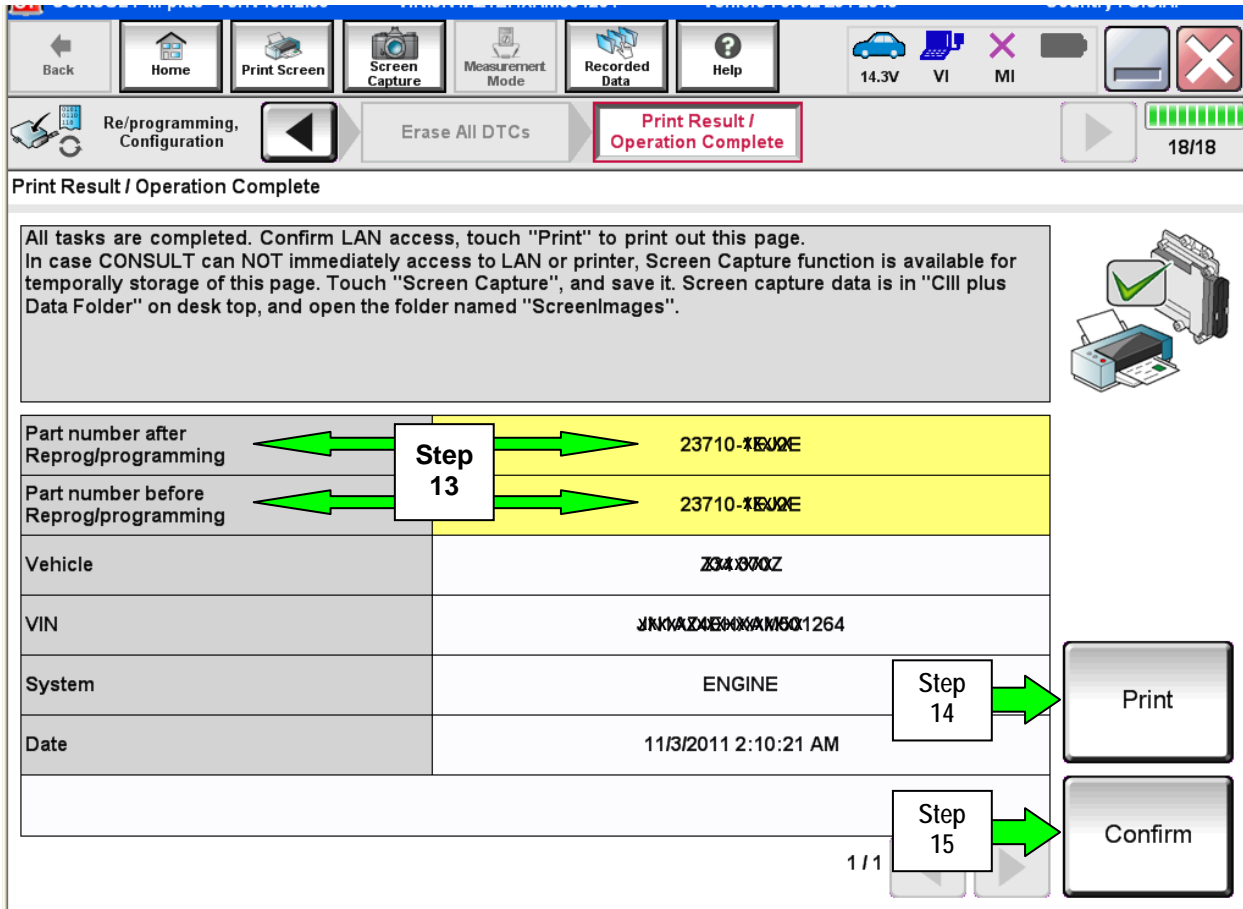
12. When the entire reprogramming process is complete, the screen in Figure 7 will display.
13. Verify the before and after part numbers are different.
14. Print a copy of this screen (Figure 7) and attach it to the repair order for warranty documentation.
15. Select **Confirm**.
