# SERVICE BULLETIN

EC13-012

## VERSA SEDAN AND VERSA NOTE; ENGINE TURNS OFF OR HESITATES WHEN ACCELERATING FROM A STOP DURING HOT AMBIENT TEMPERATURES (+100° F)

**APPLIED VEHICLES:** 2012 -2014 Versa Sedan (N17)  
2014 Versa NOTE (E12)

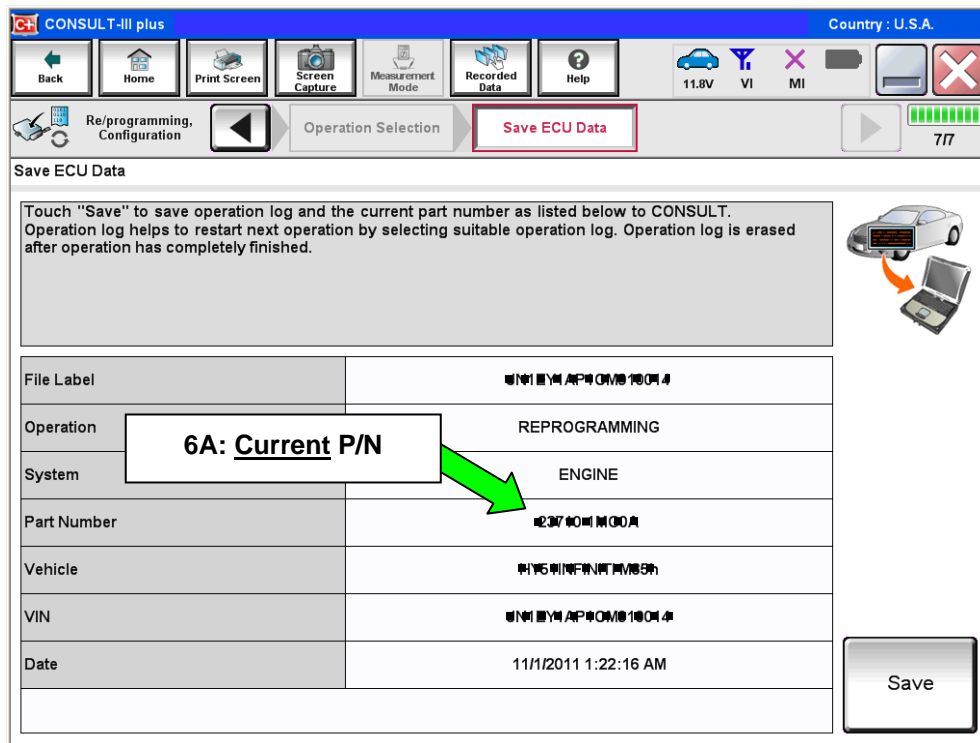
6. When you get to the screen shown in Figure 2, confirm this bulletin applies as follows:

A. Find the ECM **Part Number** and write it on the repair order.

**NOTE:** This is the current ECM Part Number (P/N).

5. Follow the on-screen instructions and navigate the C-III plus to the screen shown in Figure 2 on the next page.

**NOTE:** The screen in Figure 2 on page 4 will be similar for TCM reprogramming.
