SERVICE CAMPAIGN BULLETIN

NTB13-098

VOLUNTARY SERVICE CAMPAIGN 2013 LEAF PDM SOFTWARE UPDATE

Nissan is conducting a voluntary service campaign on certain Model Year 2013 LEAF vehicles to reprogram the Power Delivery Module (PDM). This service will be performed at no charge for parts or labor.

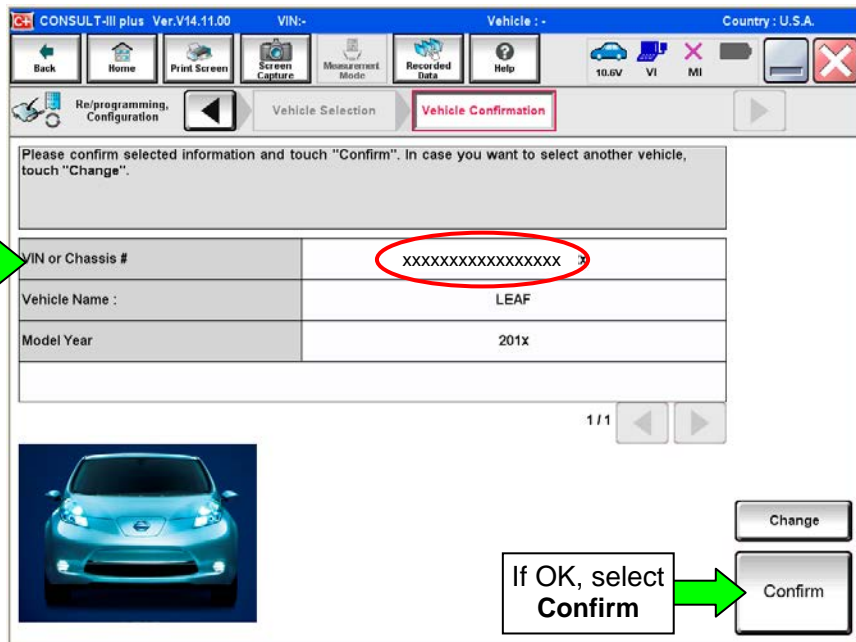
Figure 4

16. Verify the VIN in **VIN or Chassis #** matches the vehicle being reprogrammed.

- If the correct VIN is displayed, select **Confirm**.

Verify here

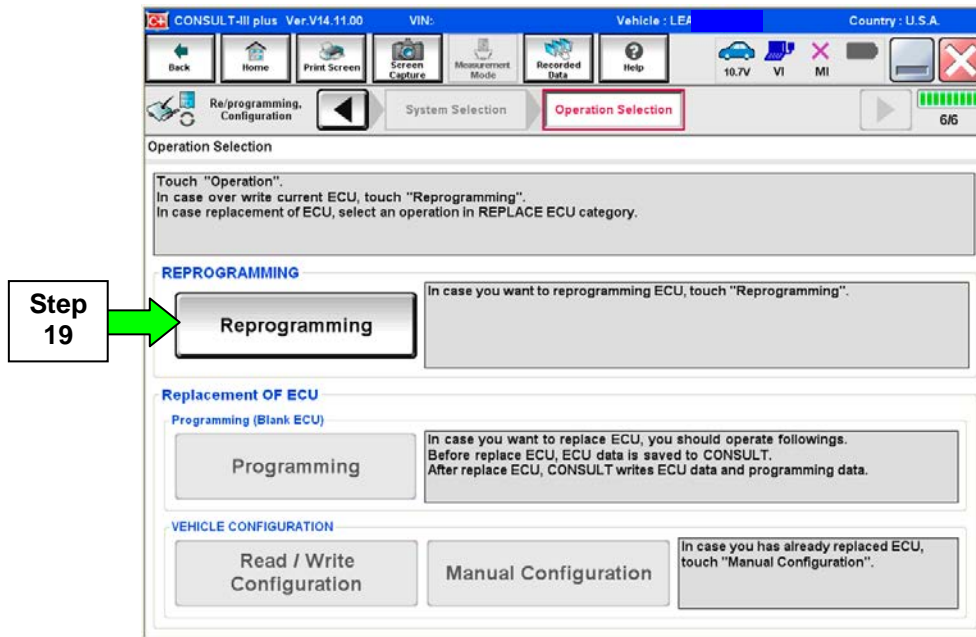
Figure 7

19. Select Reprogramming.

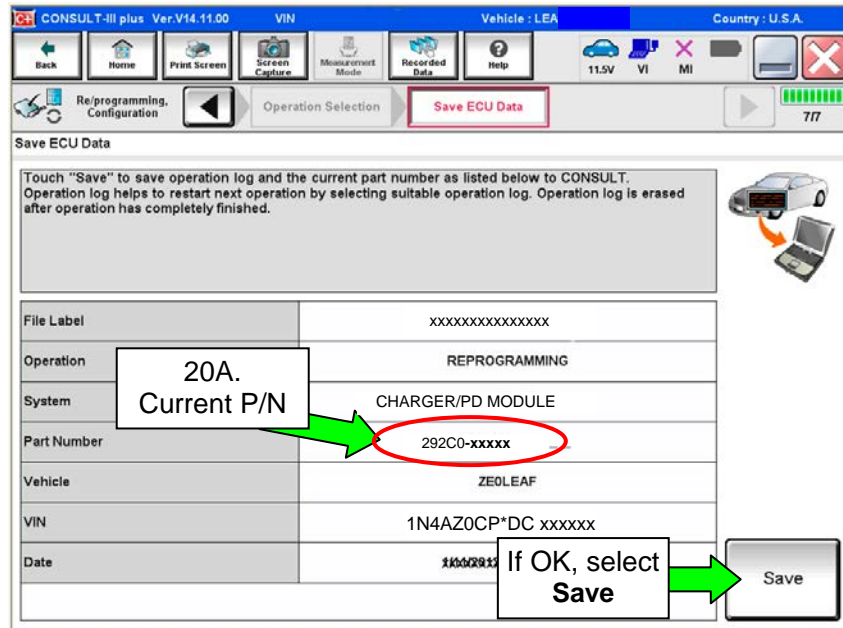
Figure 8

20. When you get to the screen shown in Figure 8, confirm this bulletin applies as follows.

A. Find the **CHARGER/PD MODULE Part Number** and write it on the repair order.

NOTE: This is the current CHARGER/PD MODULE Part Number (P/N).

B. Compare the P/N you wrote down to the numbers in the **Current CHARGER/PD MODULE Part Number** column in **Table A** below.

- If the CHARGER / PD MODULE part number **is** one of the part numbers listed in the Table A, continue with reprogramming.
 - Select **Save**, and then go to the next step.
- If the CHARGER / PD MODULE part number **is not** listed in Table A, this campaign does not apply or it has already been done.
 - Disconnect the GR8 and CONSUTLT PC.
 - Check Service COMM to confirm this campaign applies.

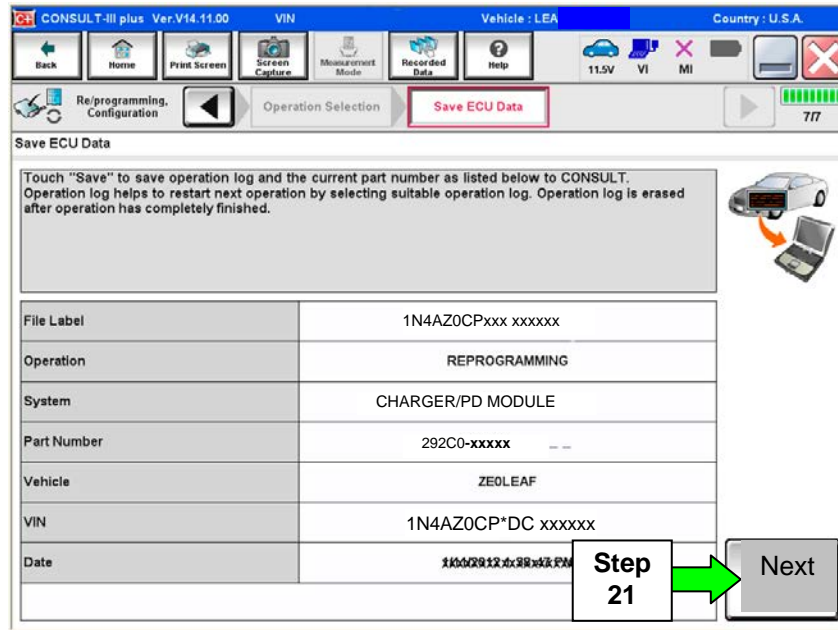
Figure 9

21. Select **Next**.

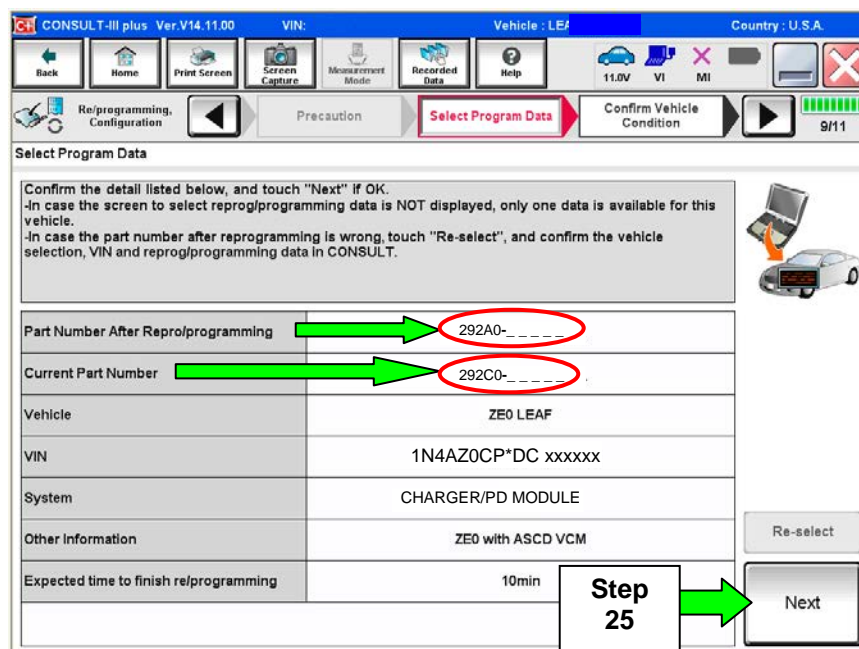
Figure 12

24. Read the **Current Part Number** and **Part Number After Reprogramming**. They should be different.

25. Select **Next**.

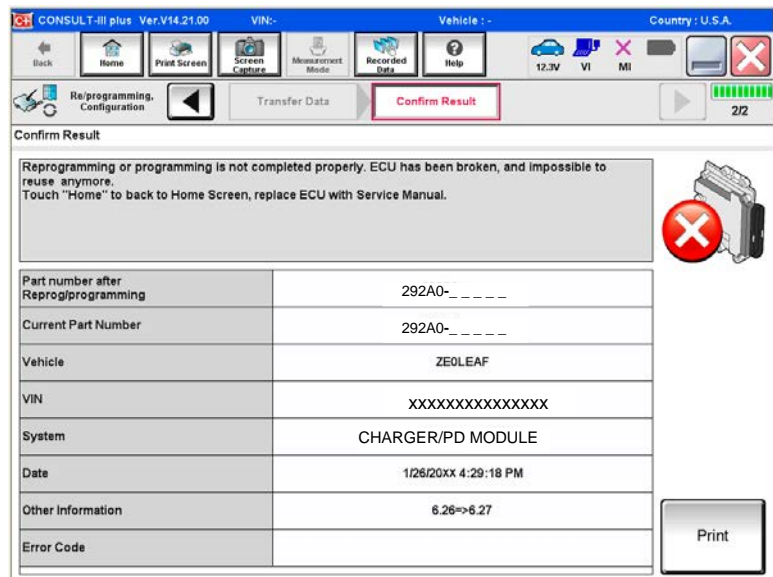
Figure 18

OR: If reprogramming does not complete and the **X** displays as shown in Figure 18:

Do not disconnect plus VI or shut down Consult III plus if reprogramming does not complete.

- Check battery voltage (12.0 - 13.5V).
- CONSULT A/C adapter is plugged in.
- Ignition is ON, Ready Mode is OFF.
- Transmission in Park.
- All C-III plus / plus VI cables are securely connected.
- All C-III plus updates are installed.
- **Select Home, and then restart the reprogram procedure from the beginning.**

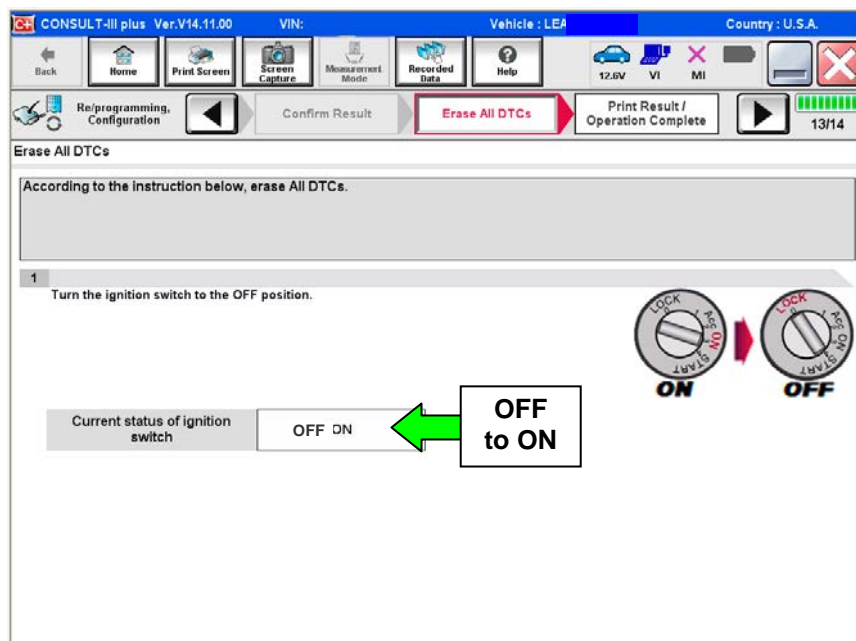
- b. Wait 1 minute with the ignition OFF.
- c. Turn the “ignition” on by depressing the power switch twice (not Ready mode).
 - Do not step on the brake pedal when depressing the power switch.
 - The screen in Figure 20 will read **ON** after pressing the power switch twice.

NOTE: Do not be confused by any screen messages. At this point, simply turn the “ignition” on.

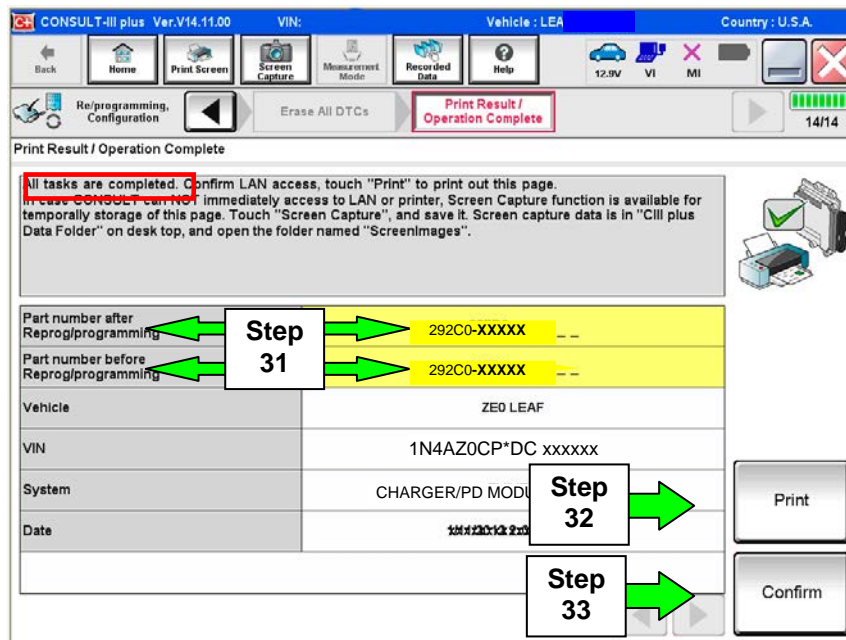
Figure 22

31 Verify the before and after part numbers are different.

32. Print a copy of this screen (Figure 22) and attach it to the repair order.

33. Select **Confirm**.

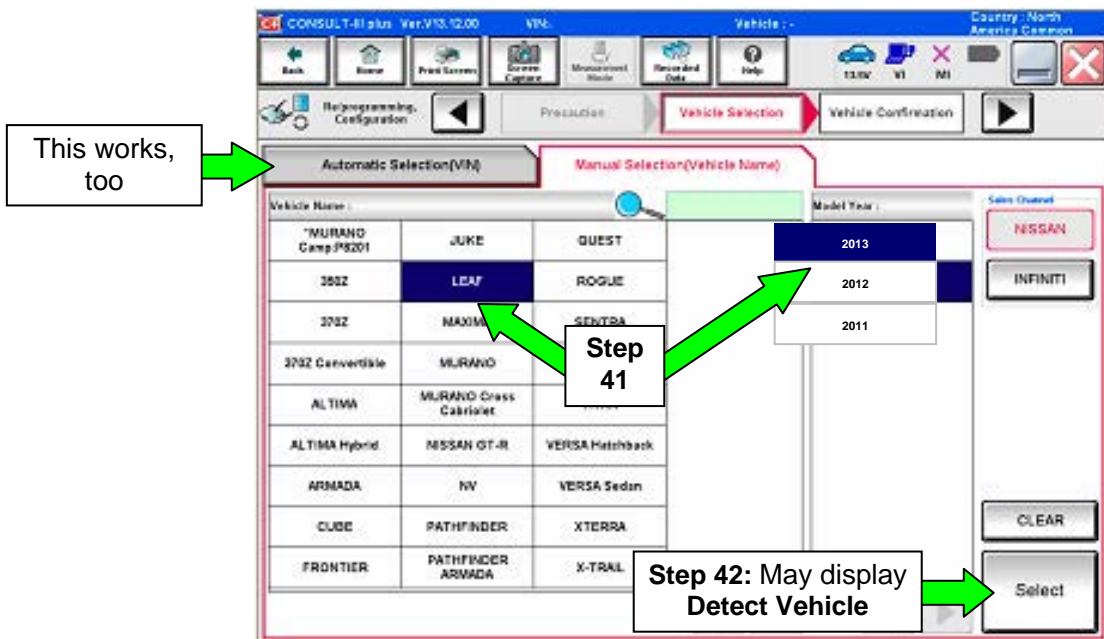
41. Select **LEAF** and **2013**, or **Automatic Selection (VIN)**.

- If **Automatic Selection (VIN)** is selected, wait for the **Reading VIN** screen to complete.
- If the screen in Figure 26 does not display, skip to step 43.

42. Select **Select** or **Detect Vehicle**, whichever displays.

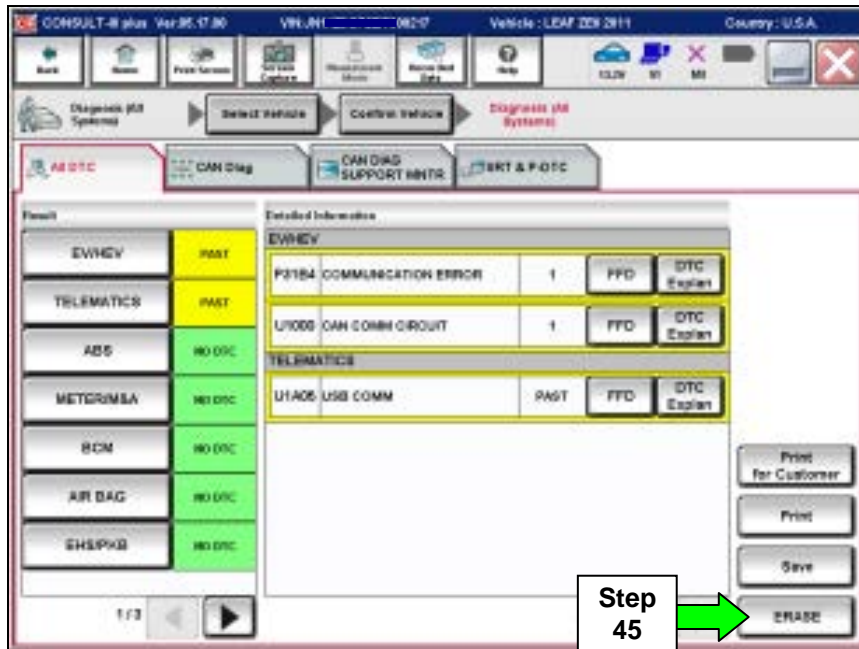
Figure 29

45. If DTCs are present, select **ERASE**.
- If no DTCs are present, skip to step 48.

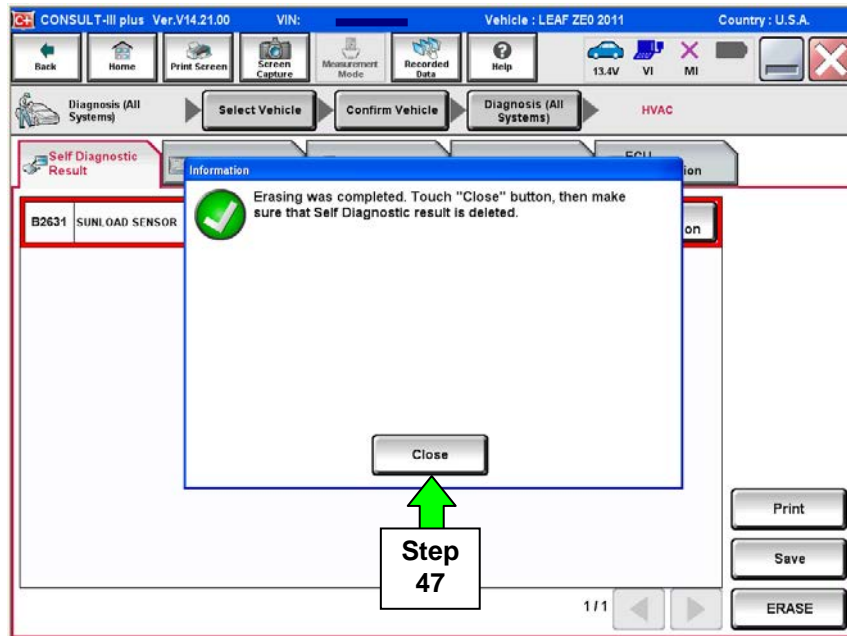
Figure 31

47. Select **Close**.

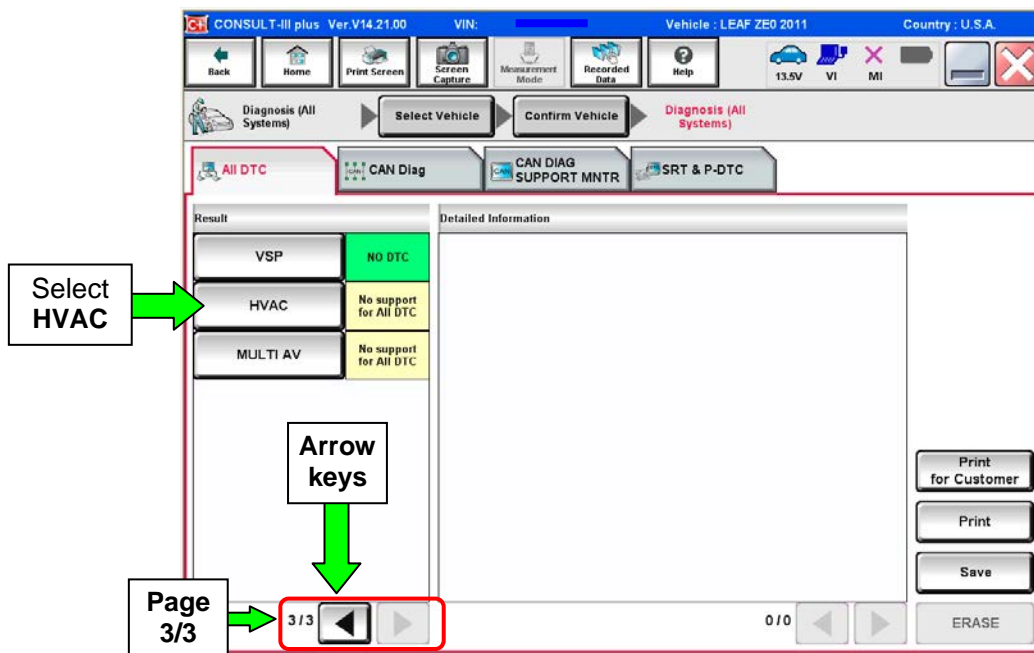
Figure 32

48. Using the arrow keys, select page **3/3**, and then select **HVAC**.

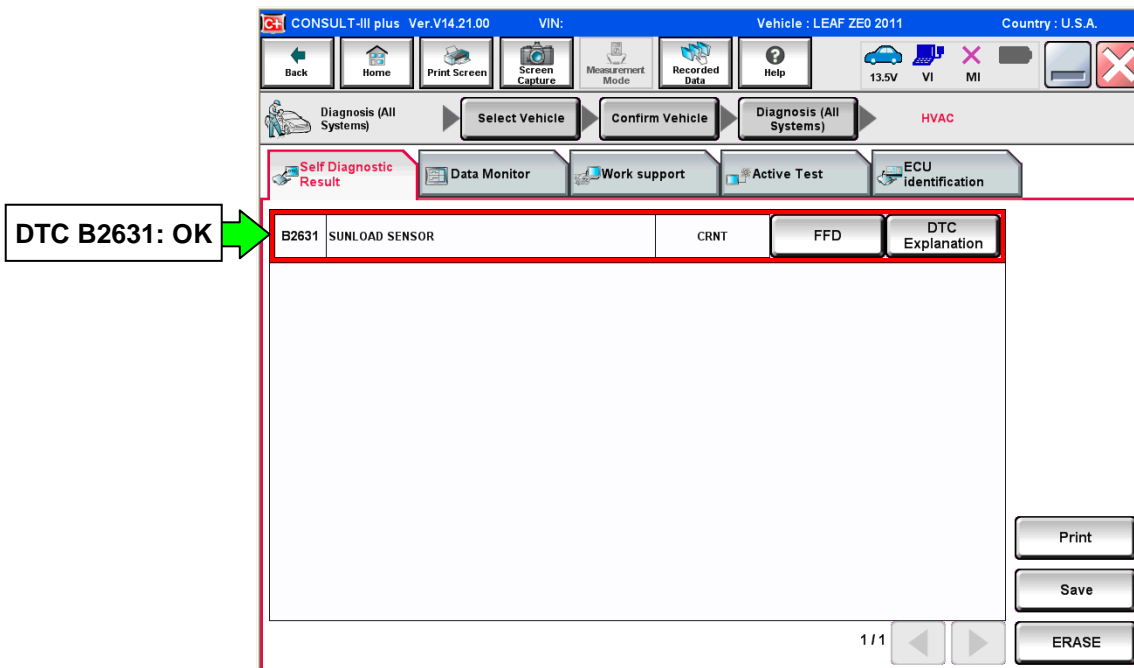
Figure 36

NOTE: If DTC B2631 (SUNLOAD SENSOR) sets again, this is okay.

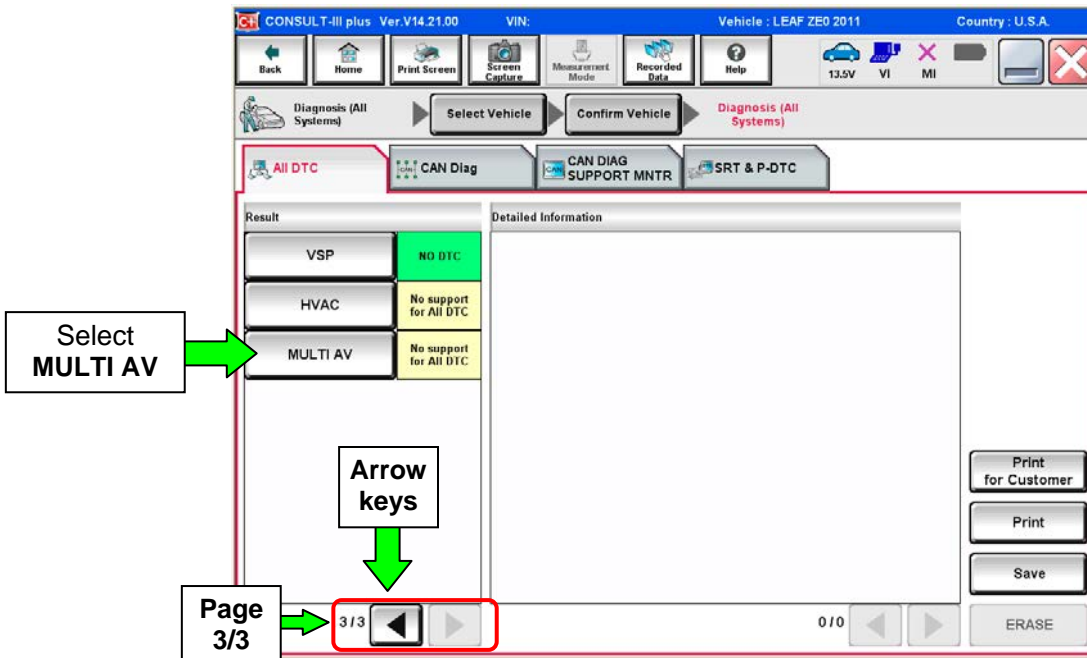
Figure 38

53. Using the arrow keys, go to page **3/3**, and then select **MULTI AV**.
