GROUP Transmission	MODEL 2012MY Soul (AM)
	NUMBER 050 (REV 1, 10/9/2013)	DATE October 2013
<h2>TECHNICAL SERVICE BULLETIN</h2>		
<b>SUBJECT: TCM UPGRADE - ACTIVE ECO ACCELERATION LOGIC IMPROVEMENT</b>

## TCM UPGRADE - ACTIVE ECO ACCELERATION LOGIC IMPROVEMENT

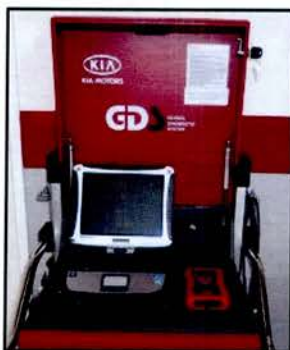
Global Diagnostic System (GDS)

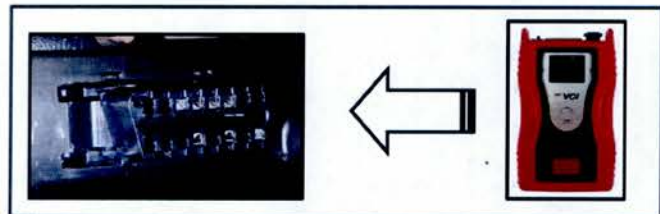
3. Connect the Main 16-pin DLC cable (GHDM – 241000) to the VCI.

4. Connect the Main 16-pin DLC cable (GHDM – 241000) to the OBD-II connector, located under the driver's side of the instrument panel.
