VOLUNTARY SERVICE CAMPAIGN 2014 Q50; DIRECT ADAPTIVE STEERING REPROGRAM

CAMPAIGN ID #: P4201

APPLIED VEHICLES: 2014 Q50 (V37)
2014 Q50 Hybrid (V37)

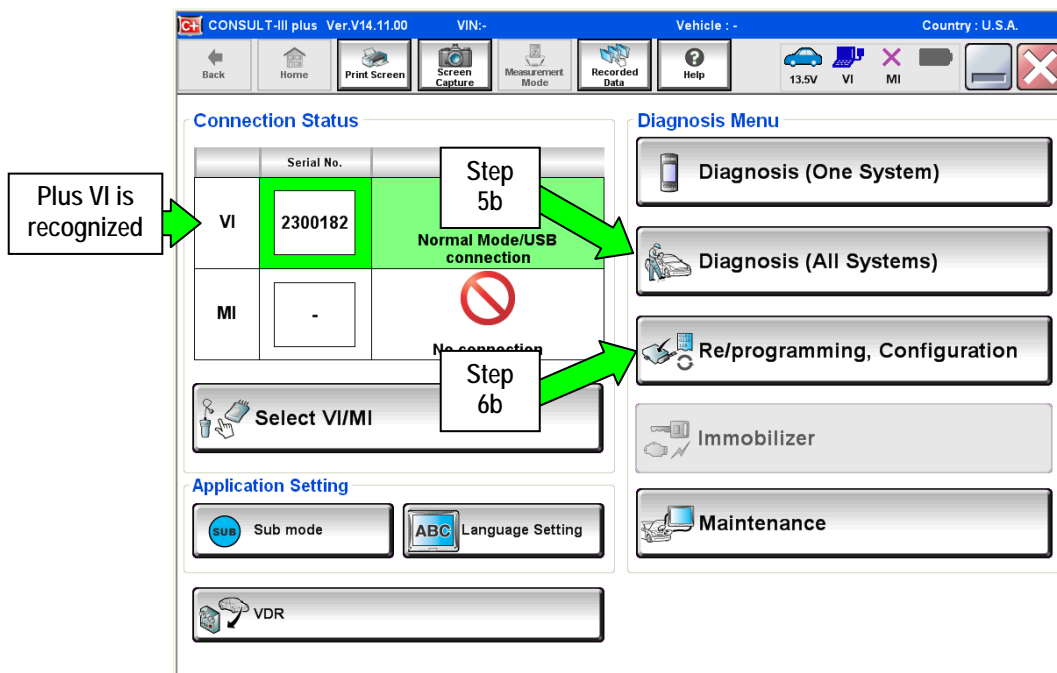
Figure 1

6. Go to **Re/programming, Configuration**.

- Select the **Home** button and then **YES** to return to the screen shown in Figure 1.
- Select **Re/programming, Configuration**.

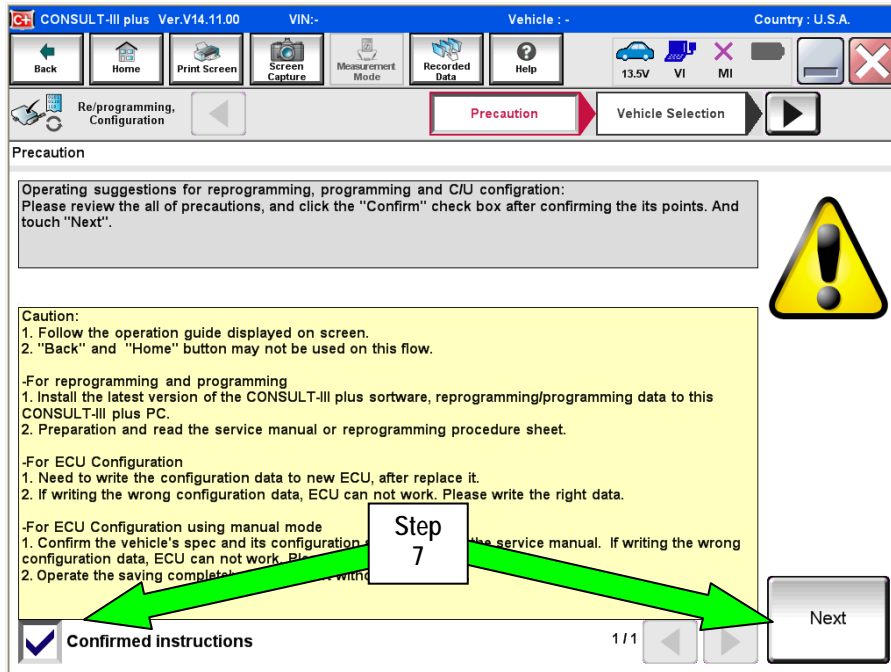
Figure 2

7. Check the box for **Confirmed Instructions**, and then select **Next**.

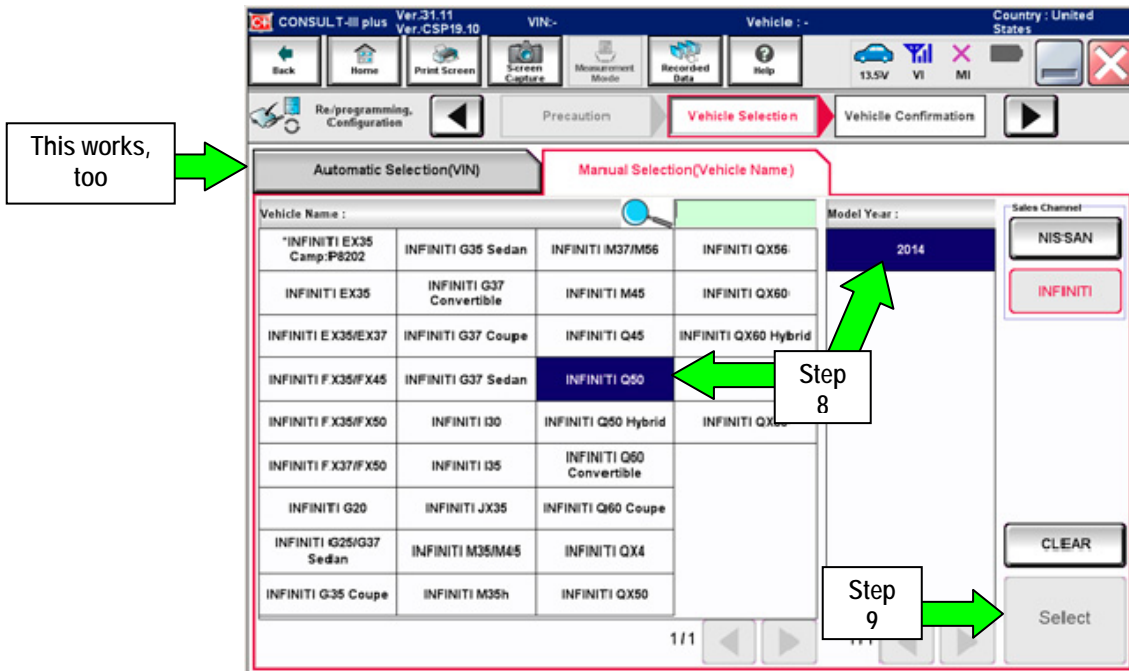
8. Select **Q50** or **Q50 Hybrid** and **2014**, or **Automatic Selection(VIN)**.

- If **Automatic Selection (VIN)** is selected, or the screen in Figure 3 does not display, skip to step 10.

9. Select **Select**.

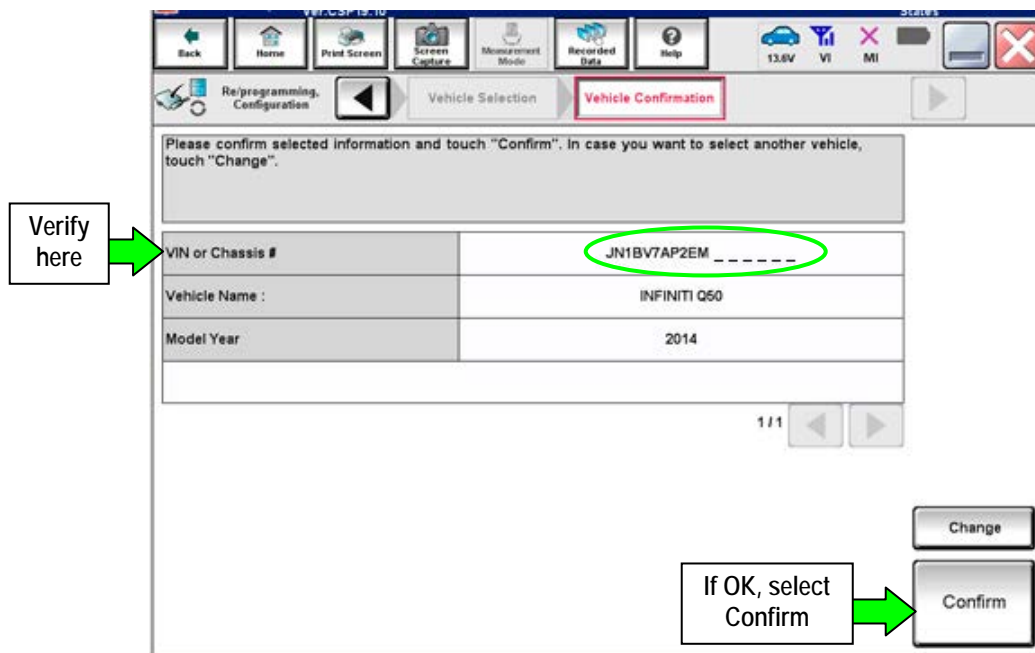
Figure 4

10. Verify the VIN or Chassis # matches that of the vehicle.

- If the correct VIN is displayed, select **Confirm**.

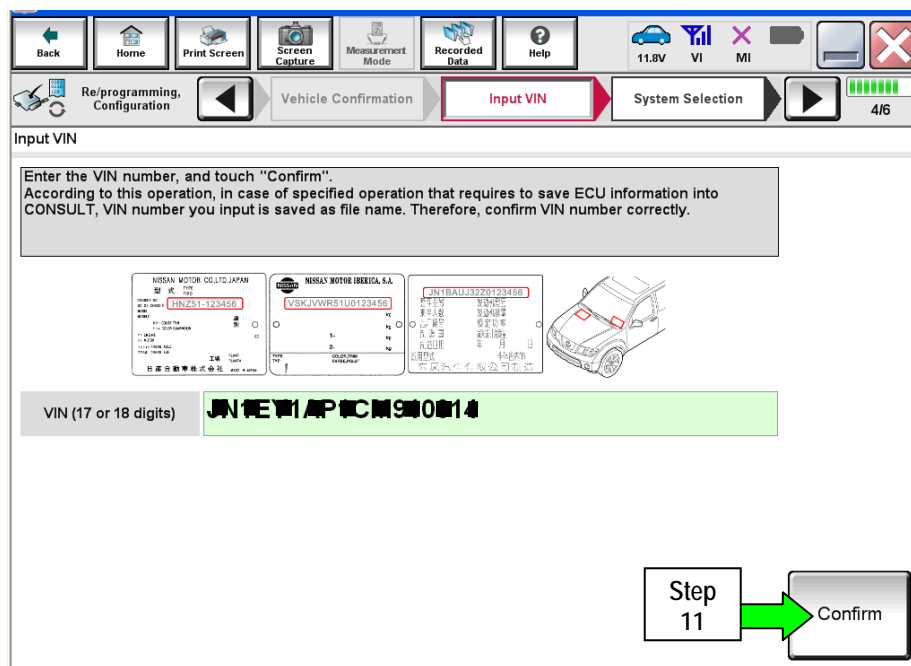
Figure 5

11. Select **Confirm** again.

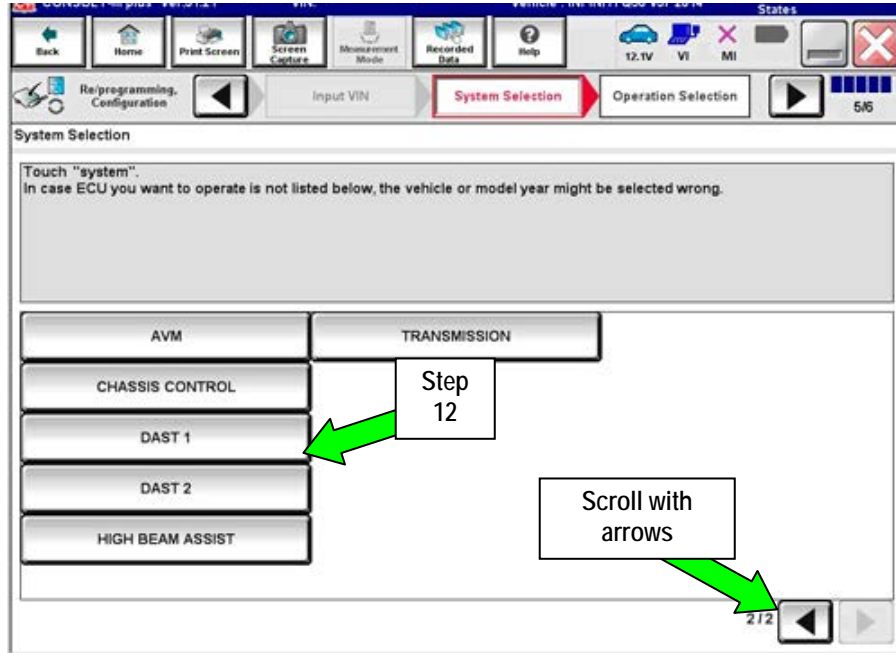
Figure 6

12. Use the page arrows to scroll and select the correct control module to be reprogrammed.

Make sure to reprogram the control modules in this order:

DAST 1, then DAST 2, and then EPS/DAST 3

NOTE: DAST 1 and DAST 2 are shown in Figure 6; EPS/DAST 3 is not shown.

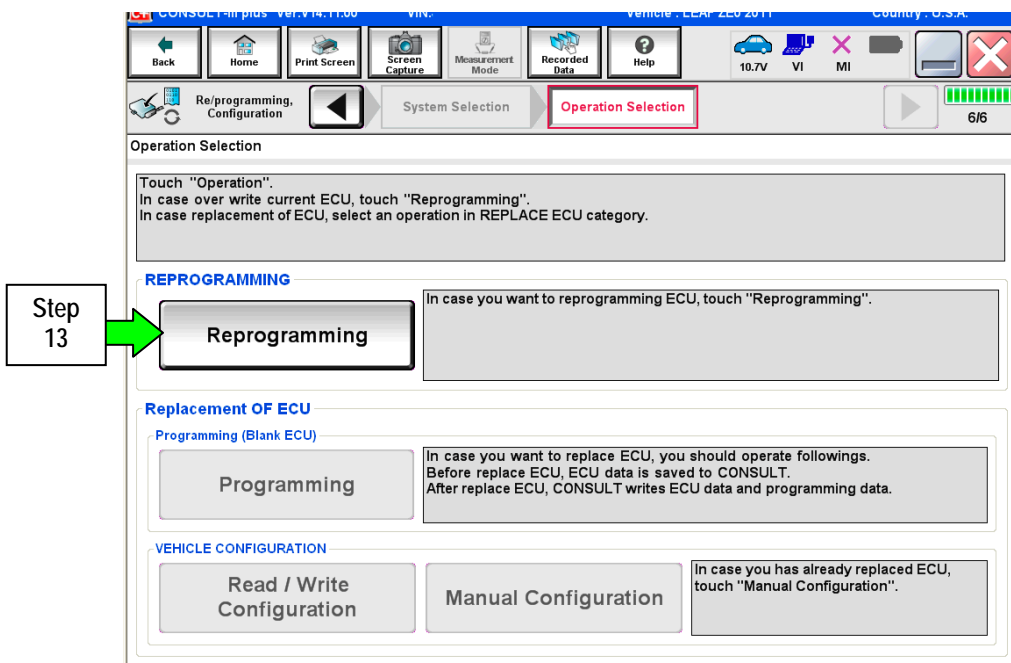
Figure 7

13. Wait for System Call to complete and then select **Reprogramming**.

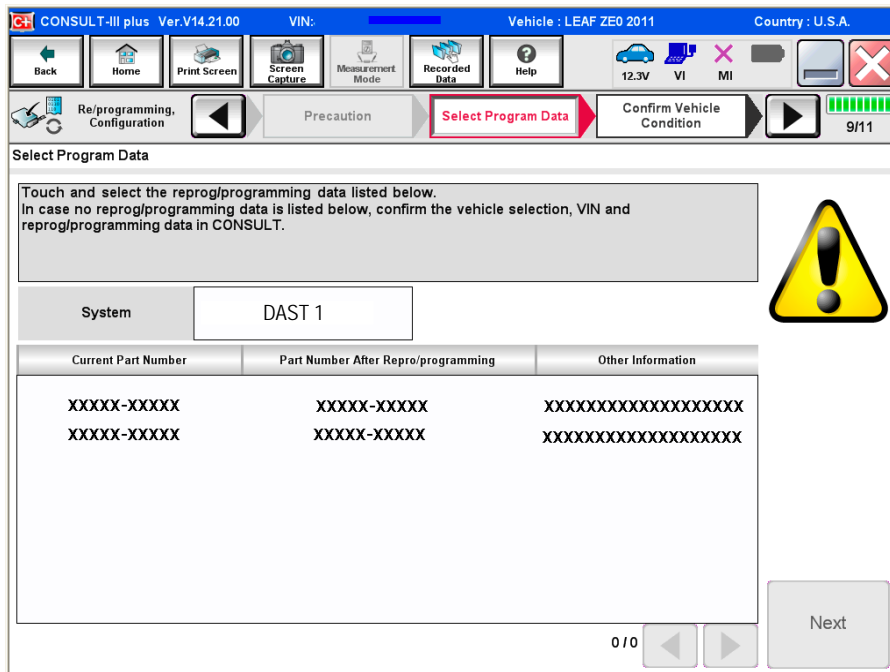
- In some cases, more than one new P/N for reprogramming is available.
 - If more than one P/N is available, the screen in Figure 10 will display.
 - Select and use the reprogramming option that **does not** have the message "Caution! Use ONLY with ITBXX-XXX".
- If you get this screen and it is blank (no reprogramming listed), it means there is no reprogramming available for that control module.

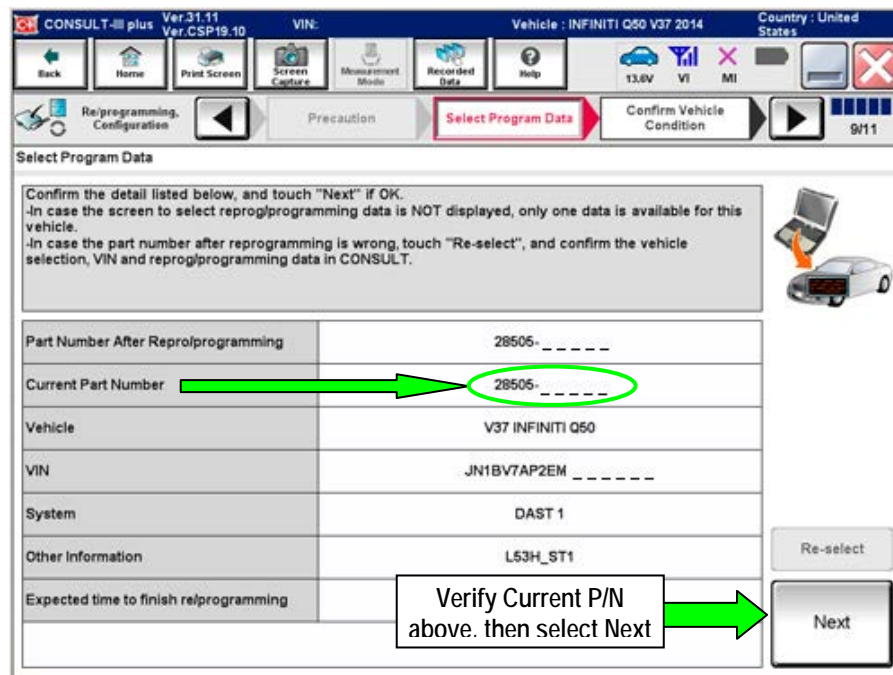
Figure 11

16. Verify the **Current Part Number** matches the Part Number written down in step 14, and then select **Next**.

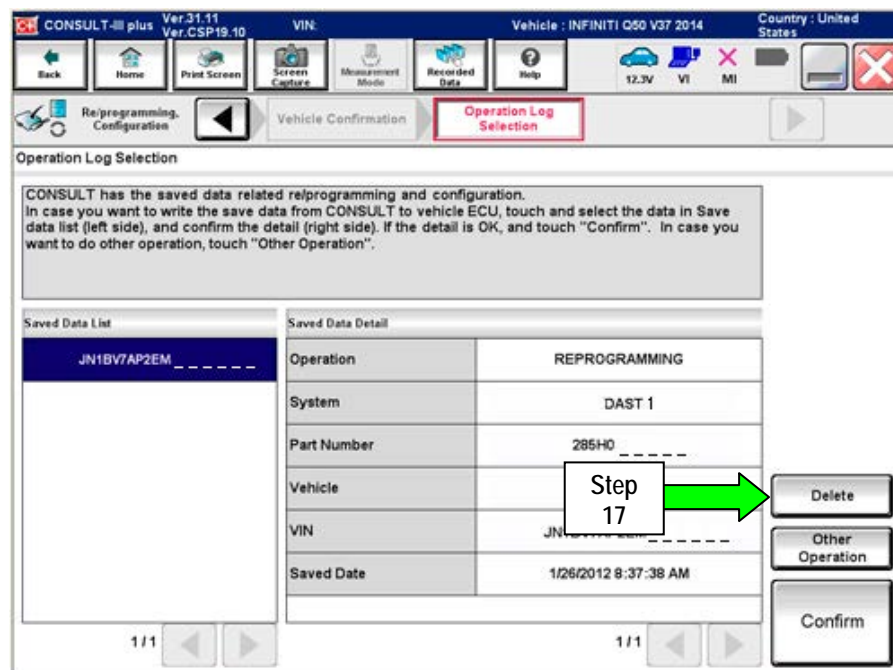
17. If the screen in Figure 12 appears, first select **Delete** then **Confirm**, and then **Other Operation**.

- This will erase the **Saved Data List** and restart the reprogram from step 12. You must go back to step 12.
- If no **Saved Data List** is stored, Figure 13 on the next page will be displayed.

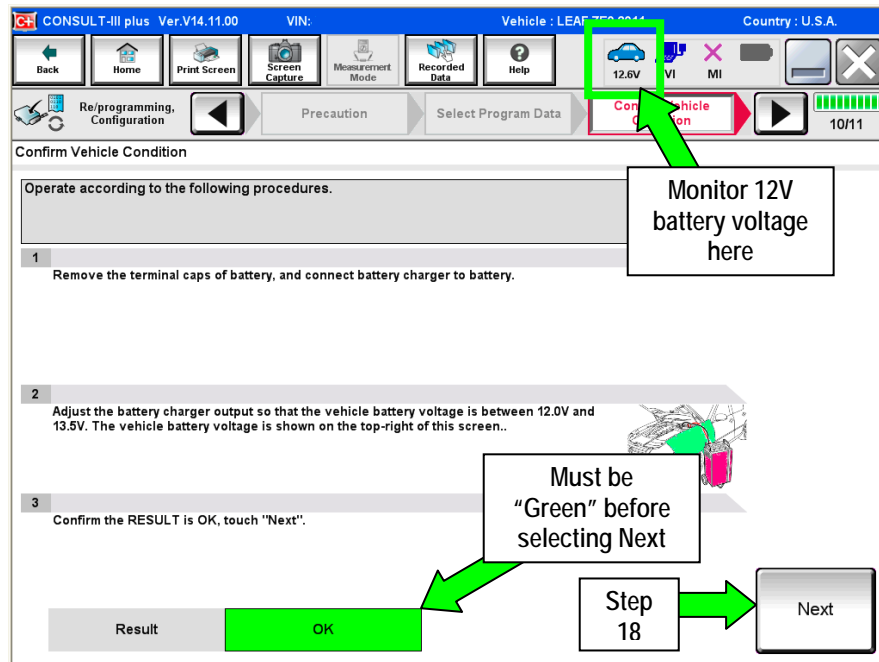
Figure 13

18. Confirm battery voltage is correct, and then select **Next**.

NOTE: Battery voltage must stay within the specified range to make the indicator turn green.

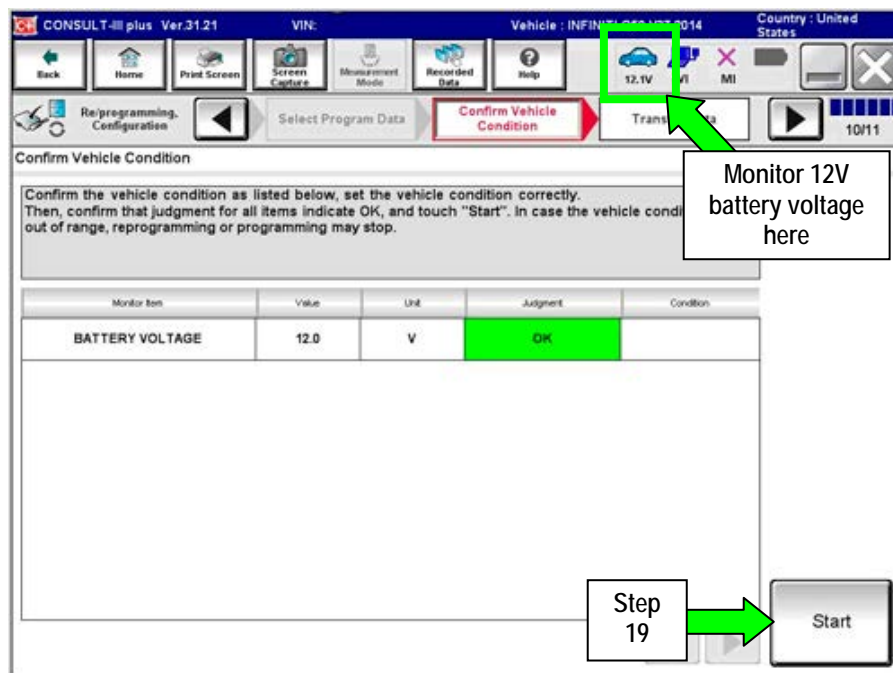
Figure 14

19. With battery voltage OK (green), select **Start**.

- The reprogramming process begins when **Start** is selected.

NOTE: For reprogramming to continue, the vehicle 12V battery voltage must stay within 12 volts and 13.5 volts. .

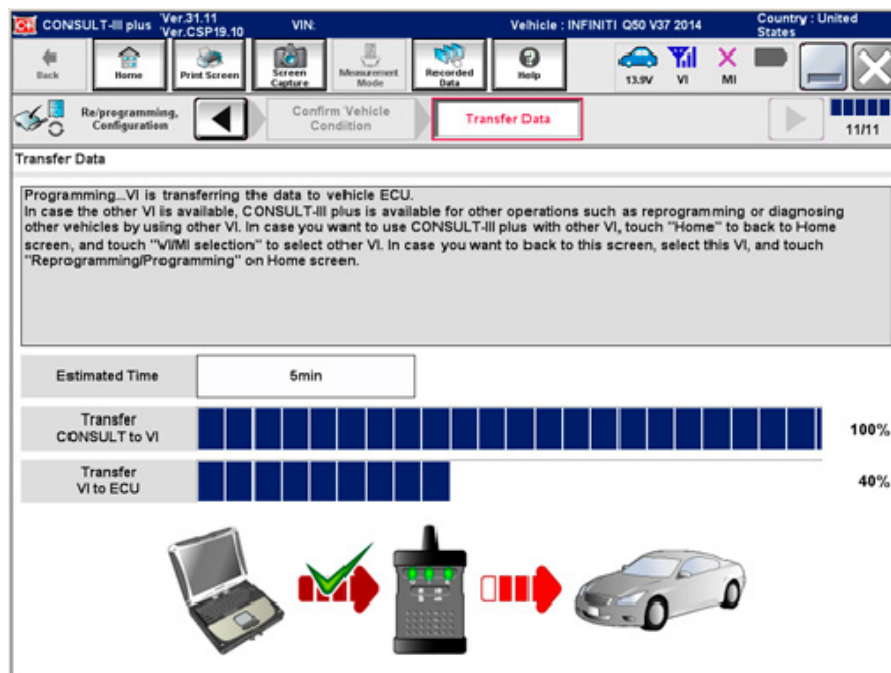
Figure 15

20. Wait for both bar graphs to complete.

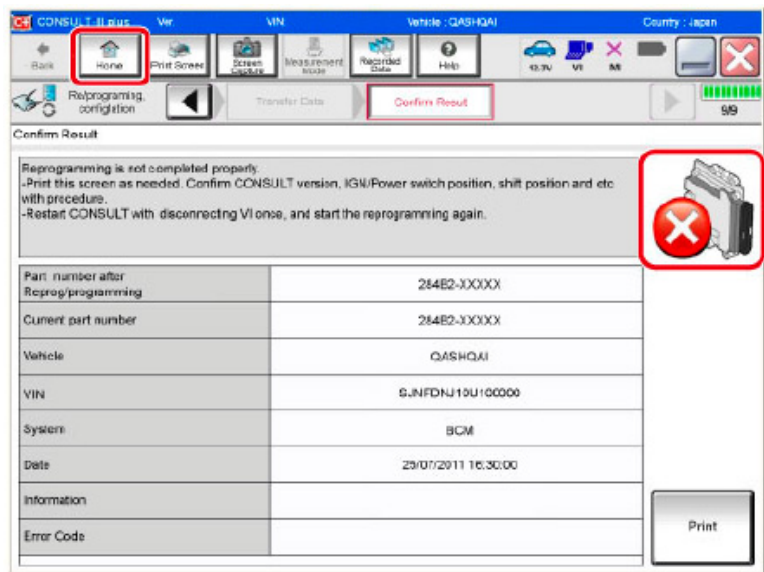
Figure 17

If reprogramming does not complete and the “X” icon displays as shown in Figure 17:

- Check battery voltage (12.0 – 13.5 V).
- CONSULT A/C adapter is plugged in.
- Ignition is ON, engine OFF (not READY).
- Transmission is in Park.
- All C-III plus / VI cables are securely connected.
- All C-III plus updates are installed.
- Select Home, and restart the reprogram procedure from the beginning.

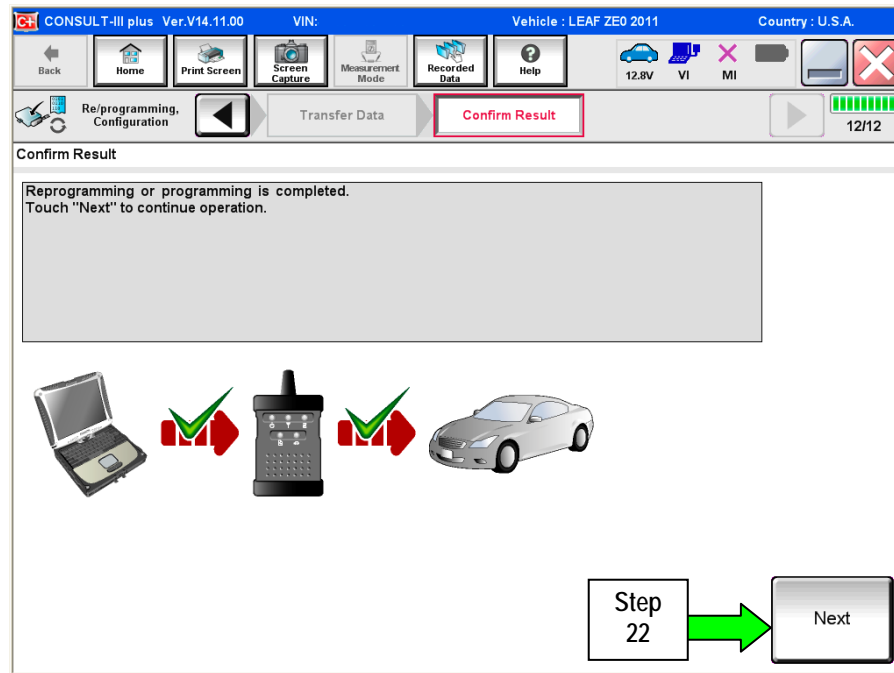
21. When the screen in Figure 18 appears, reprogramming is complete.

22. Select **Next**.

23. Wait for System Call to complete.

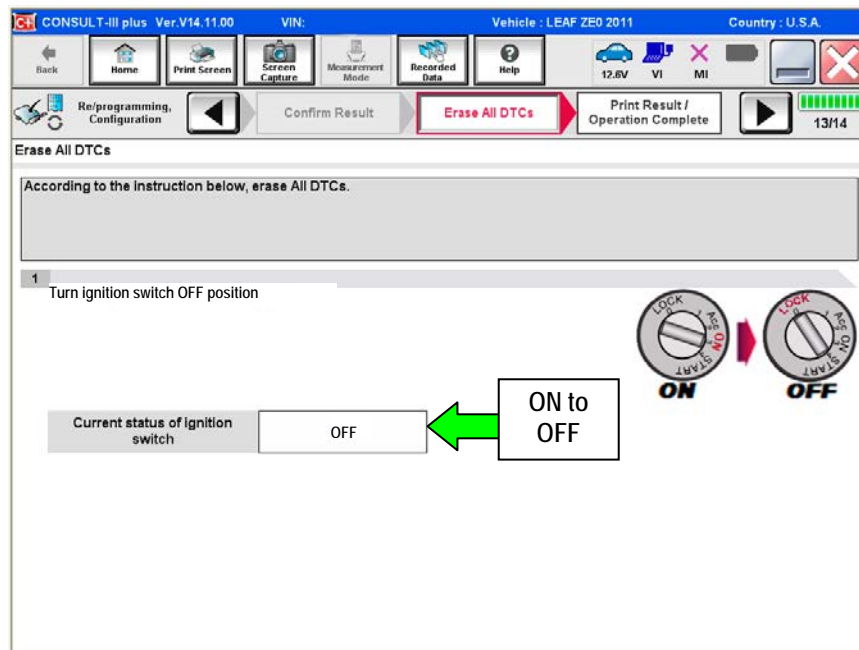
a. Turn the ignition OFF.

- The screen in Figure 19 will read OFF after pressing the power/ignition switch once.

- b. Turn the ignition ON with engine OFF (press switch twice, foot off brake).
- The screen in Figure 19 will read **ON** after pressing the power/ignition switch twice.
- NOTE:** Do not be confused by any screen messages. At this point, simply turn the ignition ON.

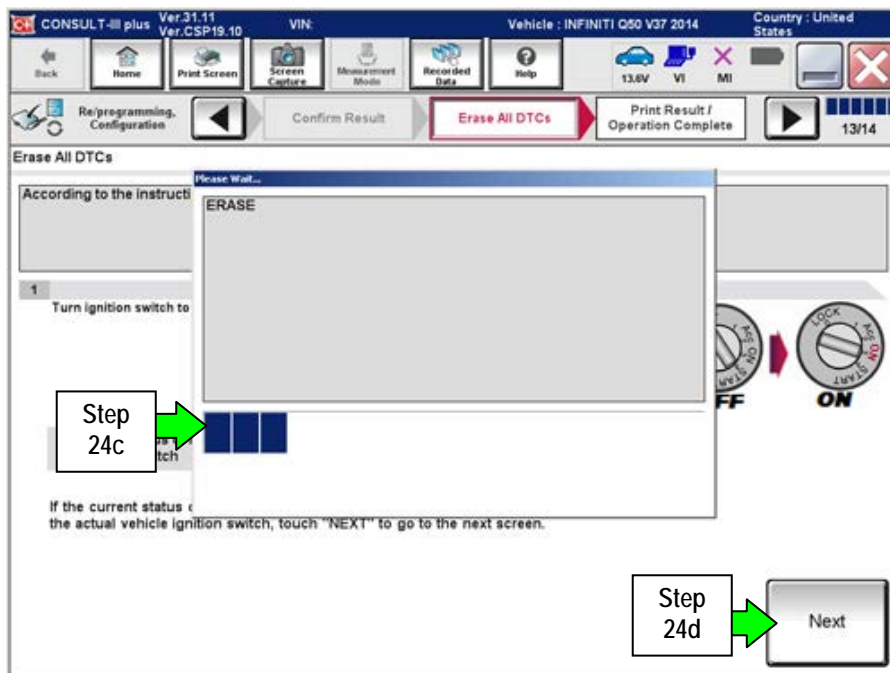
Figure 21

- c. Wait for the bar graph in the **ERASE** window to complete 100%.
- d. Select **Next**.

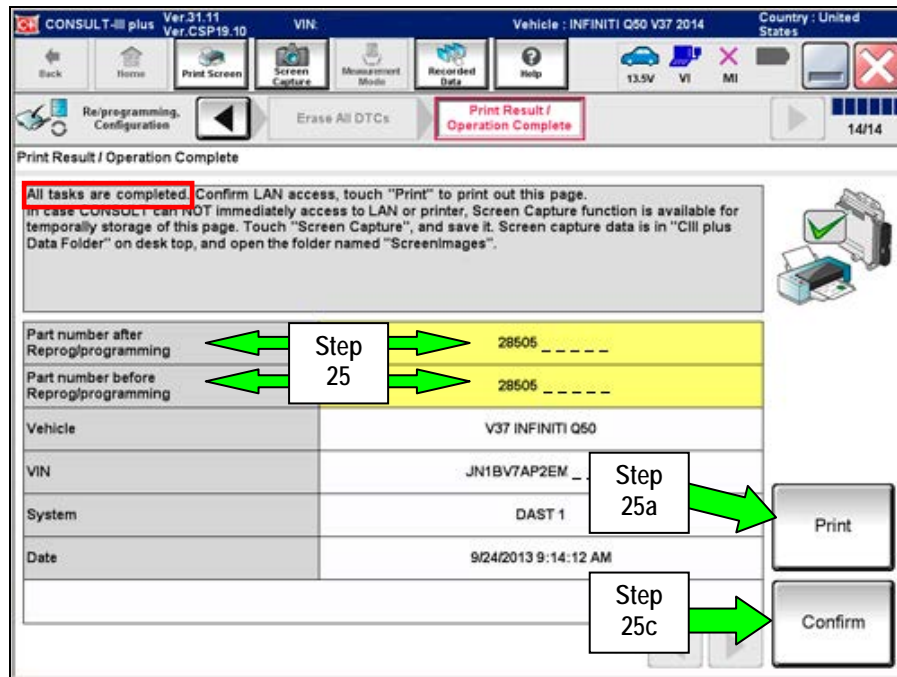
25. Verify the part number has changed (before and after reprogramming part numbers should be different).

- a. Print a copy of the screen in Figure 22 by selecting **Print**.
- b. Attach a copy to the repair order.
- c. Once a copy has been printed, select **Confirm**.

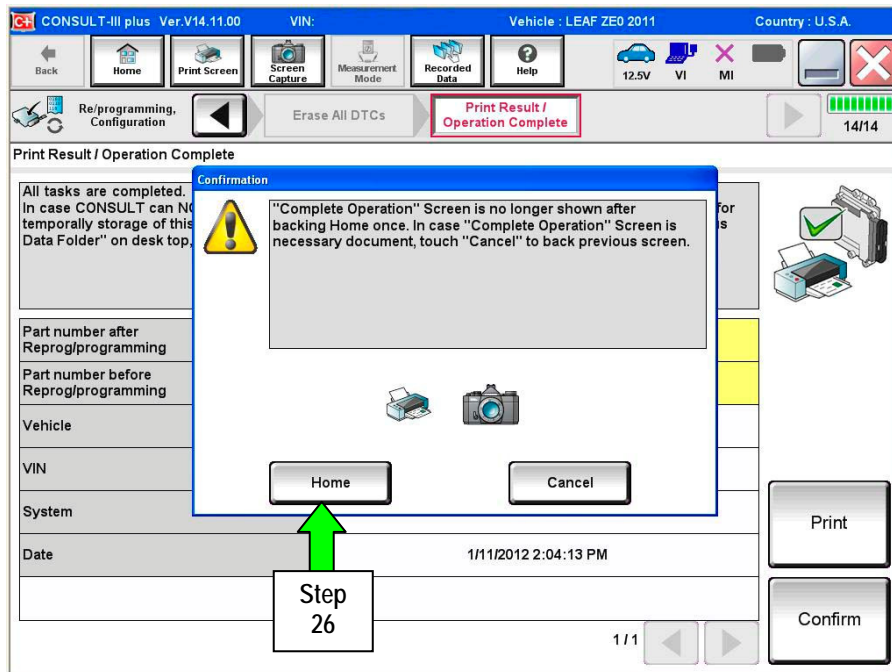
Figure 23

26. After Confirmation has completed, select Home.
