GROUP FUEL	MODEL 2014MY Forte (YD) w/2.0L GDI
	NUMBER 027 (REV 1, 11/15/2013)	DATE November 2013
TECHNICAL SERVICE BULLETIN		
SUBJECT: COMBINED TSB/SERVICE ACTION: ECM UPGRADE – MIL ON WITH DTC P0461 (SA156)

This bulletin provides information related to an ECM software upgrade for 2014MY Forte (YD) vehicles with 2.0L GDI engine, produced from January 31, 2013 to September 26, 2013, which may experience a malfunction indicator lamp (MIL) illuminated with the Electronic Control Module (ECM) system-related DTC P0461. To prevent and/or correct this condition, the ECM should be reprogrammed using the GDS download, as described in this bulletin. Kia is requesting the completion of this Service Action on all affected vehicles, including dealer stock, prior to delivery. For confirmation that the latest reflash has been done to a vehicle you are working on, verify ROM ID using the tables in this TSB.

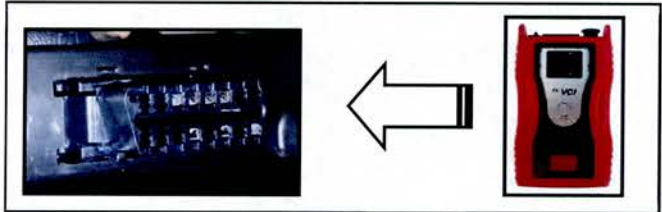
4. Connect the Main 16-pin DLC cable (GHDM – 241000) to the OBD-II connector, located under the driver's side of the instrument panel.

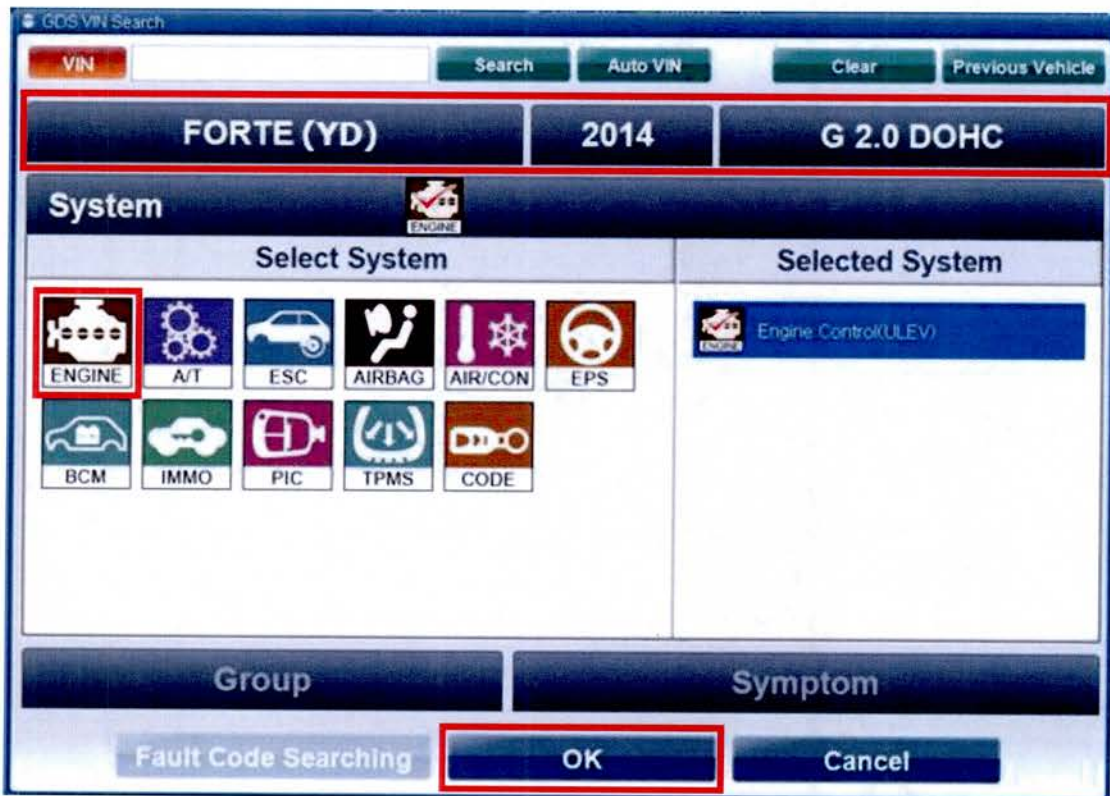
5. With the ignition key ON, turn ON the VCI and GDS. Access the GDS vehicle identification number (VIN) screen and configure the vehicle using the **VIN AUTO DETECT** Function.

6. Select **ENGINE** system and click **OK**.
