Technical Service Bulletin

SB-10056298-8928

SUBJECT:			No: TSB-14-13-002
ROUGH IDLE OR ENGINE STALL (HIGH AMBIENT TEMPERATURE, LOW RPM) – PUERTO RICO ONLY			DATE: June, 2014
			MODEL: See below
CIRCULATE TO:	<input type="checkbox"/> GENERAL MANAGER	<input type="checkbox"/> PARTS MANAGER	<input checked="" type="checkbox"/> TECHNICIAN
<input checked="" type="checkbox"/> SERVICE ADVISOR	<input checked="" type="checkbox"/> SERVICE MANAGER	<input checked="" type="checkbox"/> WARRANTY PROCESSOR	<input type="checkbox"/> SALES MANAGER

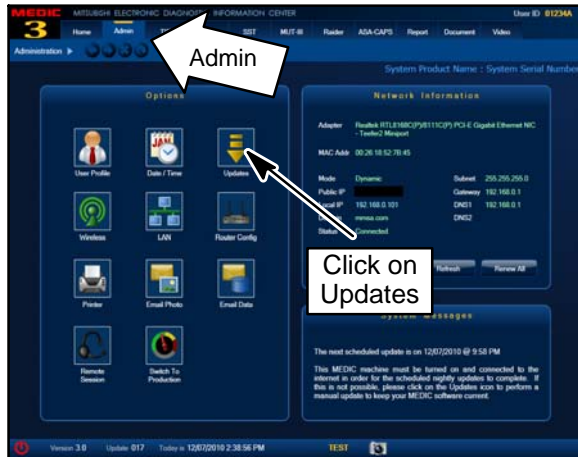
If your **MEDIC 3 update is at least 266**, continue with the Reprogramming Procedure on page 4.

If your **MEDIC 3 update is below 266**, update your MEDIC 3 as follows.

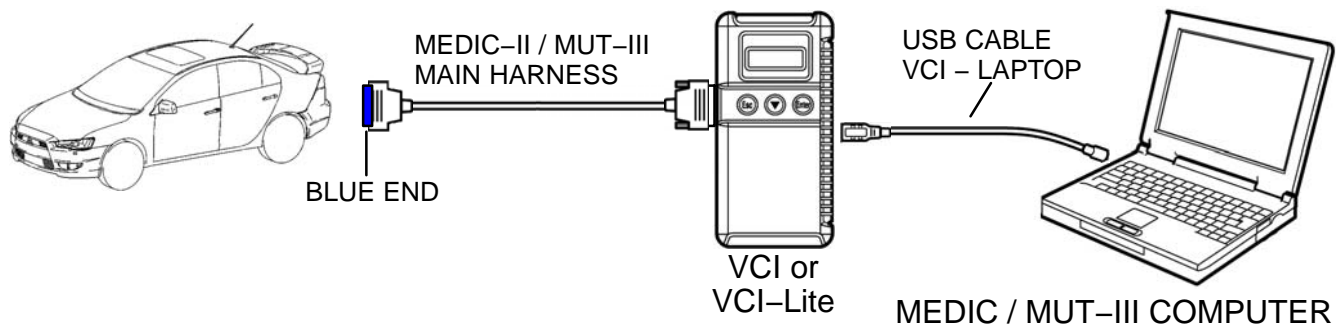
Connect the equipment as follows:

- Turn the laptop computer on. If you're running on battery power and the charge indicator in the lower right hand corner of the screen does not show a full charge, it is recommended that either the laptop battery be charged prior to beginning, or that reprogramming be completed with the A/C power adaptor connected to the laptop.
- Connect the USB cable to the VCI (or VCI-LITE).
- When the laptop displays the MUT-III main screen, connect the USB cable to the laptop.
- Connect the MUT-III main harness (blue DLC connector) to the VCI.
- Connect the blue connector of the MUT-III main harness to the vehicle's data link connector.
- Turn the VCI power switch ON. Verify the indicator lamp in the upper right corner of the screen is green.

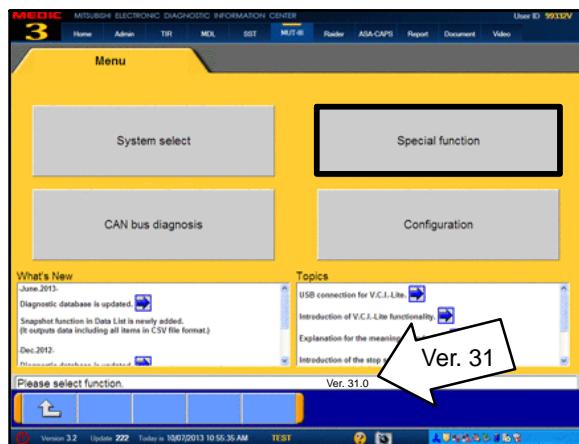
1. Conduct the following steps to reprogram the ECM.
 - a. Turn the ignition switch to the ON position. If the vehicle is equipped with the F.A.S.T. System, the transmitter must remain in the vehicle for the entire procedure.

For vehicles equipped with OSS, press the START/STOP button twice without applying the brake. The LED in the button should be green.

- b. If using MEDIC, from the main page, click the MUT-III STV icon at the top center of the screen to open MUT-III.
 - c. From the MUT-III Main Menu, select “Special Function.”
 - d. Select “ECU Reprogramming.”

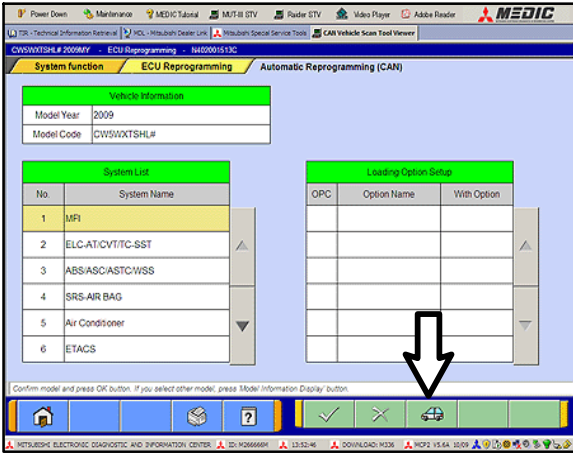
f. Click the car icon at the bottom of the page.

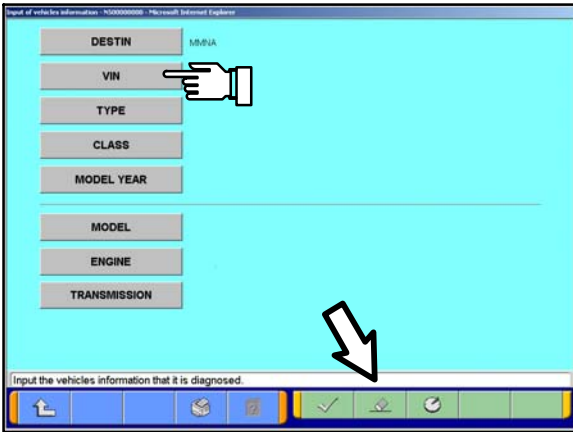
g. If the VIN or vehicle description displayed does not match the vehicle you are working on, click the eraser icon at the bottom of the page to erase vehicle data. Then click the VIN button.

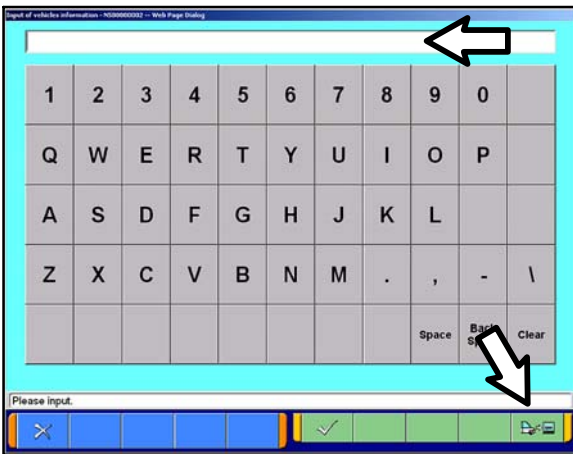
h. Click the icon in the lower RH corner of the screen to have MUT-III automatically read the VIN. If a message appears saying the VIN cannot be input automatically, manually enter the 17 digit VIN into the VIN field at the top of the page. Make sure the VIN is correct and click the check mark.

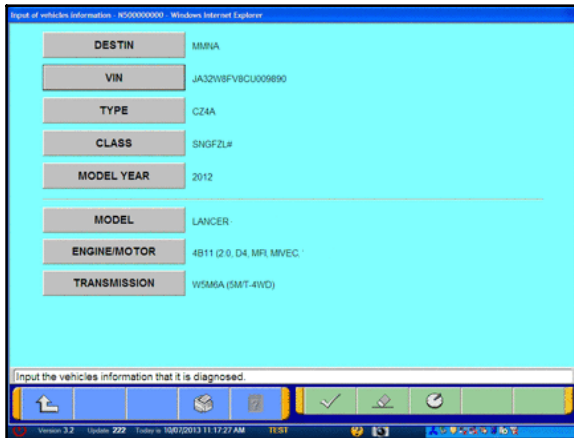
i. Confirm all data matches the vehicle and click the check mark at the bottom of the page.

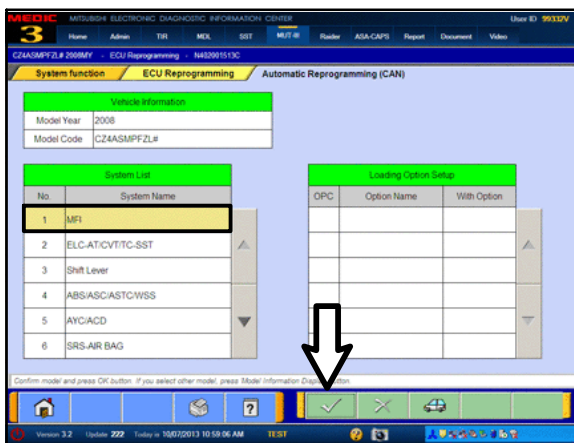
j. MFI should be highlighted as the default. If not, click it to highlight it.
Click the check mark at the bottom of the page.

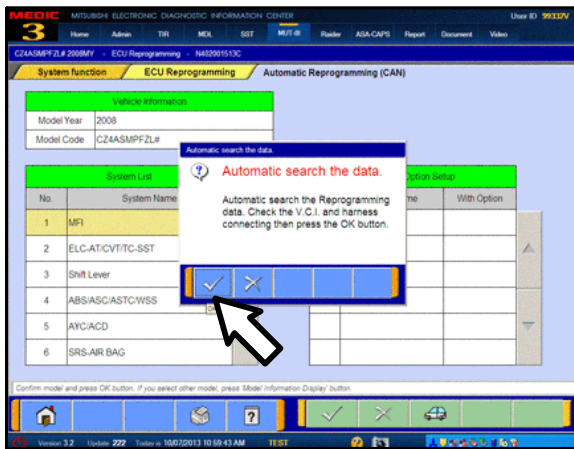
k. A message will advise the system will "Automatic search the data."
Click the check mark to continue.

If the message seen at left is displayed, the ECM software as already at the most current level. Do not continue with the reprogramming procedure. This TSB does not apply.

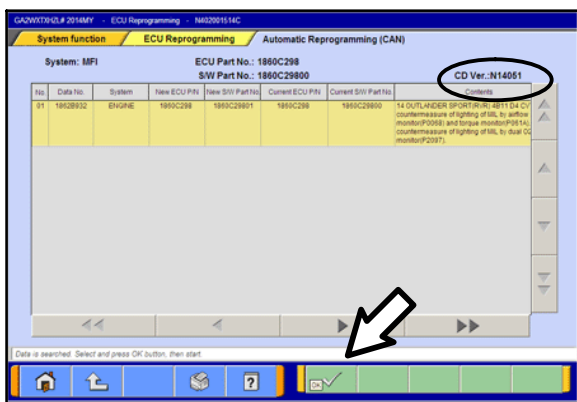
- m. A message will ask you to “Check reprogramming data.”

- n. Click the check mark to begin reprogramming.

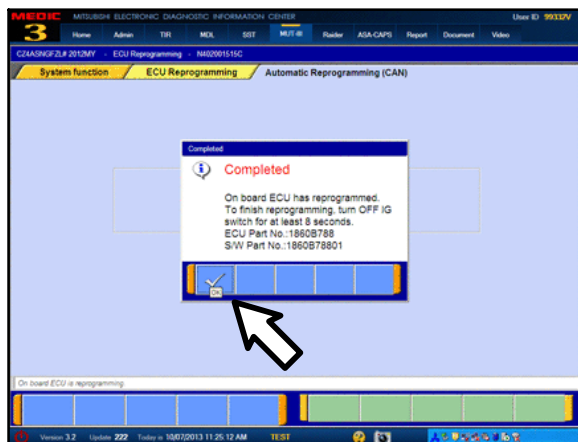
- o. This message will display when ECM reprogramming is successfully completed. Confirm the “New S/W P/N” displayed matches the table at the beginning of this TSB. Then click the check mark to clear the message.
2. Click the UP arrow at the lower left corner of the page to return to the System Function page.

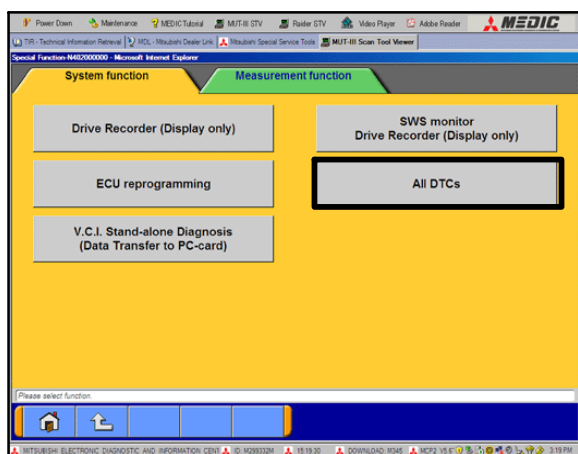
3. Using MUT-III, check and erase ALL DTCs from all systems as follows.
 - a. Select “Special Function.”
 - b. Select “All DTCs,” then select “ERASE AND READ ALL DTCs.”

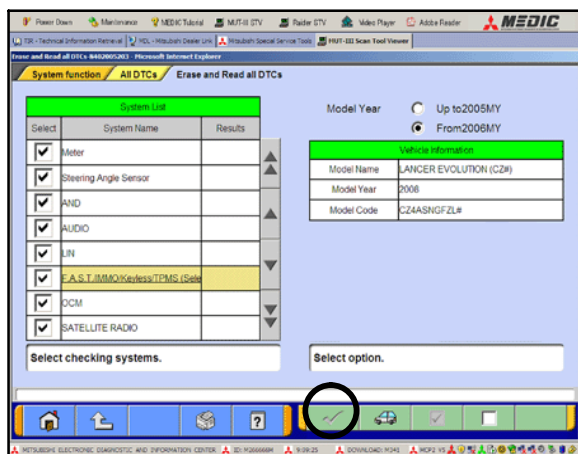
- c. The “System List” on the left side of the screen will have all selections checked. Do not change these selections. DTCs may be set if the vehicle is equipped with options that are unchecked.
- d. If the check mark at the bottom of the screen is highlighted, click it and move ahead to step 4. If not, continue with sub step e.

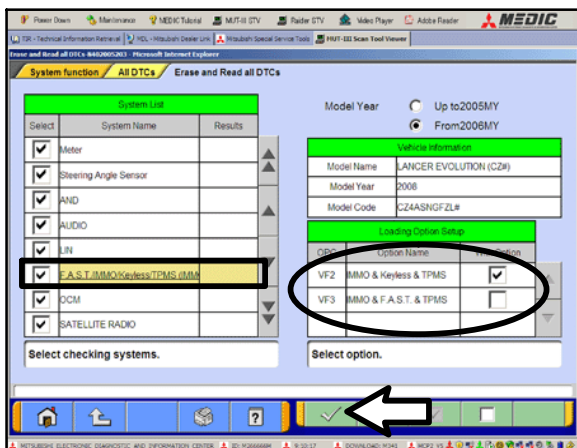
- e. In the left column, scroll to and click FAST/IMMOB/KEYLESS/TPMS. In the right column, check the correct option code (VF#) from the Loading Options Setup list. This will activate the check mark at the bottom of the page.
 - Vehicles with regular keyless entry (buttons on a multi-function key), select VF2.
 - Vehicles with F.A.S.T. Key, select VF3.
- f. In the left column, scroll to and select METER. A chart will display. Check the correct display type for the vehicle.
 - Click the check mark to continue.

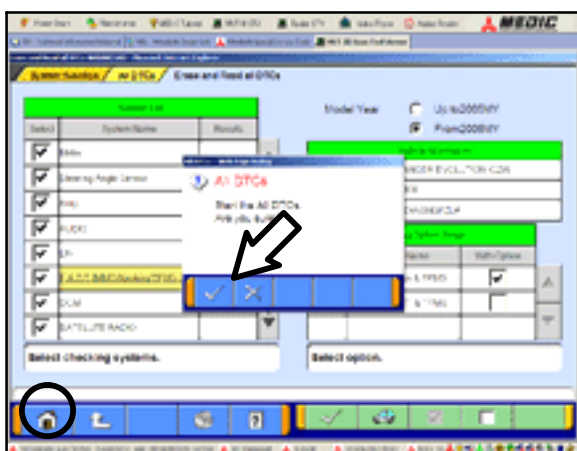
4. A window will pop up asking you to confirm DTC erasing. Click the check mark for DTC erasing and reading to begin.
5. When DTC erasing is completed, a window will display.
 - a. If DTCs return after reprogramming, click the check mark to clear the window. Diagnose and repair per the Service Manual.
 - b. If DTCs do not return, click the check mark to clear the window, then click the home icon at the lower left of the screen to return to the main menu.
6. Turn off the ignition switch and disconnect the MUT-III. Turn off and disconnect the battery charger.

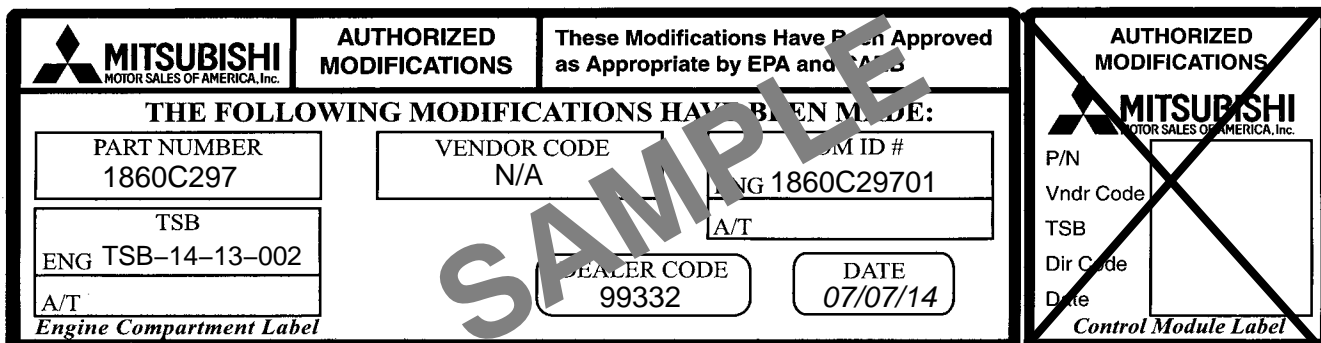
7. Using a ball-point pen, enter the appropriate Engine Control Module (ECM) part number, Software Part Number (ROM ID#), this Technical Service Bulletin number (TSB-14-13-002), your dealer code, and the current date on the Engine Compartment / Control Module Label (p/n MSSF024G00). The Vendor Code is not applicable. The label is available from your facing PDC.

The Control Module Label is NOT used for this reflash. It should be discarded.

8. Carefully remove all dirt and oil from a vacant area near the VECI label on the underside of the hood and affix the Engine Compartment Label (LH side, above) to that area.
9. Test drive the vehicle to confirm proper operation and the MIL does not illuminate. Diagnose and correct any DTCs that return.

1. Check the underside of the hood to verify there is no “Authorized Modification” label (see page 11 for example) previously installed to indicate this reprogramming has already been completed. If a label is present and the “ROM ID #” on the label matches the “New S/W Part No.” in the table above, the ECM is at the latest level and reprogramming is not necessary. Conduct normal diagnosis for the described condition.
