Technical Service Bulletin

NUMBER
14-01-034

ECM UPDATE - 2011 SULEV SONATA 2.4L COLD START LOGIC REVISION (SERVICE CAMPAIGN 930)

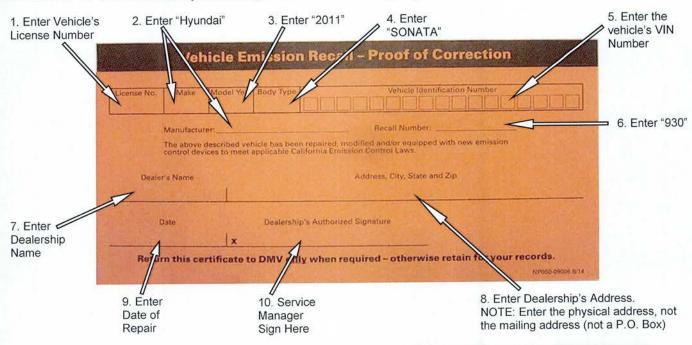
The copy of the card shown below indicates the areas to be filled in. Each area <u>must</u> be filled in. The completely filled out Vehicle Emission Recall - Proof of Correction card should be given to the owner of the vehicle upon completion of the Campaign.

The Vehicle Emission Recall - Proof of Correction card <u>must</u> be completed by the Dealership's Service Manager using a permanent ink pen. A fine point pen is recommended. When filling in the information, copy the information directly from the vehicle, <u>not</u> from the repair order. <u>ALL INFORMATION MUST BE PRINTED AND NEAT.</u>
