HYUNDAI NEW THINKING. NEW POSSIBILITIES. Technical Service Bulletin	GROUP	NUMBER
	FUEL SYSTEM	14-FL-006
	DATE	MODEL(S)
	November, 2014	ELANTRA (MD/UD)
SUBJECT:	ECM UPDATE – P2096 AND/OR MISFIRE DTC(s)

ECU Update

THIS TSB SUPERSEDES TSB 13-FL-006 WITH A REVISED ECM UPDATE AND OP CODE.

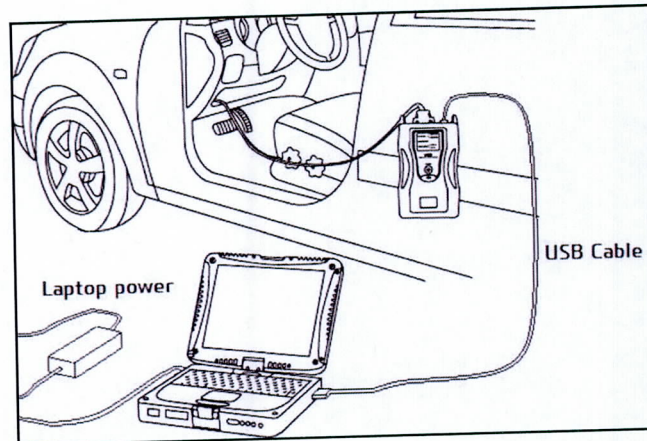
- Connect the USB cable between the GDS and the VCI.
- Connect the 16-pin DLC connector from the VCI into the DLC located under the driver's side dash.

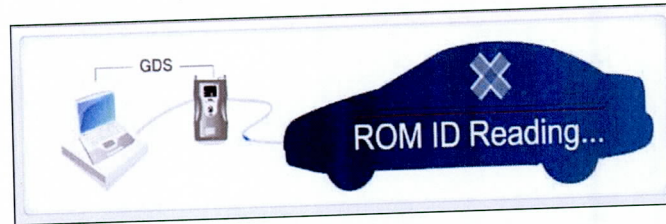
4. From the **System** tab, select **Engine** and then select **OK**. The GDS will read the ROM ID. Confirm the ROM is applicable as shown on Page 2-3, "ECM ROM ID Information".
NOTE: Record the ECM ROM ID in case the auto update fails and a manual update is needed.

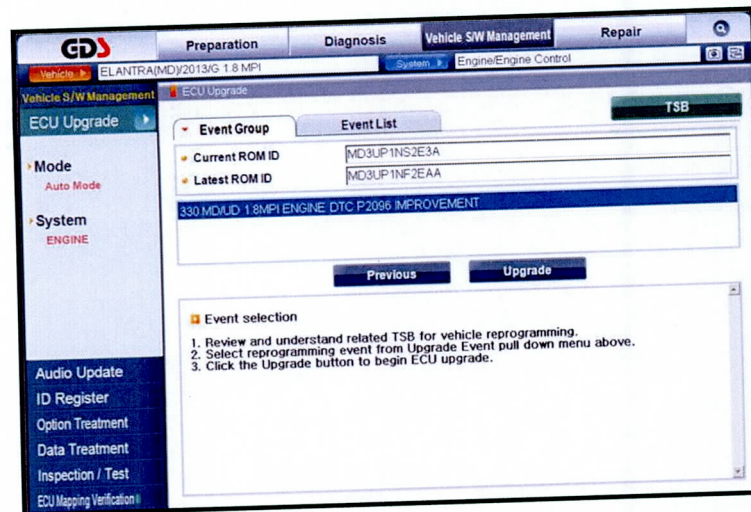
5. Update event "330. UD/MD 1.8MPI ENGINE DTC P2096 IMPROVEMENT" will display. Select **Upgrade**.
