# Technical Service Bulletin

SUBJECT:		No: <b>TSB-15-13-002</b>	
<b>ECM REPROGRAMMING FOR FALSE MIL ILLUMINATION WITH DTC P2097 – REVISED</b>		DATE: <b>March, 2015</b>	
		MODEL: <b>See Below</b>	
CIRCULATE TO:	<input type="checkbox"/> GENERAL MANAGER	<input checked="" type="checkbox"/> PARTS MANAGER	<input checked="" type="checkbox"/> TECHNICIAN
<input checked="" type="checkbox"/> SERVICE ADVISOR	<input checked="" type="checkbox"/> SERVICE MANAGER	<input checked="" type="checkbox"/> WARRANTY PROCESSOR	<input type="checkbox"/> SALES MANAGER

## PURPOSE

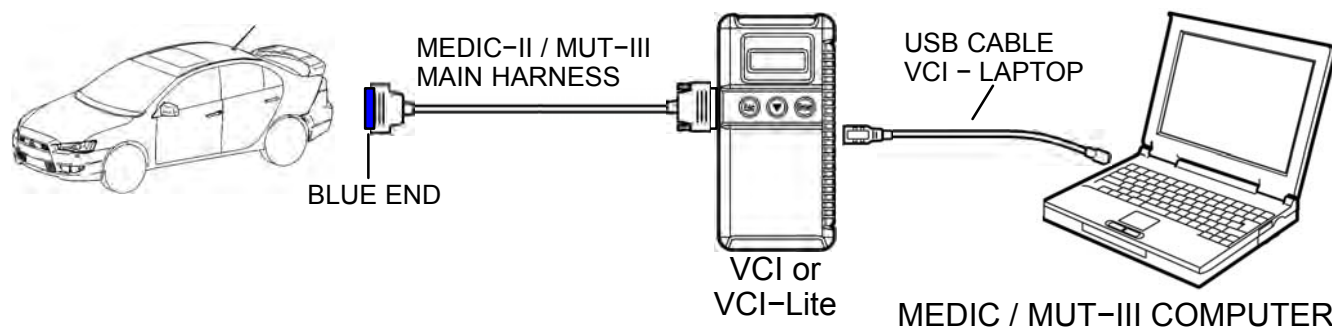
Connect the equipment as follows:

- Turn the laptop computer on. If you're running on battery power and the charge indicator in the lower right hand corner of the screen does not show a full charge, it is recommended that either the laptop battery be charged prior to beginning, or that reprogramming be completed with the A/C power adaptor connected to the laptop.
- Connect the USB cable to the VCI (or VCI-LITE).
- When the laptop displays the MUT-III main screen, connect the USB cable to the laptop.
- Connect the MUT-III main harness (blue DLC connector) to the VCI.
- Connect the blue connector of the MUT-III main harness to the vehicle's data link connector.
- Turn the VCI power switch ON. Verify the indicator lamp in the upper right corner of the screen is green.

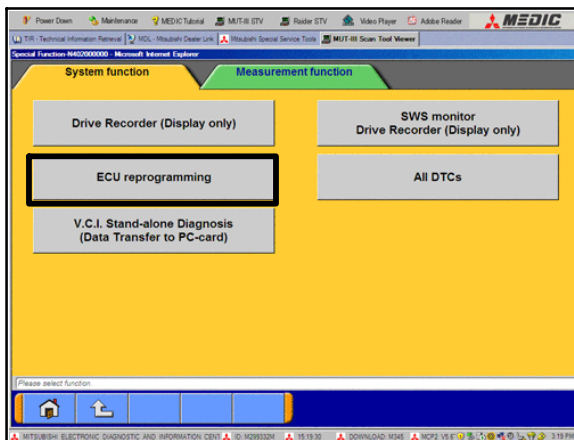
- b. If using MEDIC, from the main page, click the MUT-III STV icon at the top center of the screen to open MUT-III.
  - c. From the MUT-III Main Menu, select “Special Function.”
  - d. Select “ECU Reprogramming.”

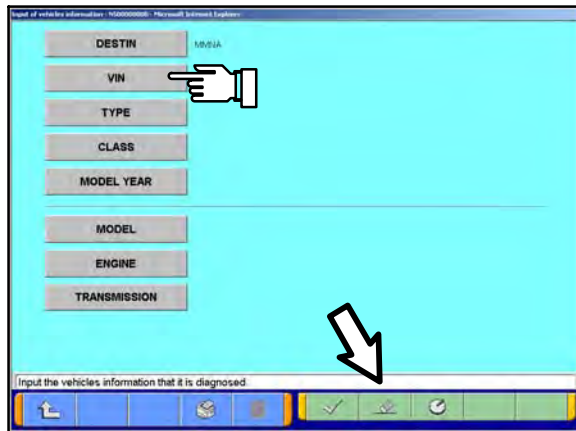
f. Click the car icon at the bottom of the page.

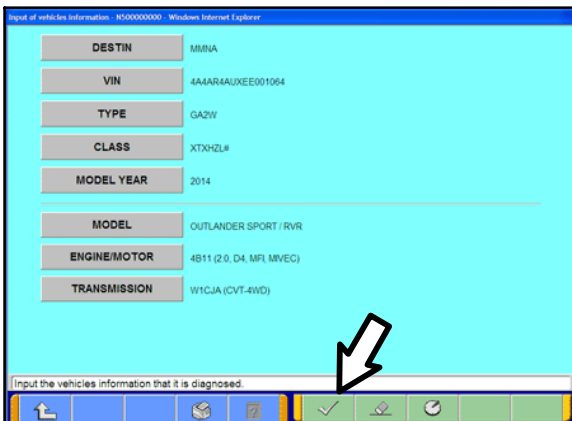
h. Click the icon in the lower RH corner of the screen to have MUT-III automatically read the VIN. If a message appears saying the VIN cannot be input automatically, manually enter the 17 digit VIN into the VIN field at the top of the page. Make sure the VIN is correct and click the check mark.

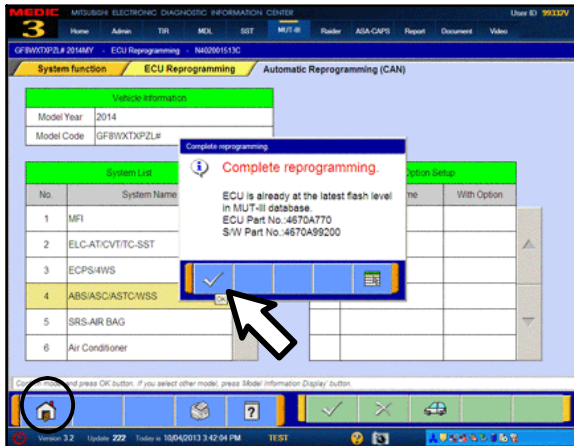
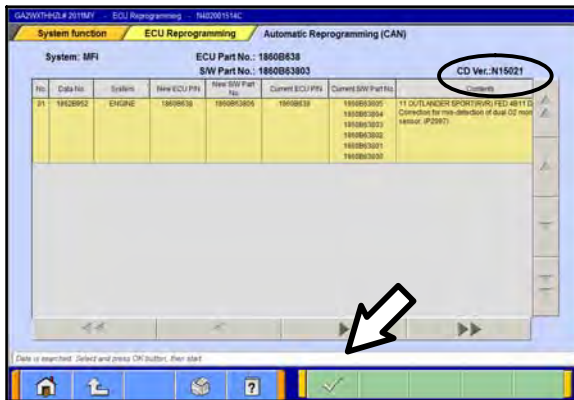
If a “Complete Reprogramming” message **does not** appear, continue with step I.

If the message seen at left is displayed, the ECM software is already at the most current level. Do not continue with the reprogramming procedure. This TSB does not apply.

Click the check mark to clear the window, then click the Home icon at the lower left corner of the screen to return to the System Select main page.

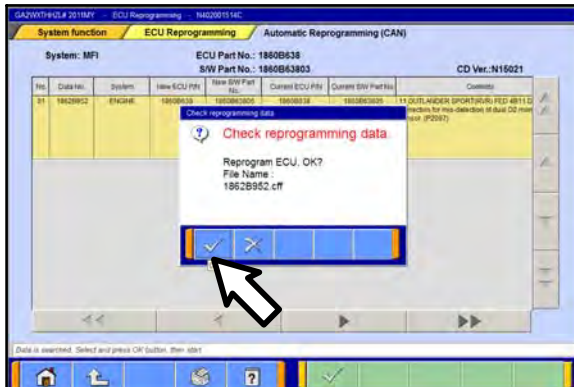
I. The Automatic Reprogramming (CAN) database screen will display.

Confirm the database number at the top right of the table is **N15021** or higher.

If more than one row is displayed in the table, refer to the ECM Reprogramming Chart on Page 2 to select the correct row.

Click on the row to highlight it.

Click the check mark to continue.

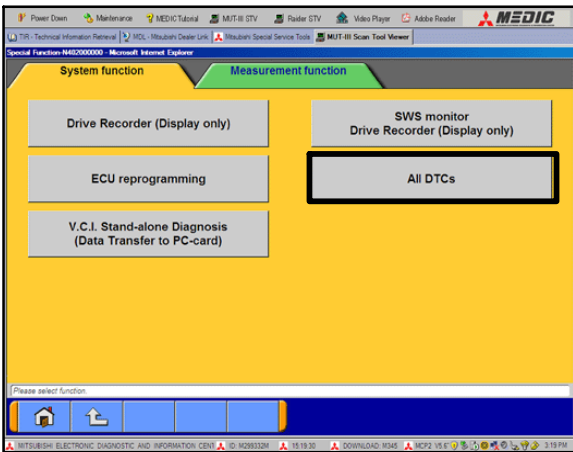
- 2. Click the UP arrow at the lower left corner of the page to return to the System Function page.
- 3. Using MUT-III, check and erase ALL DTCs from all systems as follows.
  - a. Select “Special Function.”
  - b. Select “All DTCs,” then select “ERASE AND READ ALL DTCS.”

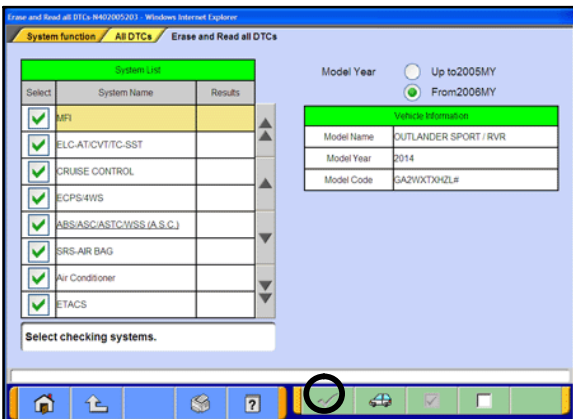
- c. The “System List” on the left side of the screen will have all selections checked. Do not change these selections. DTCs may be set if the vehicle is equipped with options that are unchecked.
- d. If the check mark at the bottom of the screen is highlighted, click it and move ahead to step 4. If not, continue with sub-step e.

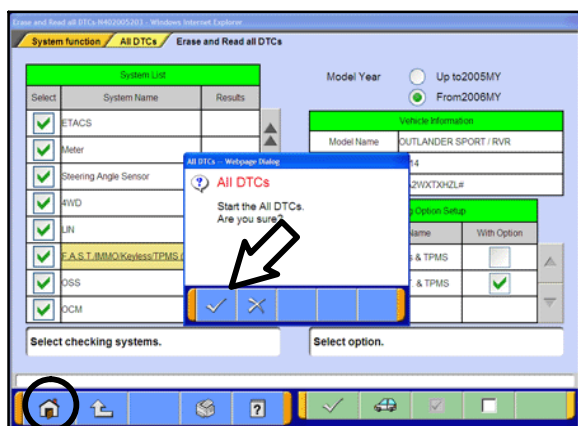
- e. In the left column, scroll to and click FAST/IMMOB/KEYLESS/TPMS. In the right column, check the correct option code (VF#) from the Loading Options Setup list. This will activate the check mark at the bottom of the page.
  - Vehicles with regular keyless entry (buttons on a multi-function key), select VF2.
  - Vehicles with F.A.S.T. Key, select VF3.
- d. If the check mark at the bottom of the screen is highlighted, click it and move ahead to step 4. If not, continue with sub-step f.
- f. In the left column, scroll to and select METER. A chart will display. Check the correct display type for the vehicle.  
Click the check mark to continue.
