Technical Service Bulletin

GROUP	NUMBER
CAMPAIGN	14-01-007
DATE	MODEL
JANUARY 2014	TUCSON (LM)

AUTOMATIC TRANSAXLE ECM & TCM UPDATE (SERVICE CAMPAIGN TS3)

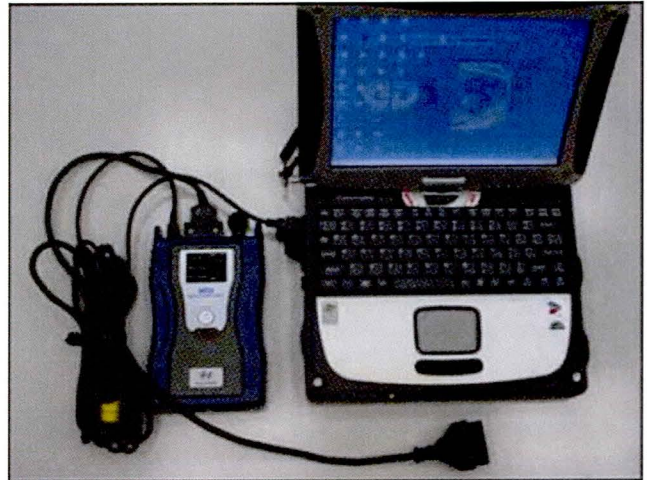
- Connect the USB cable between the GDS and the VCI.
- Connect the 16-pin DLC connector from the VCI into the DLC located under the driver's side dash.

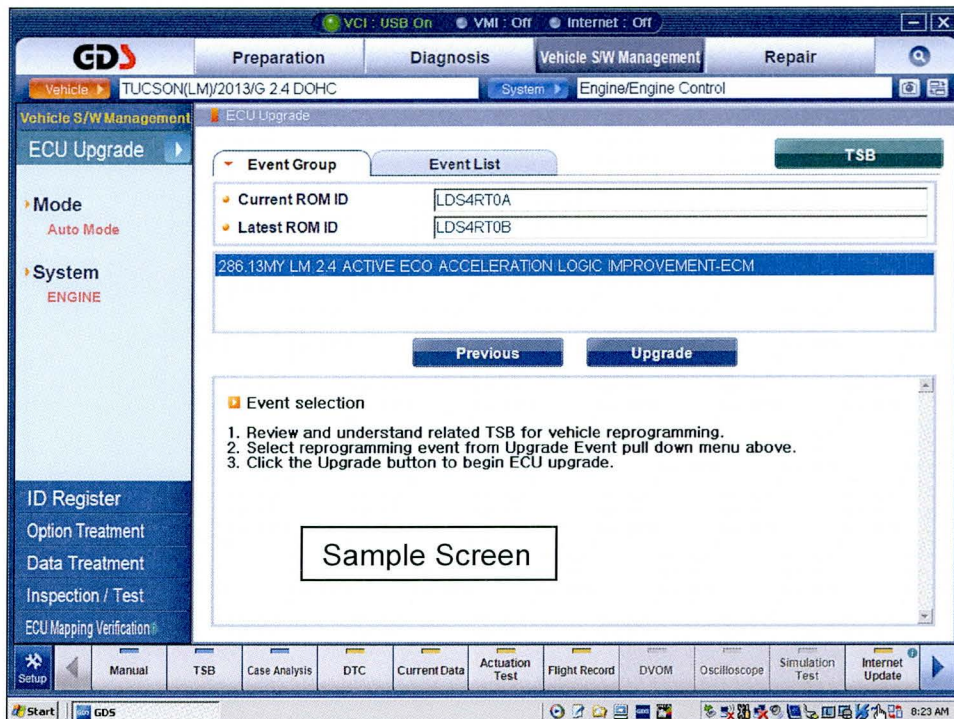
1. From the GDS home page, select **ECU Upgrade**. If necessary, select the VIN.
2. Select **Engine** as the system and then select **OK**.
3. Select **Auto Mode** and then select **Next**.
4. From the **System** tab, select **Engine** and then select **OK**. The GDS will read the ROM ID. Confirm the ROM is applicable as shown on Page 1, “ECM ROM ID Information”. **NOTE:** Record the ROM ID in case the auto update fails and a manual update is needed.
5. Update event **317.13MY LM 2.4 MPI P030X DTC LOGIC IMPROVEMENT** will display. Select **Upgrade**.
