GROUP FUE	MODEL 2014MY Forte (YD) w/2.0L GDI
	NUMBER 027	DATE October 2013
TECHNICAL SERVICE BULLETIN		
SUBJECT: ECM UPGRADE –MIL ON WITH DTC P0461

ECM UPGRADE – MIL ON WITH DTC P0461

UPGRADE EVENT NAME
218.YD DTC(P0461) LOGIC IMPROVEMENT(ECU)

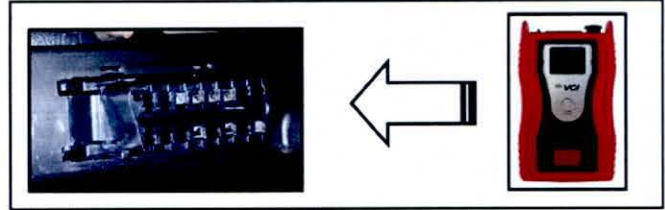
- Connect the Main 16-pin DLC cable (GHDM – 241000) to the OBD-II connector, located under the driver's side of the instrument panel.

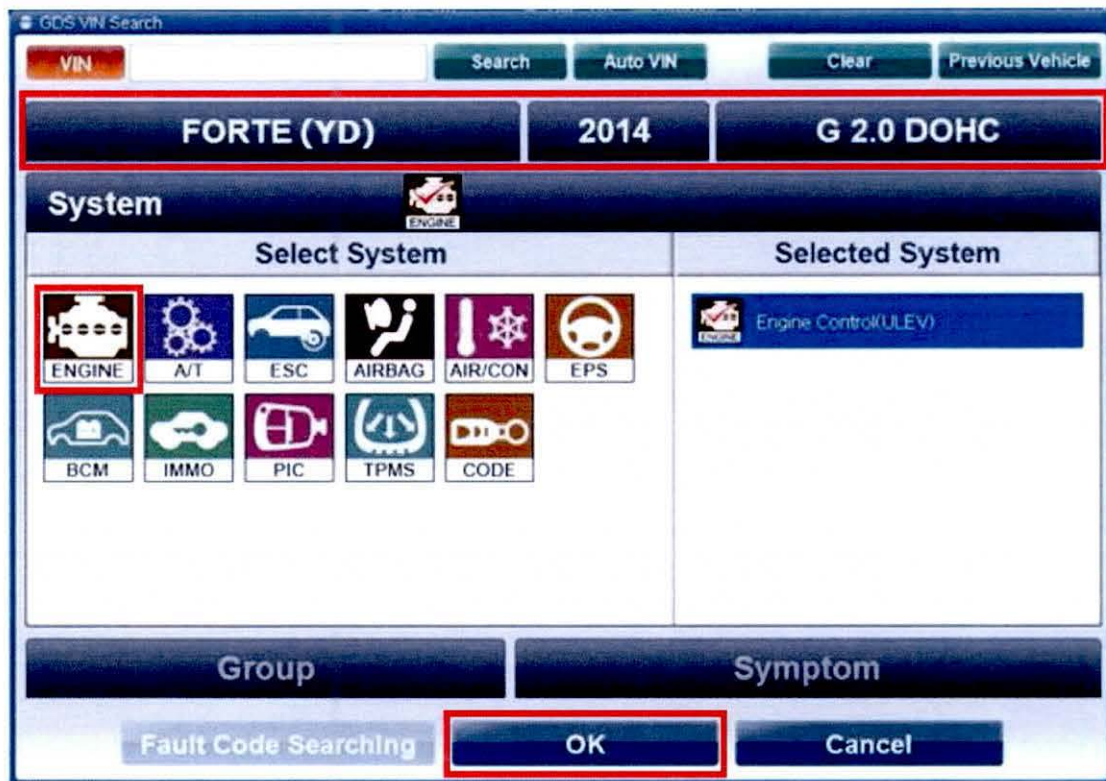
- With the ignition key ON, turn ON the VCI and GDS. Access the GDS vehicle identification number (VIN) screen and configure the vehicle using the **VIN AUTO DETECT** Function.
- Select **ENGINE** system and click **OK**.

- Select **ECU Upgrade** from the bottom right-hand corner. Next select **Auto Mode**, and then **Engine**. Perform the ECM upgrade in accordance with normal GDS ECM upgrade procedures.
