TECHNICAL SERVICE BULLETIN

SUBJECT: SERVICE ACTION: NAVIGATION UNIT SOFTWARE
UPGRADE (SA172)

This bulletin provides the procedure for upgrading the navigation system software of some Sedona (YP), Soul (PS) and Optima (QF) vehicles to resolve concerns related to no sound coming from the head unit after ending a Bluetooth call. Kia is requesting the completion of this Service Action on all affected vehicles. Before conducting the procedure, verify that the vehicle is included in the list of the affected VINs.

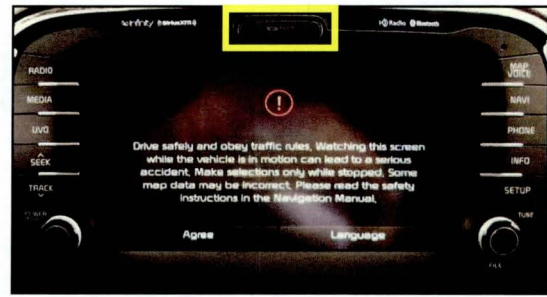
1. Start the vehicle or connect the Midtronics GR8-1299 charger.
2. Remove the map SD Card from the slot and insert the upgrade SD Card.

*** NOTICE**
Screens shown in this bulletin are for demonstration purposes ONLY and will vary depending on the vehicle.

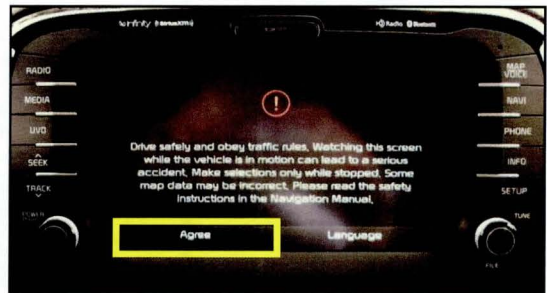
3. Touch the **Agree** icon on the screen.

*** NOTICE**
This AVN software update will take approximately twenty (20) minutes to complete.

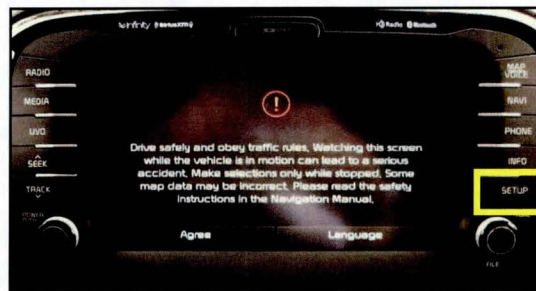
4. Press the **SETUP** button.

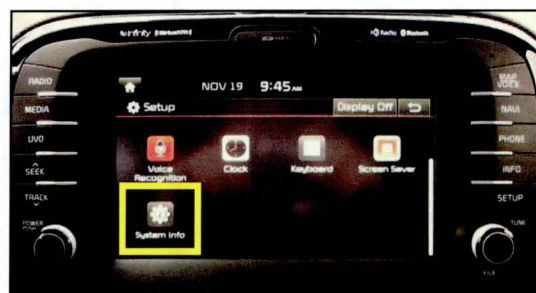
5. Scroll to the bottom of the screen and touch **System Info**.

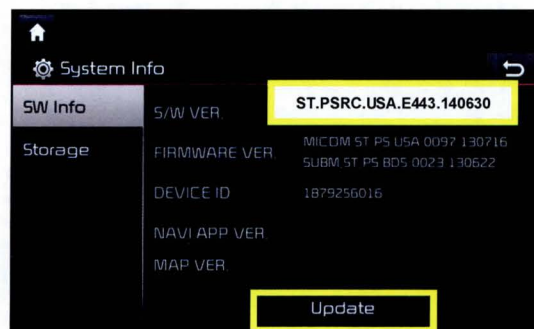
6. Compare the original software version to the versions shown in the table below and press **Update**.

Model	Original Software Version
Sedona (YP)	ST.YP.USA.E445.140708
Soul (PS)	ST.PSRC.USA.E443.140630
Optima (QF)	ST.TF.USA.E443.140630

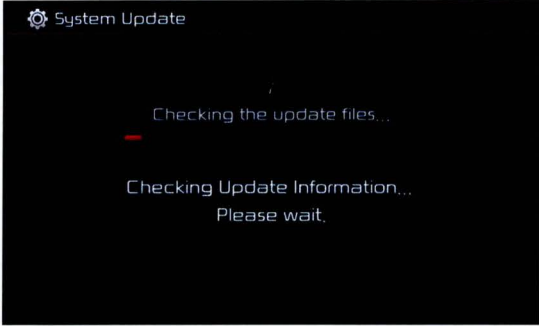
- 7. The upgrade screen will be displayed and the system will install multiple updates.

*** NOTICE**
Do NOT turn the vehicle OFF while the update is in progress.

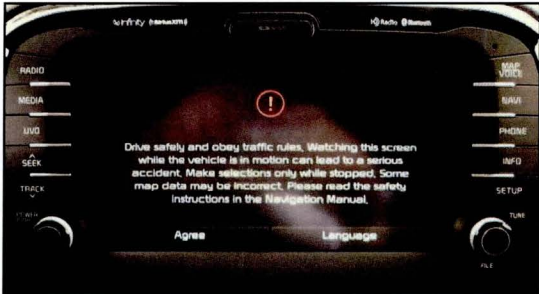
- 8. If the updates are completed successfully, the display will turn off. Once the Kia logo is displayed on the screen, cycle power to the navigation system by pressing the ON/OFF button.

*** NOTICE**
If the AVN update fails, turn the ignition OFF and restart the procedure from step 1.

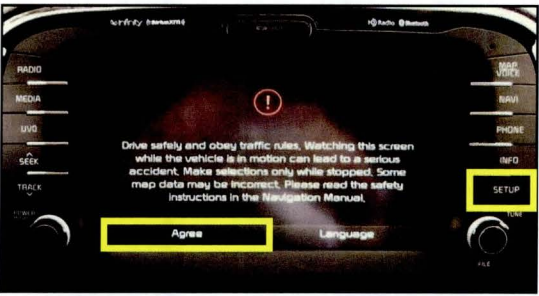
- 9. Remove the upgrade SD Card and reinstall the original map SD Card. Allow the system to reboot and press the **Agree** button on the screen. Then, touch the **Setup** button.

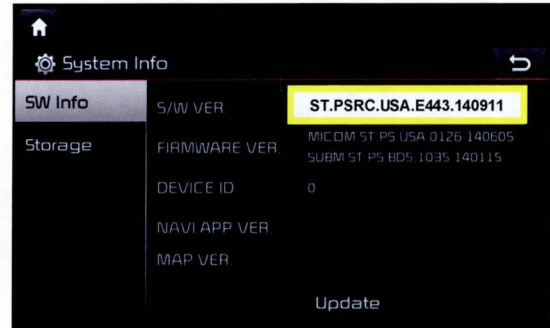
10. Touch the **System Info** button on the screen and verify the software version by referring to the information on the table below.

Model	New Software Version
Sedona (YP)	ST.YP.USA.E445.140904
Soul (PS)	ST.PSRC.USA.E443.140911
Optima (QF)	ST.TF.USA.E443.140911
