Technical Service Bulletin

13-01-036

Genesis (BH), Equus (VI)

DIS NAVIGATION SYSTEM MAP UPDATE INSTALLATION PROCEDURE (SERVICE CAMPAIGN TQ3)

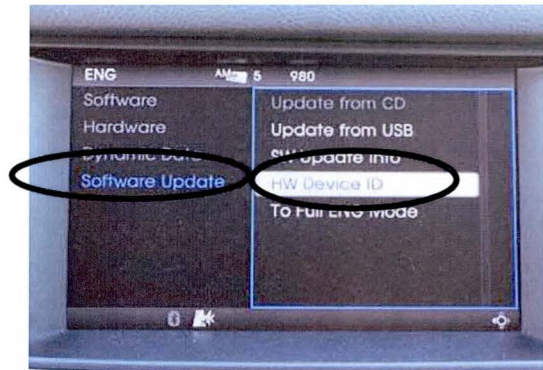
2.2 Using the CCP (Center Control Panel), scroll the focus bar down to 'Software Update' on the left side of the display screen, and 'jog' the CCP to the right. Select 'HW Device ID'.

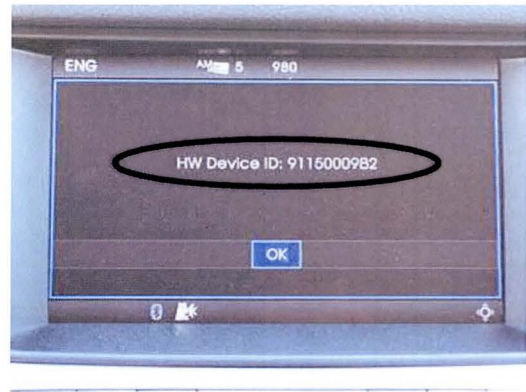
2.3 The HW Device ID will be displayed on screen.

If the HW Device ID is not shown on screen, then proceed with updating the operating software in the next section. After updating the operating software, then the device ID will be shown on the screen.

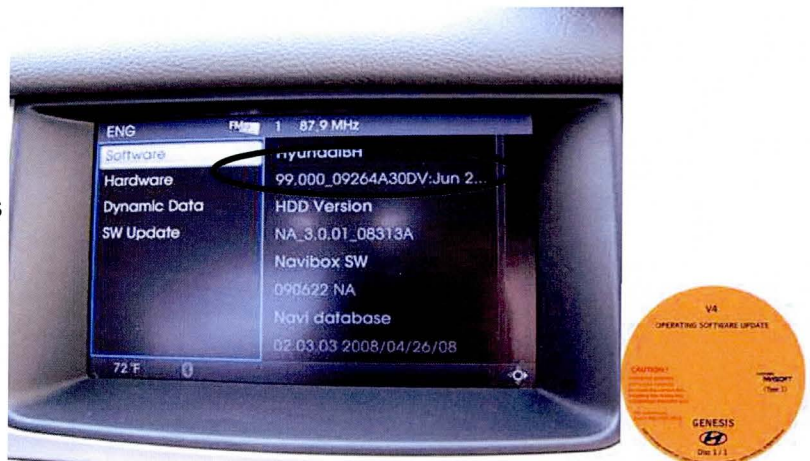
Check unit version under 'HyundaiBH'. If the unit version starts with **NUMBERS** and **NO LETTERS**, then use the **ORANGE** disc (Type 1).

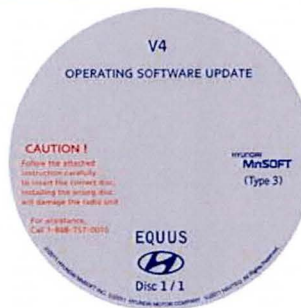
All Equus vehicles will use the **GRAY** disc.

*** NOTE**
Complete operating software update first, and then follow with Map Disc1 (PURPLE), Map Disc2 (PURPLE) and Map Disc3 (PURPLE).

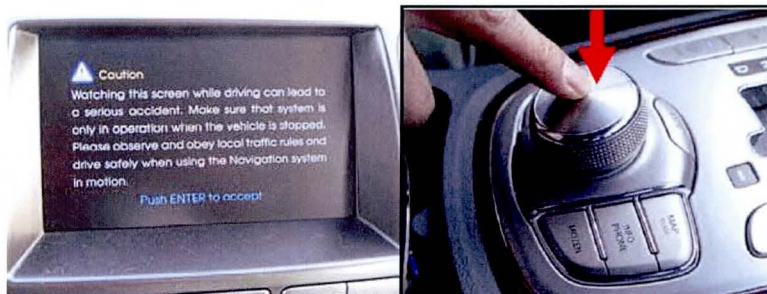
3.3 Press the CCP (Center Control Panel) knob DOWN to acknowledge the caution screen message.

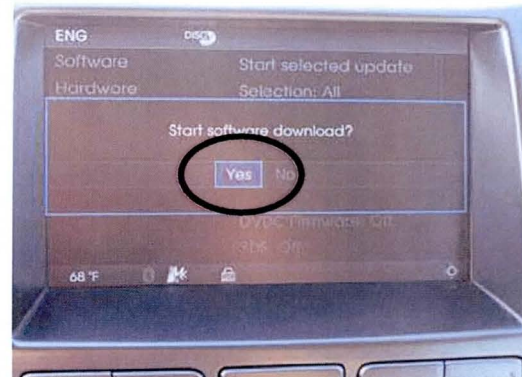
- 3.7 Select 'Start selected update'. A pop up message will appear, then select 'Yes' to start software download.

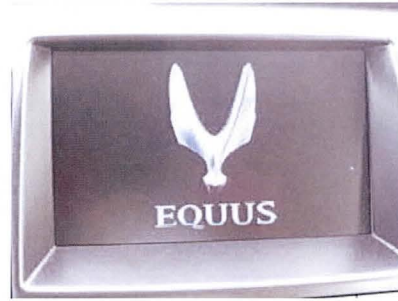
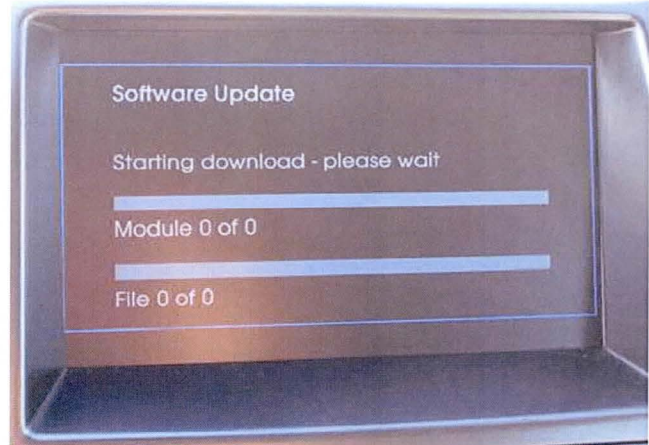
3.8 The system will then re-boot. You will see the system's splash screen momentarily.

The software update process will begin and a download progress indicator will appear for a few moments.

3.9 The installation progress indicator will now be displayed and the installation will begin.

After the successful download and installation of the operating software, the system will re-boot and display the splash screen for a few seconds.

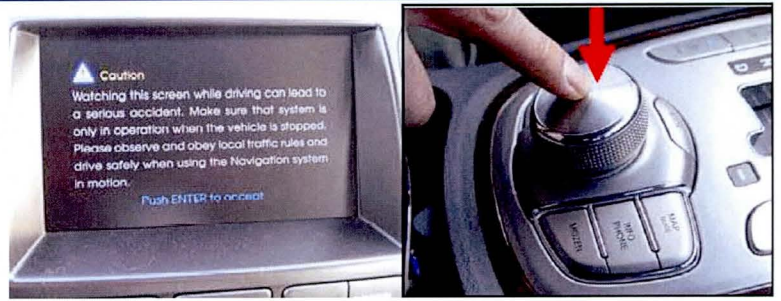
4.2 Press the CCP (Center Control Panel) knob DOWN to acknowledge the caution screen message.

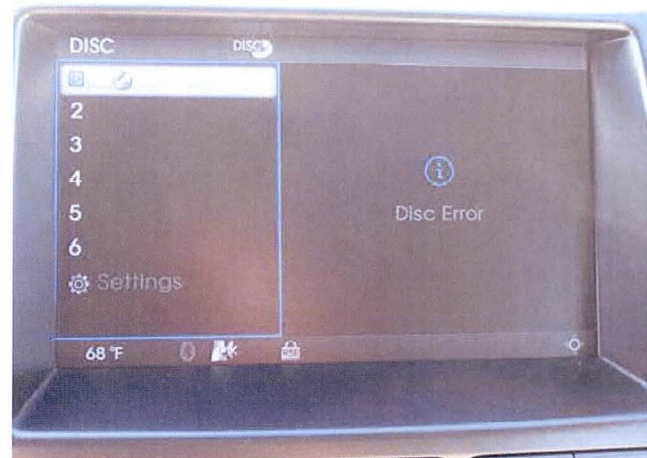
4.5 After a few moments, the LCD screen will display a "Disc Error" message indicating the disc is a "non-playable format" disc. This is normal.

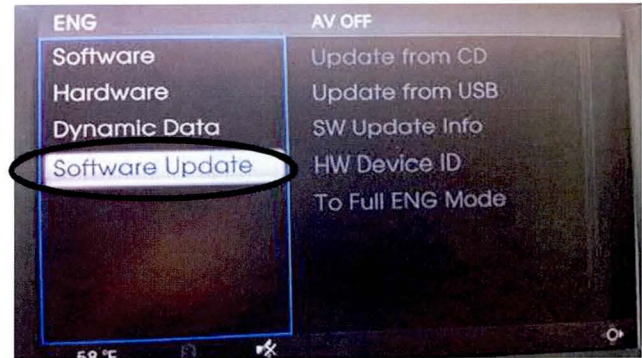
4.7 Using the CCP (Center Control Panel), scroll the focus bar down to **'Software Update'** on the left side of the display screen, and 'jog' the CCP to the right.

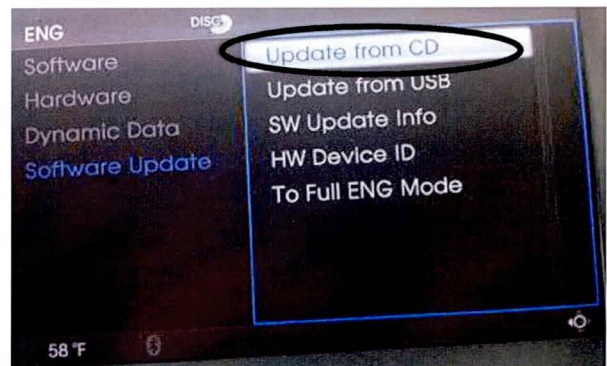
4.8 Highlight **'Update from CD'** and then press the CCP (Center Control Panel) down.

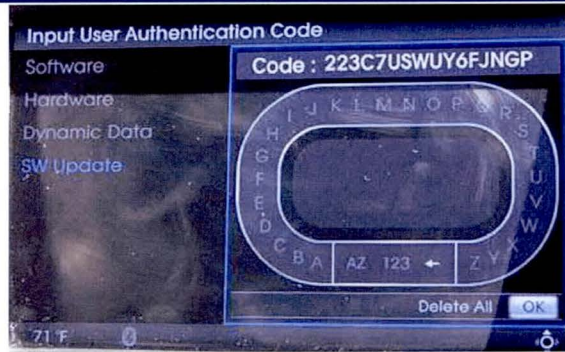
4.10 The user authentication guide screen will display.

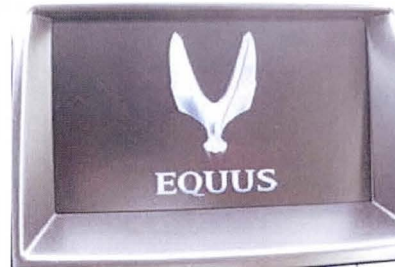
4.12 The system will then re-boot. You will see the system's splash screen momentarily.

The software update process will begin and a download progress indicator will appear for a few moments.

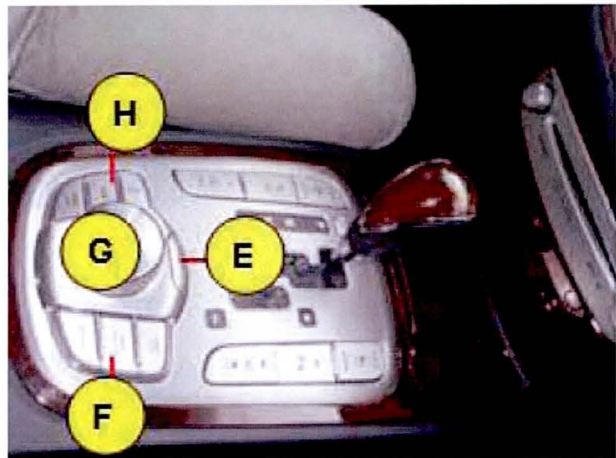
If you get error "0x1101" on the screen, press (H) XM/DISC, (E) BACK, (F) NAVI MENU, Rotate knob CCP (G) at the same time to reset the head unit. Begin step 4.6 again to enter the S/W update menu and re-enter the Authentication Code.

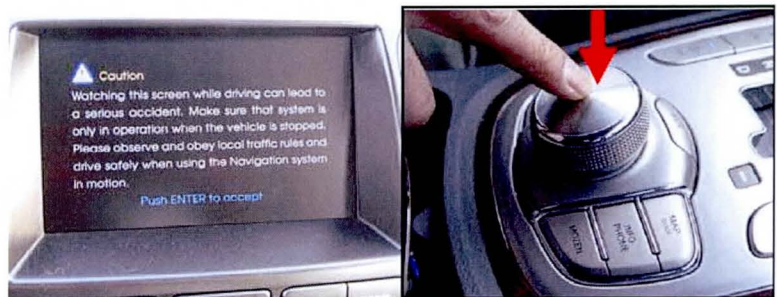
4.15 The caution screen disclaimer will be displayed. Press the CCP (Center Control Panel) down to acknowledge the disclaimer.

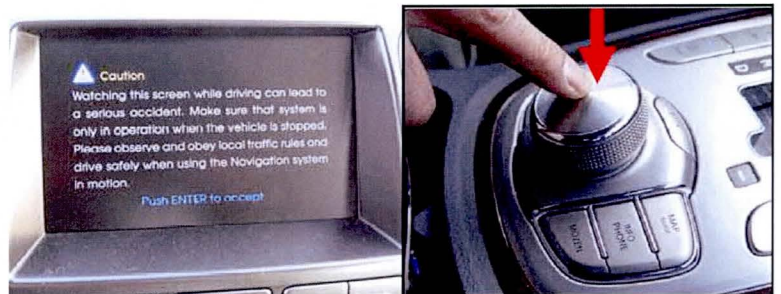
4.19 The caution screen disclaimer will be displayed. Press the CCP (Center Control Panel) down to acknowledge the disclaimer.

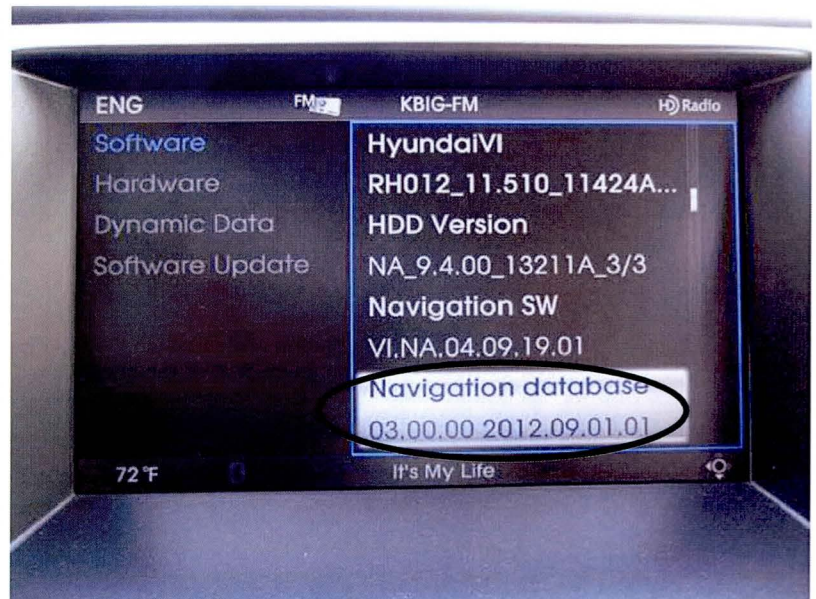
4.21 The software version for “Navigation database” should display:

03.00.00 2012.09.01.01

*** IMPORTANT**
Refer to steps 4.19 – 4.21 to check the current map version. If the version is 03.00.00 2012.09.01.01, then an update is not necessary.

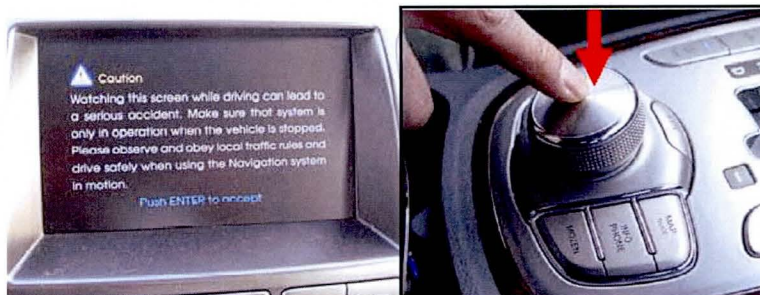
4.22 Start the engine. Press the CCP (Center Control Panel) down to acknowledge the disclaimer.

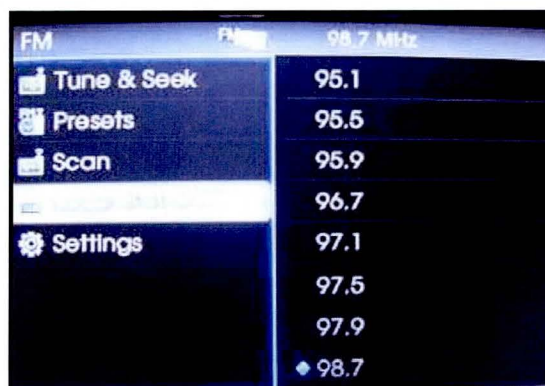
4.23 Press the AM/FM button on the CCP (Center Control Panel) panel.

- Using the CCP dial, jog to the left of the screen and highlight 'Local Stations'.
- The right side of the screen should now be populated with a list of local (strong) FM stations.

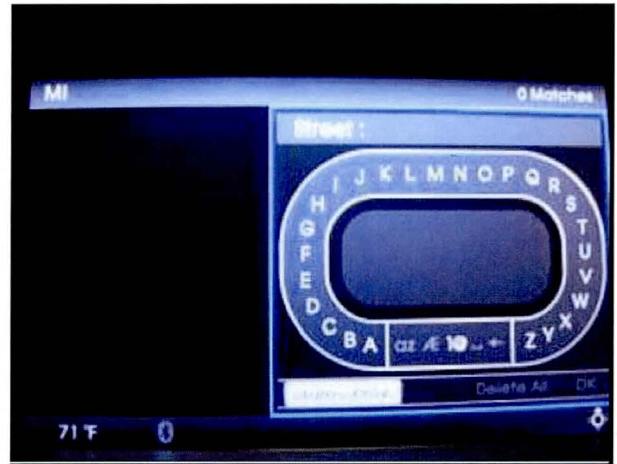
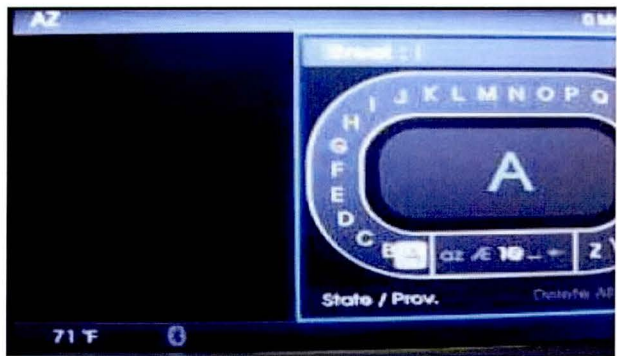
4.25 In the navigation address search, if the location is different, change the default state value from MI (Michigan) to the customer's state of residence.

- Press the NAVI/MENU button, jog the dial to the right of the screen, and highlight ADDRESS. Press the CCP knob down.

- From the Smart Speller, jog the dial down to highlight STATE/PROV. Press the CCP knob down.

- Using the Smart Speller, spell the state. Alternately, you may simply move the dial to the left and select the state from the list. Once you have selected the state from the list, press the CCP knob down to change the default state.

- The upper left-hand of the screen should now display the new default state.
