Secondary Air Injection System - MIL "ON" DTC P2440 and/or P2442

Service Category Engine/Hybrid System

Section Emission Control

YEAR(S)	MODEL(S)	ADDITIONAL INFORMATION
2012 – 2013	Sequoia	
2012 – 2013	Tundra

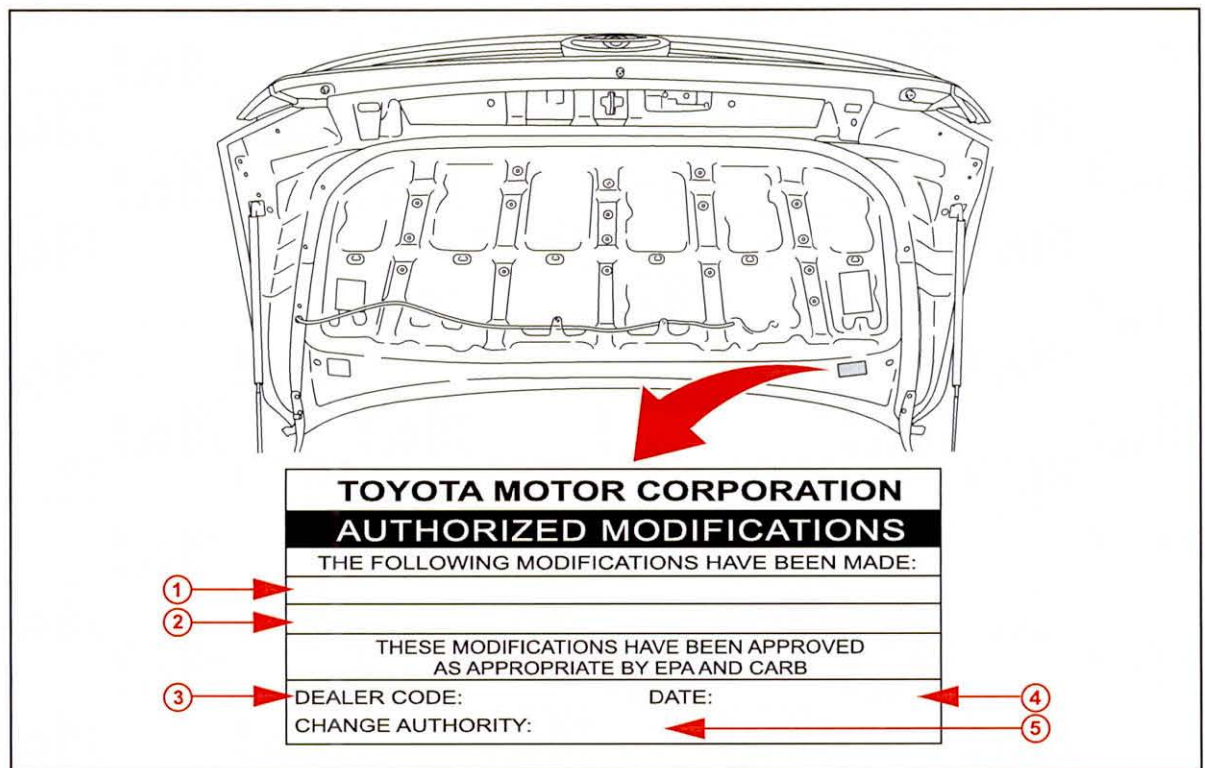
Figure 1. Location of Authorized Modifications Label on 2012 – 2013 Sequoia and Tundra

1	Replacement ECM (PCM) Part Number (i.e., 89661-0CM94)
2	New Calibration ID(s) (i.e., 30CK2400)
3	Dealer Code

4	Date Completed
5	This SB Number

2. Check for the Authorized Modifications Label affixed to the vehicle in the location shown in Figure 1. Confirm if the ECM (PCM) calibration has been updated.
 - If the calibration ID listed is NOT the latest ECM (PCM) calibration — go to step 3.
 - If the calibration ID listed is the latest ECM (PCM) calibration – this bulletin does NOT apply. Continue diagnosis using the applicable Repair Manual.

- Install the Authorized Modifications Label.
 - Using a permanent marker, enter the following information on the label:
 - ECM part number [Refer to the **Parts Information** section for the **NEW PART NUMBER**]
 - Calibration ID(s) [Refer to the **Calibration Information** section for the **NEW CALIBRATION ID**]
 - Dealer Code
 - Repair Date
 - Change Authority [**This bulletin number**]
 - Affix the Authorized Modifications Label to the vehicle at the location shown in Figure 1. The Authorized Modifications Label is available through the MDC, P/N 00451-00001-LBL.
- Test drive the vehicle to confirm proper vehicle operation.
