# Navigation System Firmware Improvement (Generation 6)

Service  
Category Audio/Visual/Telematics

Section Navigation/Multi Info Display

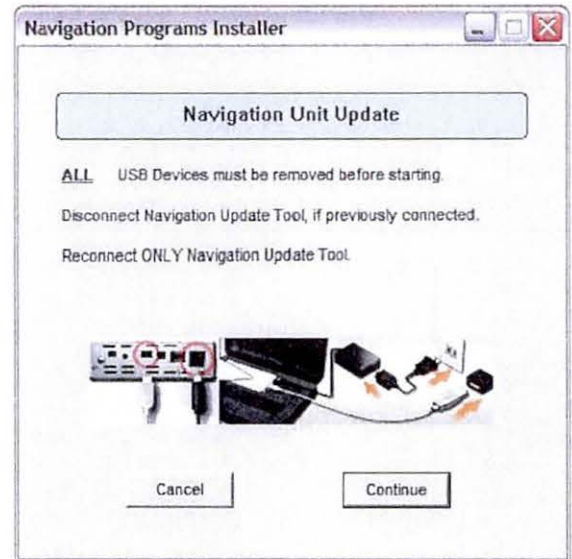
Figure 2.

7. Verify that both the transfer mode display light (green) and power supply display light (blue) are lit, then click *Continue*.

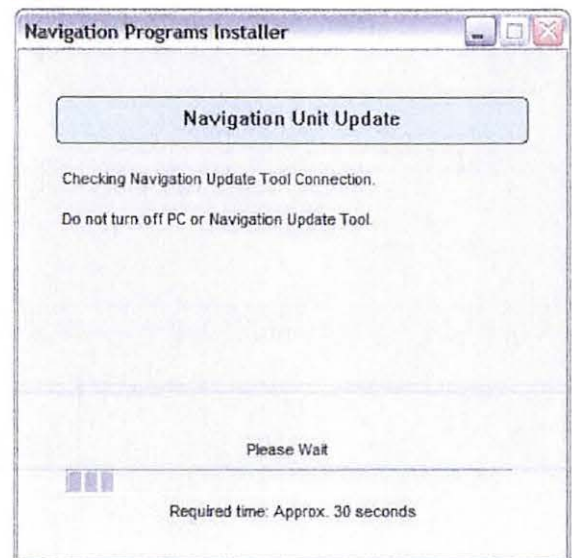
Figure 3.

8. The software will perform a connection check with the Navigation Update Tool. In the event an error is shown, please recheck the USB connection.

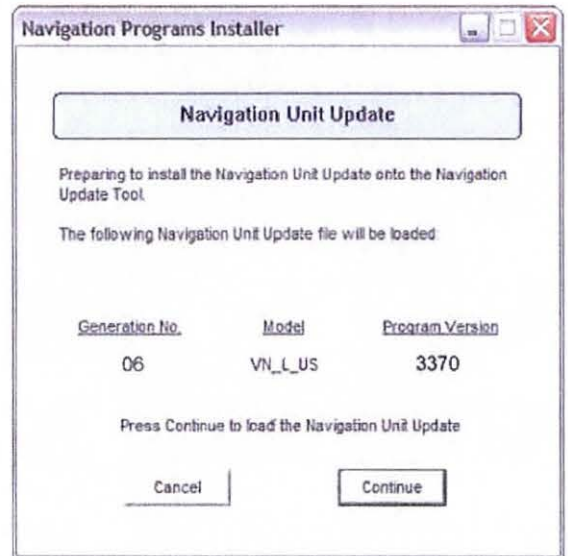
Figure 4.

9. Navigation Firmware is ready to be loaded onto the Navigation Update Tool, click *Continue*.

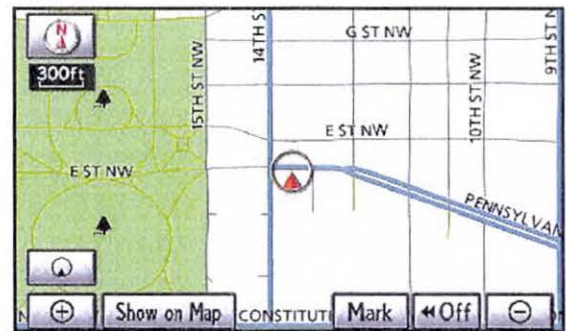
Figure 8.

4. Select *Show on Map*.

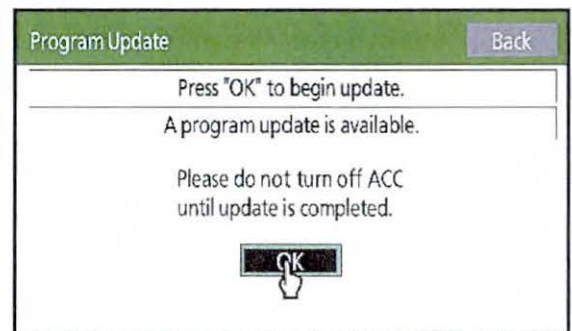
Figure 10.

7. Select *OK*.

Load time for the program update is between 5 and 15 minutes.

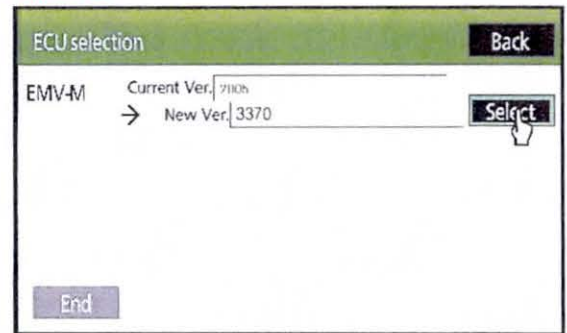
Figure 12.

- When the *ECU Selection* screen appears, confirm the Current version is less than the New version. If yes, then press *Select*. If no, then select *End* and go to step 11.
