Recall Bulletin

PRODUCT SAFETY RECALL

SUBJECT: Unintended Ignition Key Rotation

MODELS: 2005-2009 Buick Allure (Canada)
2005-2009 Buick LaCrosse
2006-2011 Buick Lucerne
2000-2005 Cadillac DeVille
2006-2011 Cadillac DTS
2006-2007 Chevrolet Monte Carlo
2006-2013 Chevrolet Impala
2014 Chevrolet Impala Limited (U.S. Fleet Only)

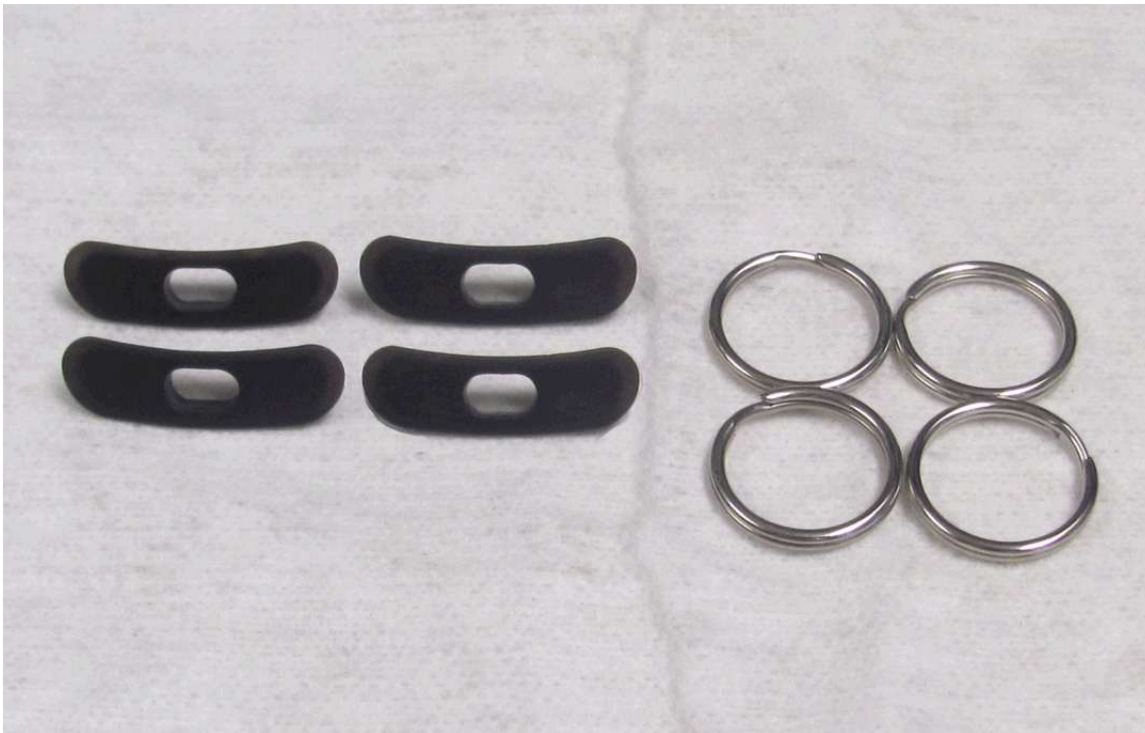
3970365

Key Insert Repair

Note: Locate the four key inserts and four 16 mm rings. Two key inserts are required to modify one key. Two 16mm key rings are required for each key repair.

Note: If the key slot is too small or large for the insert, use the two-piece key cover repair. If the head of the insert does not cover the entire slot, the key insert repair cannot be used.

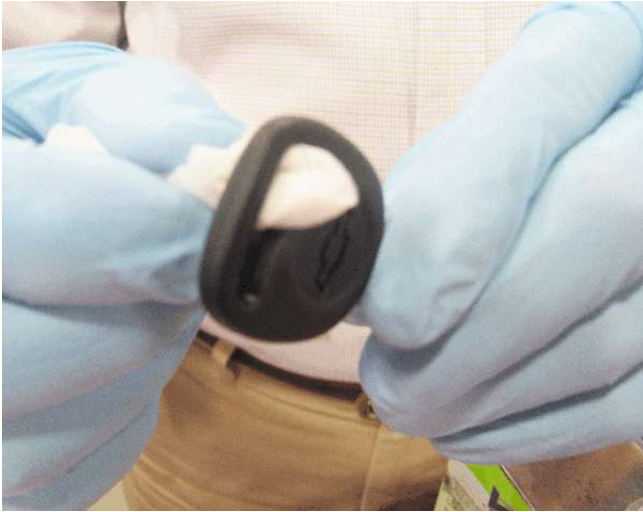
3970395

1. Test fit the customer-provided key. Insert a key insert into the front slot of the key and insert a second key insert into the back slot of the key. Ensure the key insert fits flush into the slot of both sides of the key.

2. Remove the inserts from the front and back key slots.

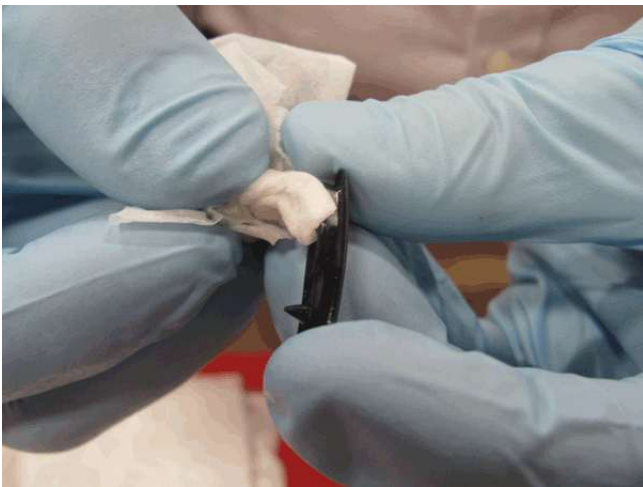
3970397

3. Clean the head and slot of the keys using a shop towel and isopropyl alcohol.

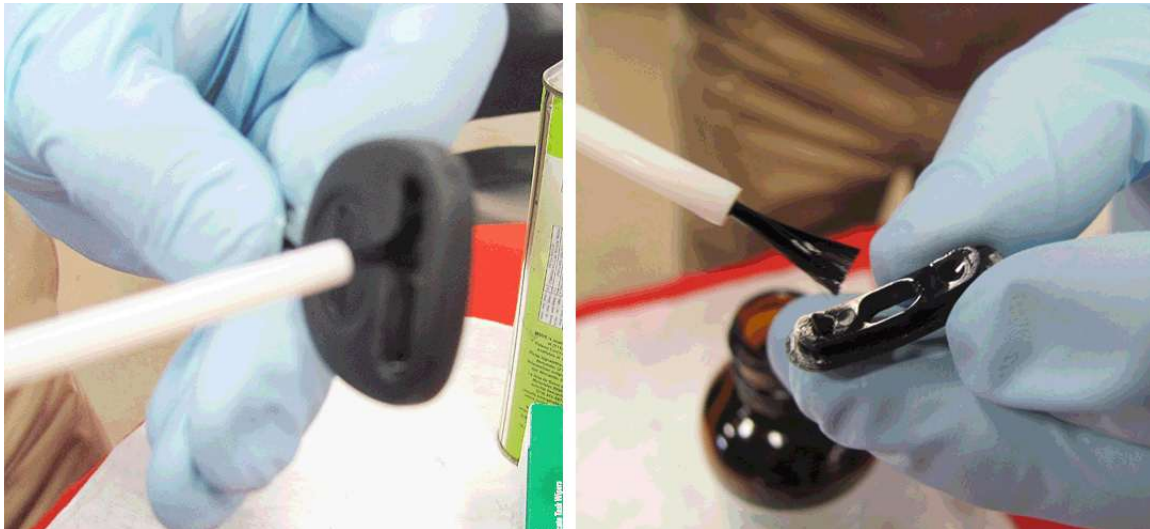
3970399

4. Clean the key inserts using a shop towel and isopropyl alcohol.

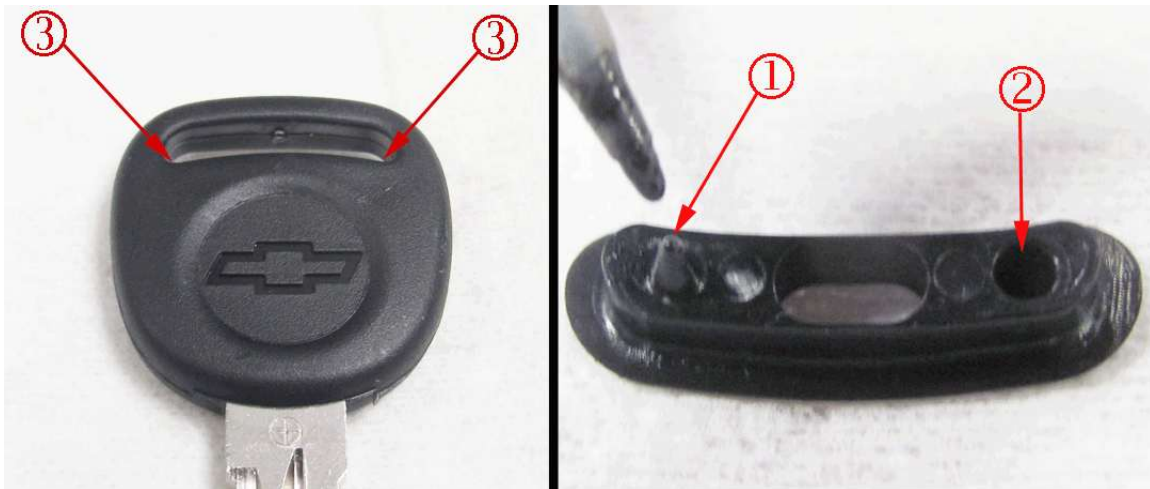
3970372

- 5. Apply the primer to the front and back key slot of the two keys.
- 6. Apply the primer to the four inserts.

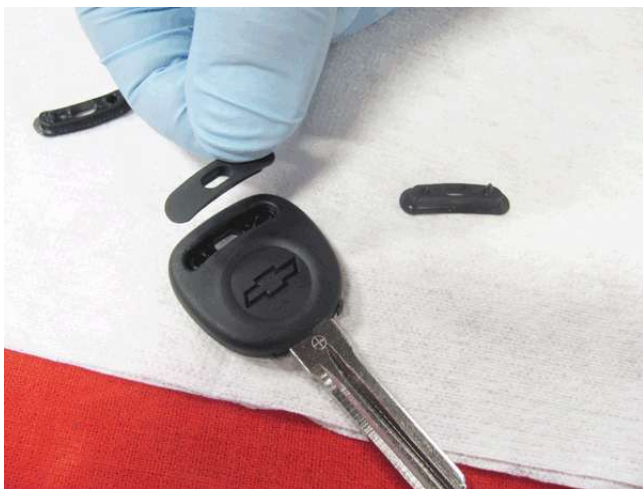
3970401

- 7. Apply adhesive to the corners (3) of the key slots.
- 8. Apply adhesive to the post (1) and hole (2) of each insert.

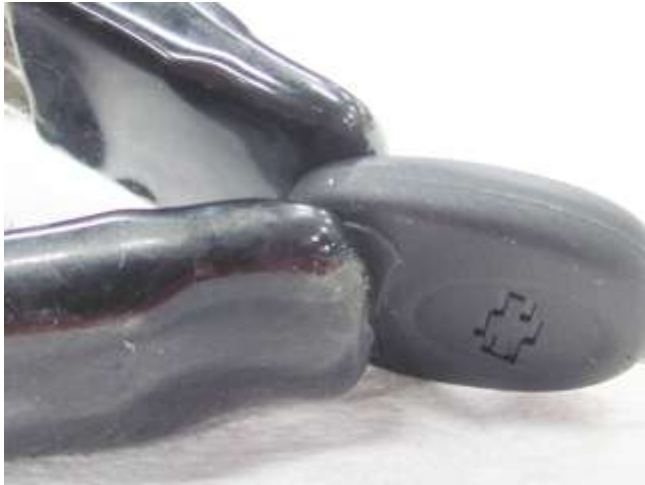
3970376

- 9. Insert a front and back insert to the key slot of each key.

10. Clean the body of the keys with a shop towel.
11. Clean the hole of each key with a shop towel and screwdriver.

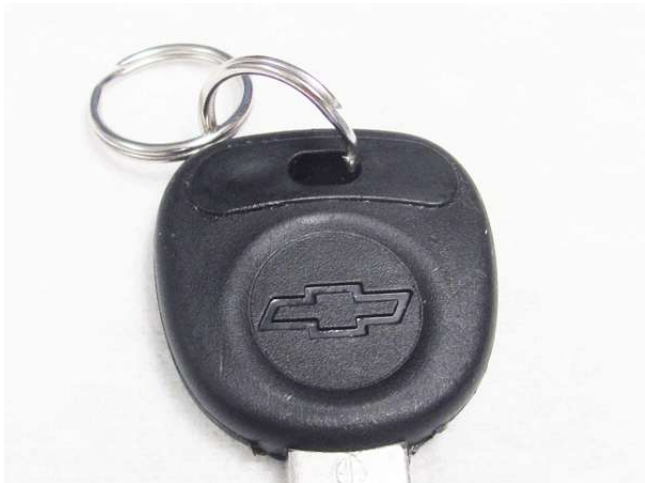
3970400

12. Clamp the two key insert to the key slot using a spring clamp with rubber ends.
13. Remove the clamp from the key assembly after allowing the adhesive to dry for 5 minutes.

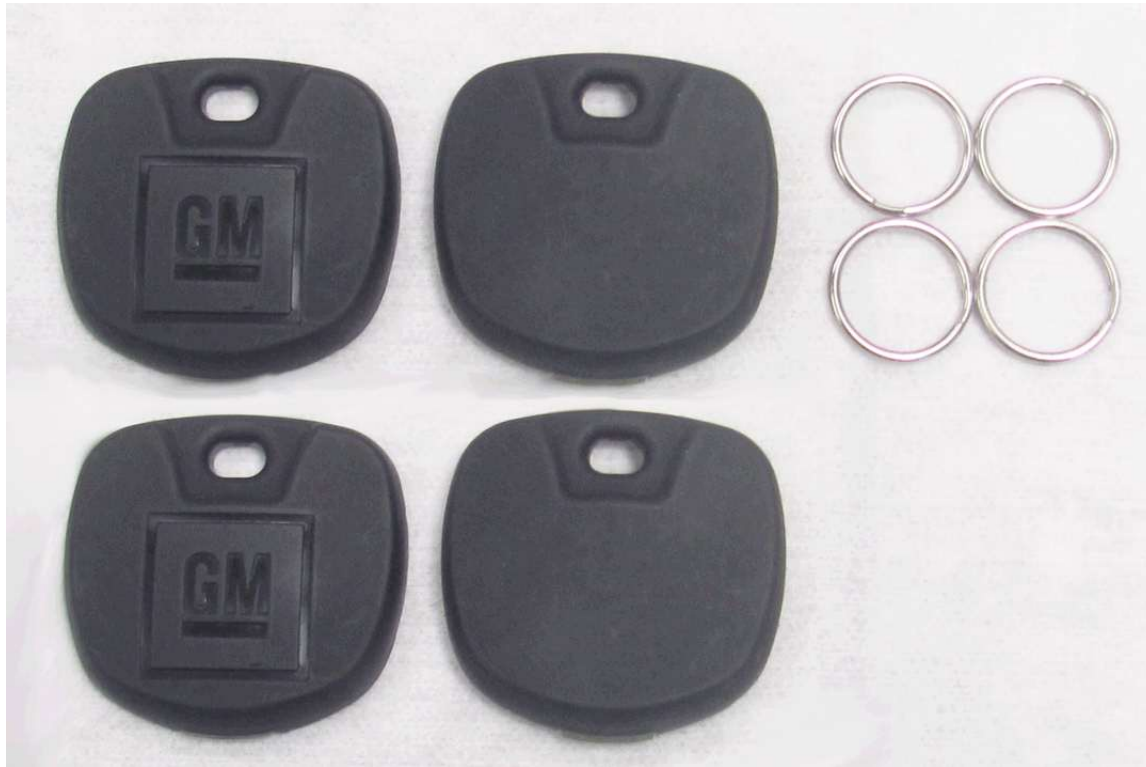
3971048

Two-Piece Key Cover Repair

Note: Locate the four key covers and four 16 mm rings. A front and back cover are required to modify one key. Two 16mm key rings are required for each key repair.

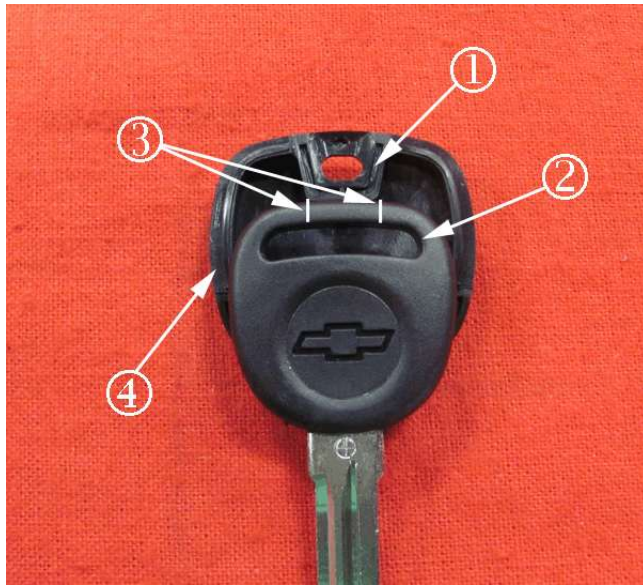
1. Test fit the customer-provided key into the back key cover.
 - 1.1 Ensure the body of the key fits into the back key cover. The body of the key may require some filing to fit into the cover. Use a file to remove the material from the body of the key.
 - 1.2 Align the back cover boss (1) with the slot (2) of the customer-provided key.
 - 1.3 Using a pen or knife mark the top portion of the slot (3) that must be cut in order for the customer-provided key to fit inside of the back cover.

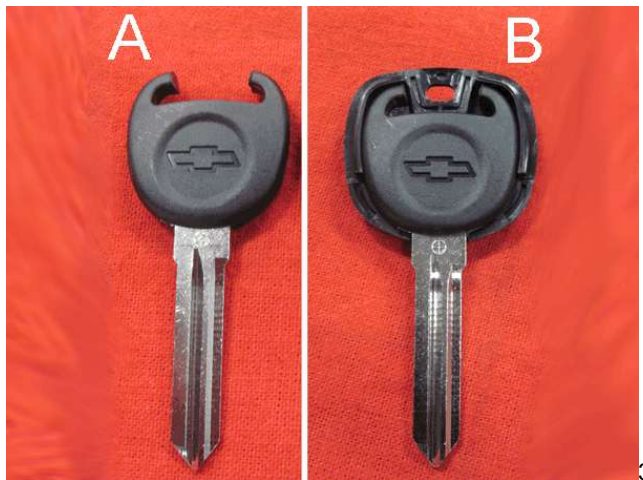
- 1.4 Using a knife or box cutter, cut out a notch (A) in the slot of the key.
 - 1.5 The back cover boss must fit inside of the notched area of the key (B).
 - 1.6 Remove the key from the back cover.

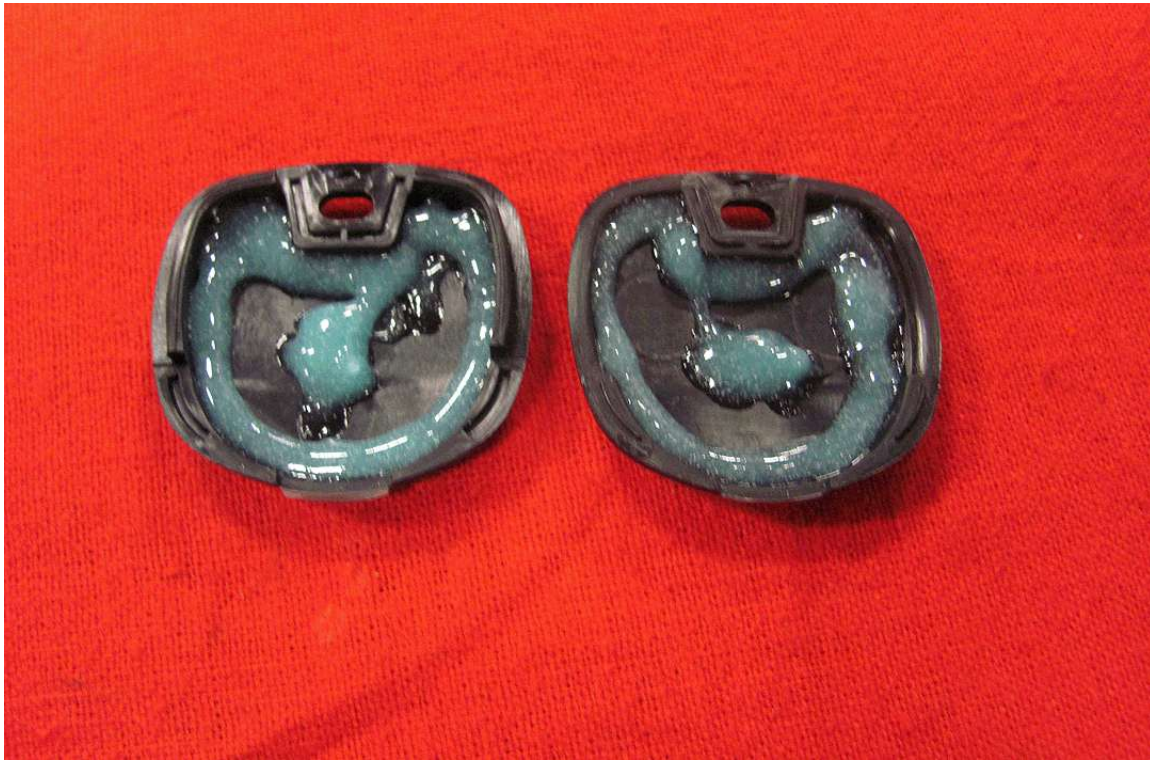
3971030

4. Assemble the front and back key cover over the key. Ensure the front and back cover fit over the key and that the two covers snap together.
 - If the key covers fit over the key and snap together correctly, proceed to step 5.
 - If the key covers do NOT fit over the key, file more material off the body of the key. Re-assemble the key covers over the key to ensure proper cover fit. Clean the key and covers BEFORE applying the adhesive.

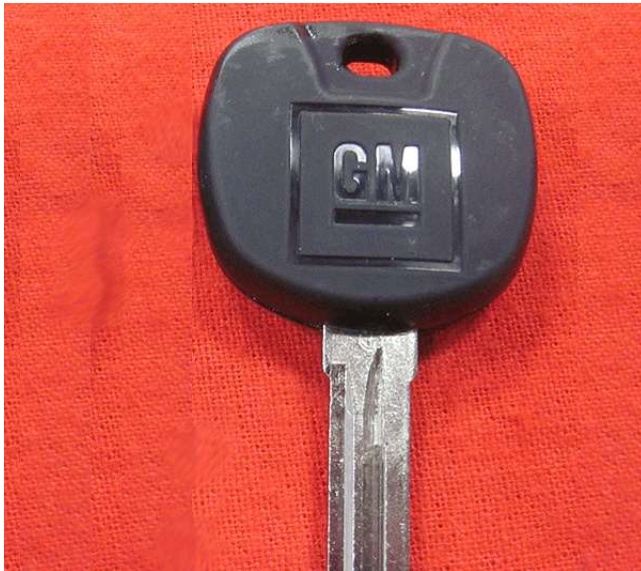
3970991

5. Dispense a small amount of adhesive to ensure the mixed adhesive is blue or green (not white or brown) in color. Then apply a bead of adhesive to the inside of the front and back key cover. Ensure a bead of adhesive is applied to the whole perimeter of the cover.

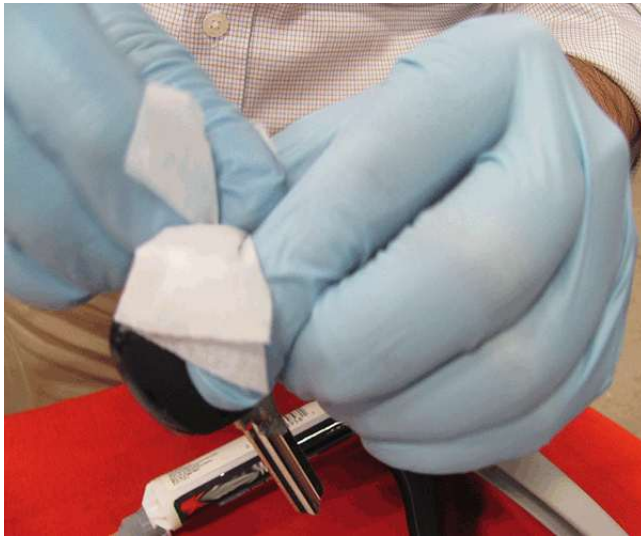
3971005

6. Press the front and back key cover over the key.
