SERVICE BULLETIN

APPLICABILITY: 2013MY Legacy and Outback Models with 2.5L FB Engines
 2011-14MY Forester Models with 2.5L FB Engines
 2012-13MY Impreza and 2013MY XV Crosstrek Models with 2.0L FB Engine

NUMBER: 02-157-14R
DATE: 08/28/14
REVISED: 09/08/14

SUBJECT: Surface Treatment Change To Oil Control Piston Rings

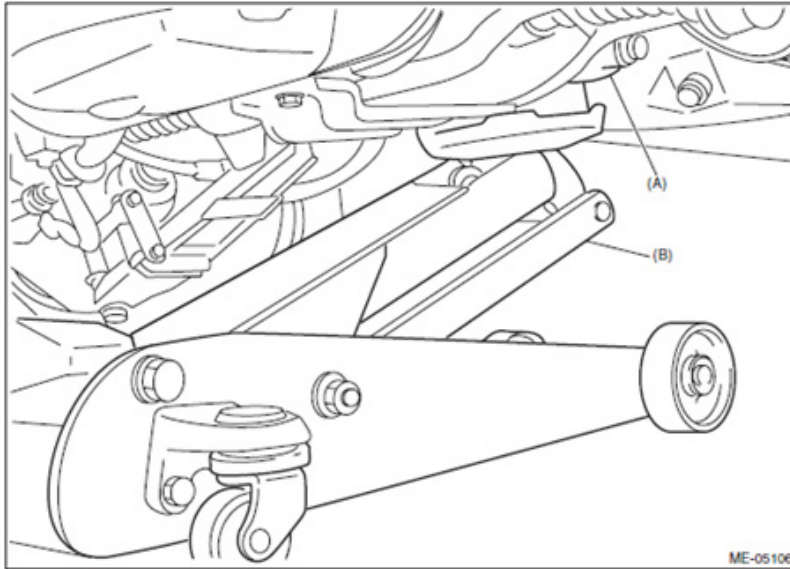
- When draining the engine oil, do not remove the engine oil filter. Leave the existing oil filter in place through engine disassembly, reassembly, installation and initial startup after engine reassembly.
- When removing the engine, there is no need to remove the transmission case cover (CVT only) or to disconnect / disturb any of the transmission harness connectors. While raising the transmission with the service jack placed under the front differential as shown in the illustration below, **only raise it enough to access and remove the engine mounting hardware**. Raising it too high can push the transmission up into the bulkhead / transmission tunnel and possibly cause damage.

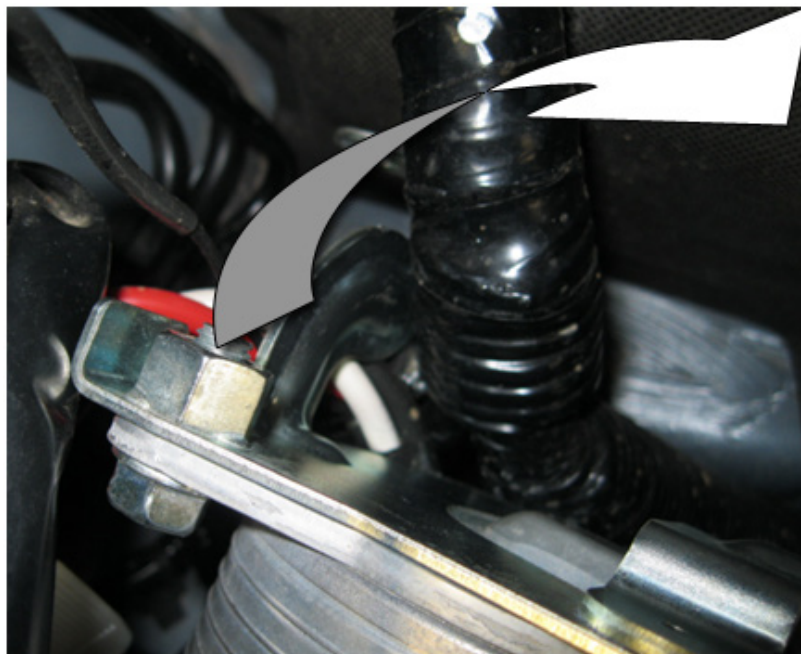
- When removing the CVT fluid cooler (if equipped), leave it attached to its mounting bracket and remove as an assembly (3 bolts) from the transmission. Disconnect just the engine coolant hoses from it and do not disturb the 2 short CVT fluid lines. Hook one of the cooler's mounting bracket "ears" behind the bulkhead harness as shown in the photo below to keep the cooler assembly out of your way. Use a shop cloth between the "ear" and the bulkhead harness to prevent any chafing.

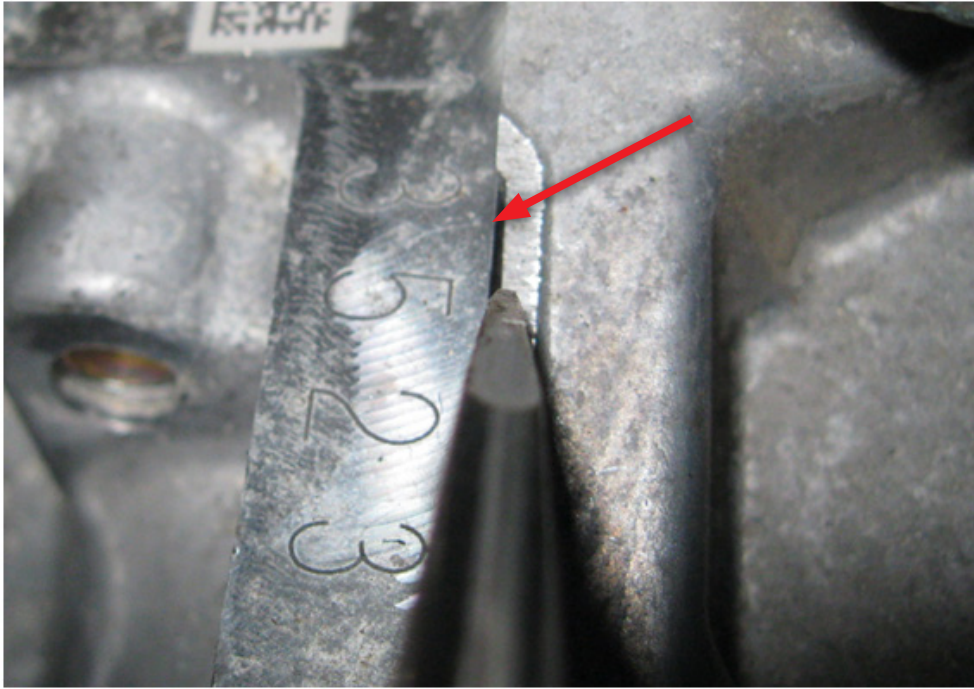
- To make separating the transmission (CVT) from the engine easier, there is a pry relief shown below in the machined mounting surface of the transmission case near the engine number. Use caution when applying any prying pressure and avoid twisting the tool to prevent case damage.

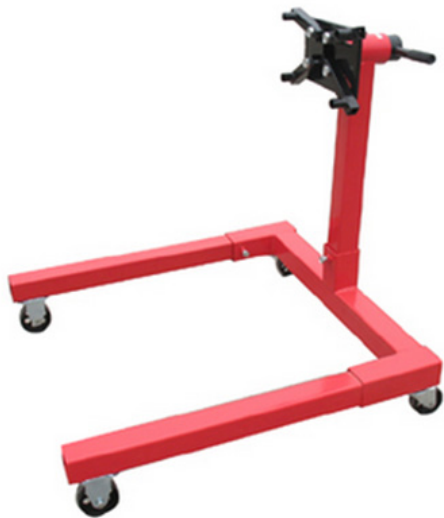
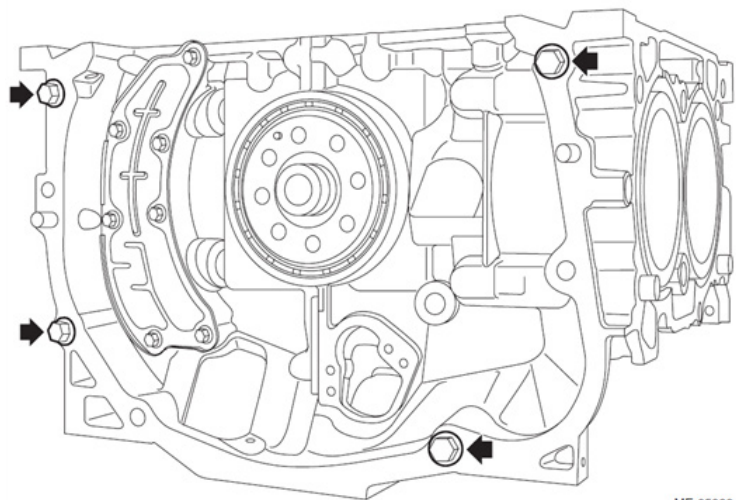
ME-05926

- Once the engine is removed, if you are using a generic engine stand (preferable since engine rotation is necessary), use the four mounting holes on the engine block shown below to mount it. **NOTE:** Do not use the mounting studs in the upper oil pan.

Begin by putting the new short block onto your engine stand using the same mounting points as before.

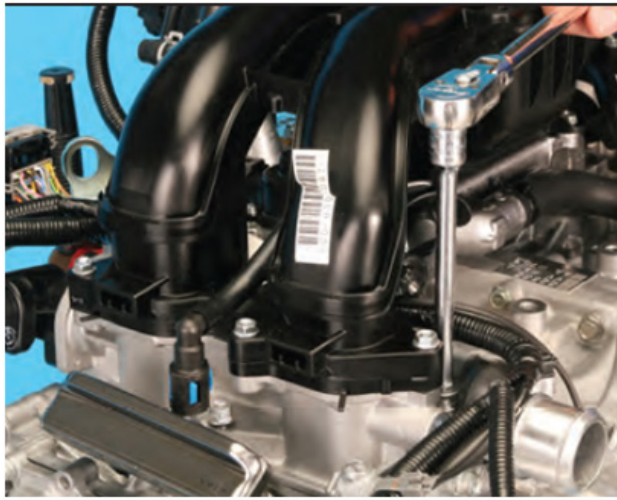
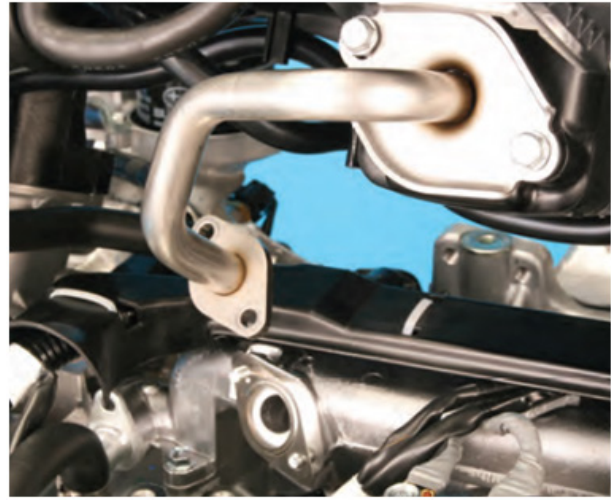
- When removing the intake manifold, as shown in the photos below, leave the TGV assemblies attached to the upper intake, remove the 2 nuts holding the EGR tube to the water pipe then remove the complete assembly from the cylinder heads as a unit.

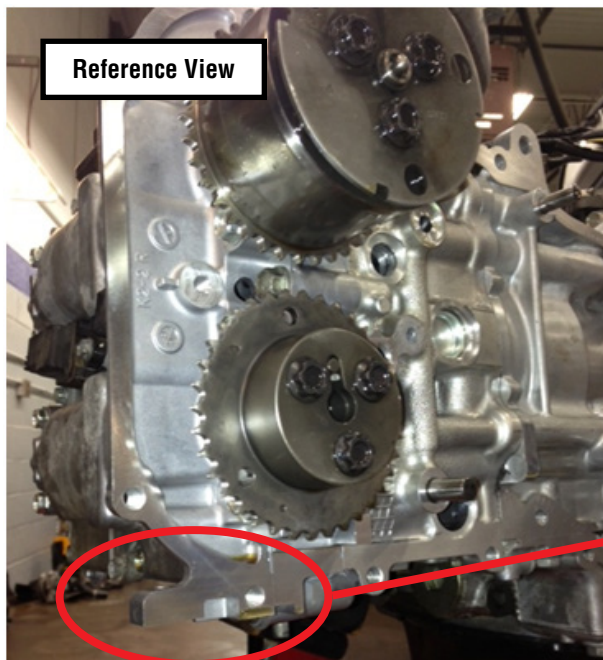
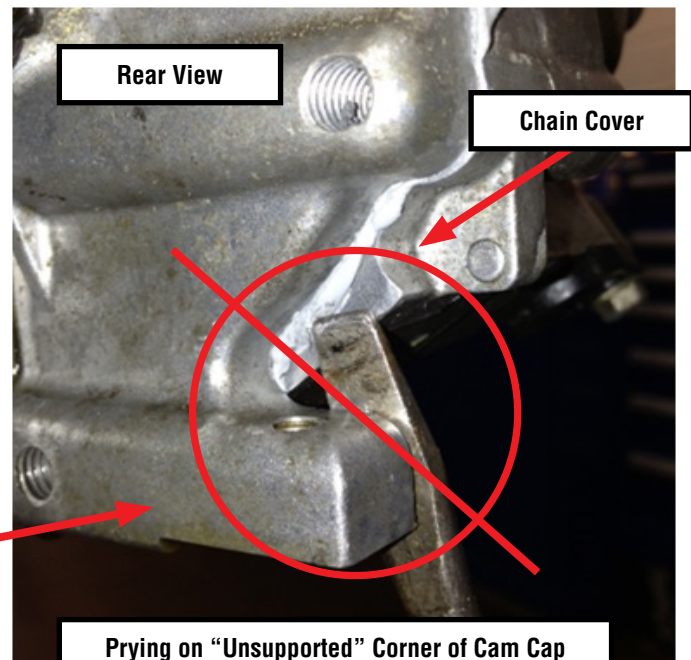
- There is no need to remove the oil dipstick tube or the original oil filter from the front chain cover. While the cover is removed, store it face (front side) down to minimize the chances of damaging the machined sealing surface on the block / head side. Also, don't use it as a tray to store other removed parts.
- **IMPORTANT:** After all 32 bolts securing the chain cover are removed, be **EXTREMELY** careful where you pry and what you pry on to break the silicone sealant's bond. The photos below show an example of where **NOT** to pry. In this case, the cam cap became cracked requiring a complete cam carrier replacement. *Patience is the key!*

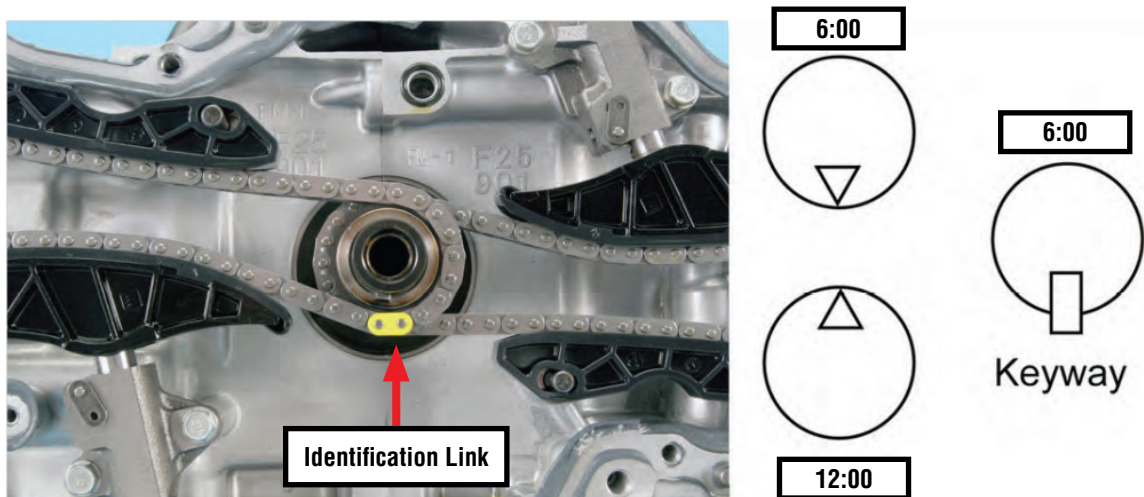
- Begin timing chain removal by positioning the crankshaft keyway at the 6:00 position. The RIGHT bank intake camshaft timing mark (Δ) must be at 6:00 with right bank exhaust timing mark at 12:00 (camshafts will be unloaded).

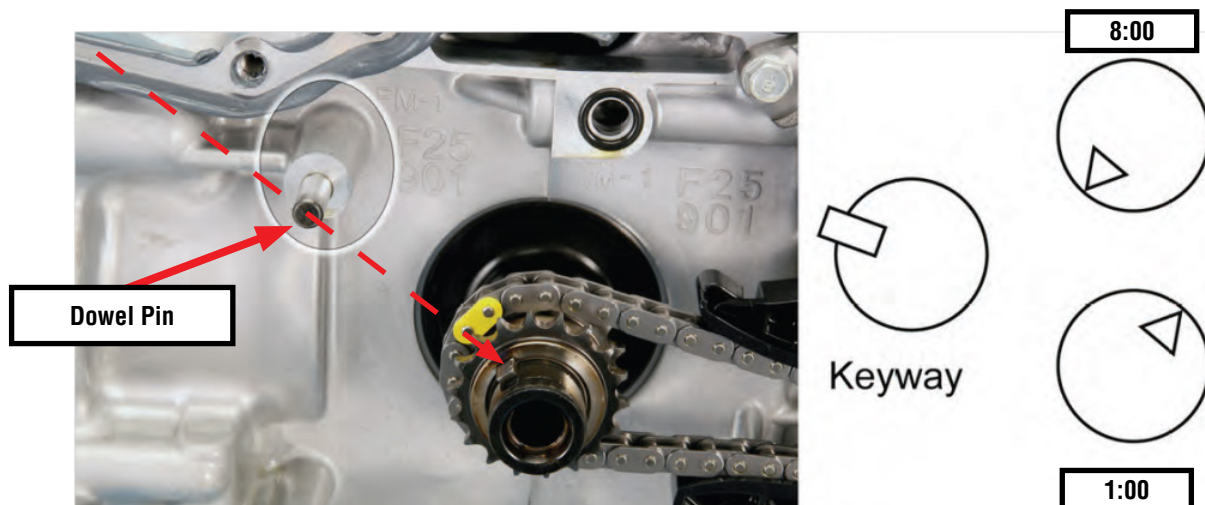
- Compress the chain tensioner by hand, insert a pin through the lever into the access hole to lock the plunger in place then remove the 2 bolts, tensioner, guides and right side timing chain.
- After turning the crankshaft CLOCKWISE, repeat the procedure for the LEFT side with the timing marks (Δ) positioned as shown below. Align the crank sprocket keyway with RH chain dowel pin (shown in red below).

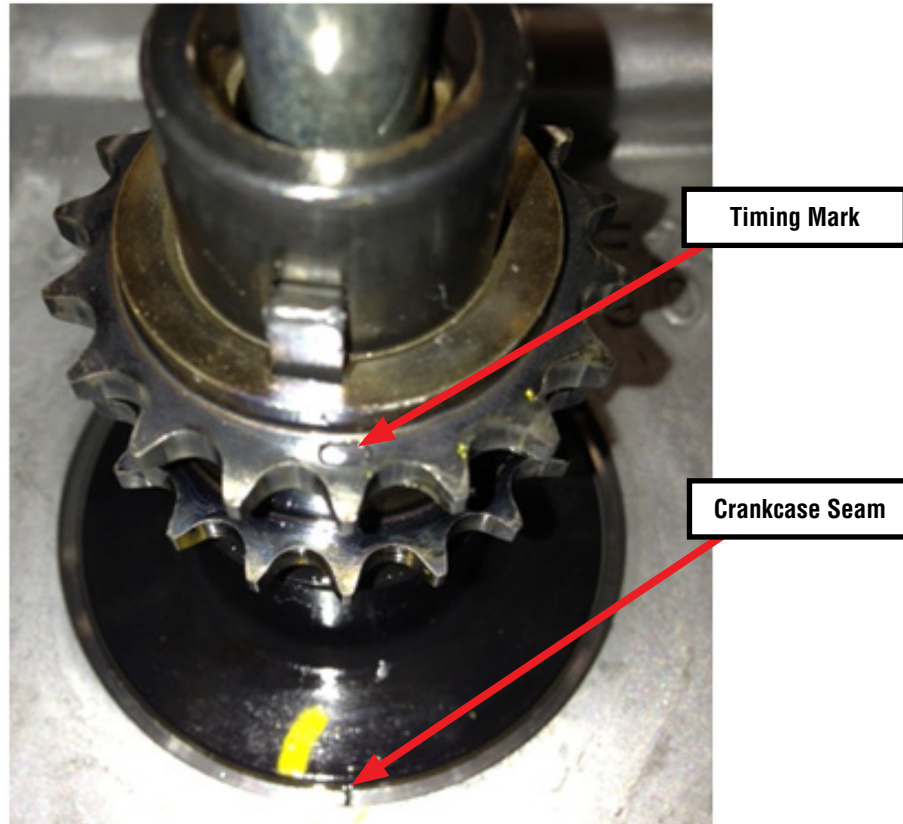
- Compress the chain tensioner by hand, insert a pin through the lever into the access hole to lock the plunger in place then remove the 2 bolts, tensioner, guides and the left side timing chain.
- After the left chain is removed, turn the crankshaft in a COUNTER CLOCKWISE direction until the timing mark on the crankshaft sprocket (NOT the keyway) is back to the 6:00 position as shown below. This positions all the pistons away from TDC and prevents accidental contact between the pistons and valves.

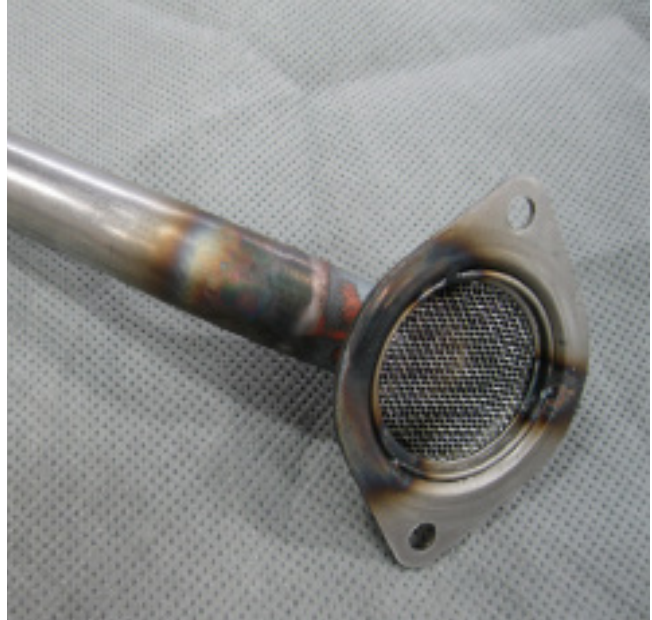
Oil Pick Up Tube/Filter Screen Assembly

- Don't forget to clean (**without removing**) the filter screens in the cam carriers (one filter in each carrier). In addition, always be sure to do a thorough inspection and cleaning of the oil pan, pick-up tube and screen as shown in the photos below before reassembly.

- Before installing the upper and lower oil pans, **always thoroughly clean and inspect the pick-up tube and screen.** Always use new o-rings on the pick-up tube and both oil pans during reassembly.
- Once the basic “long block” has been reassembled (valve cover to valve cover), proceed with installation of the timing components as outlined below.

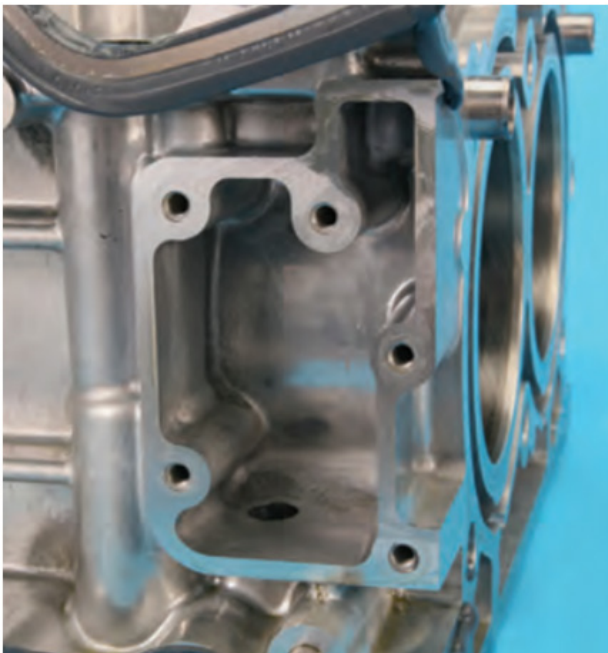
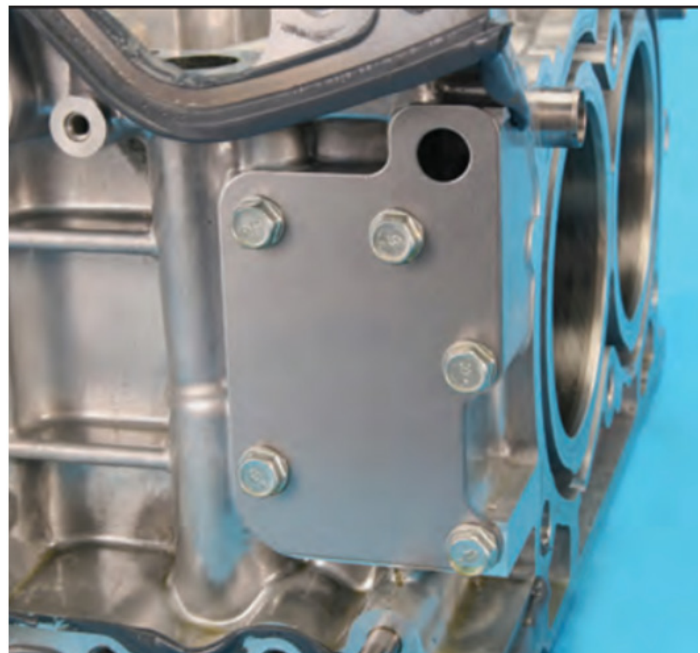
- Install the new **one-time use** PCV adapter. **NOTE:** Never try to reuse the original.
- Swap over the PCV assembly and the PCV baffle plate onto the front of the block. **NOTE:** No sealer is used between the baffle plate and the block.

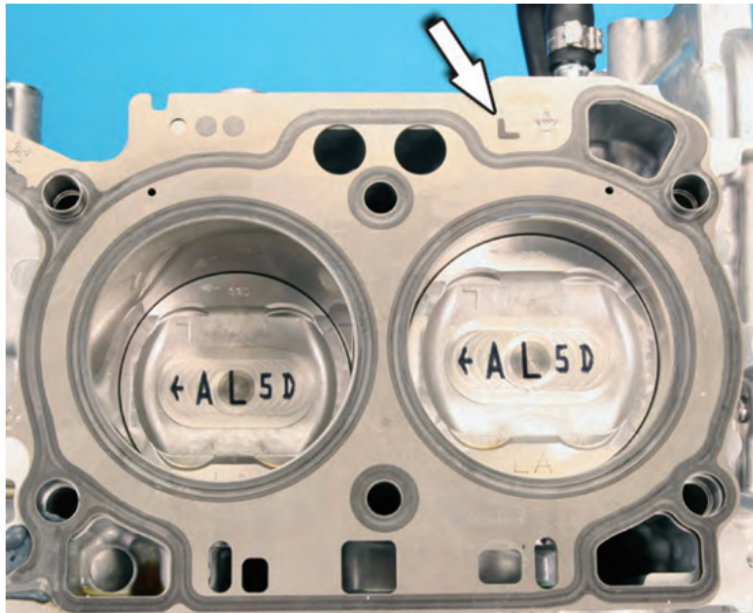
- If equipped, swap over the lower water jacket coolant baffles into the new block.
- Head gaskets are marked “L” and “R”. Always make sure they are properly installed while paying close attention to the sealer application areas as outlined in the Service Manual.

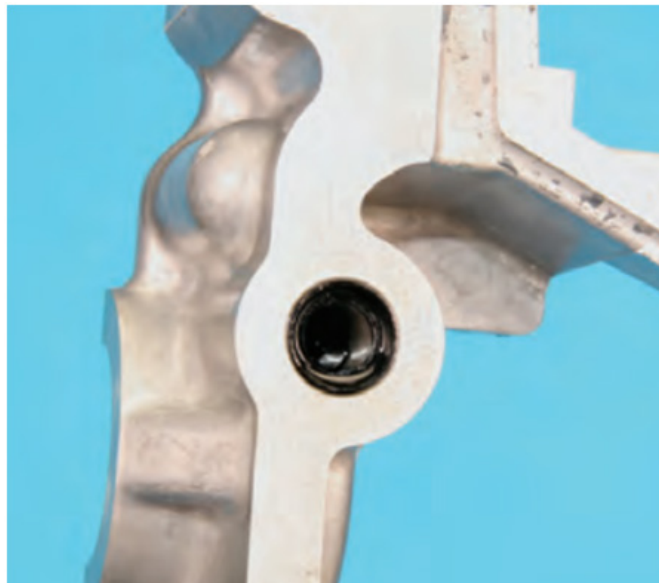
- Always make sure to clean the head bolt threads and apply engine oil to the threads and head bolt washers before starting the torque sequence. **Always follow the torque sequence closely.**
- **IMPORTANT:** If by chance the AVCS filter screens in the cam carriers have come loose or fallen out during disassembly, **they are directional and MUST be reinstalled in their original position.** There is an oil passage in the cam case which **MUST** align with a hole on the outside diameter of the filter screen tube otherwise, oil flow to the AVCS will be restricted or blocked resulting in engine damage.

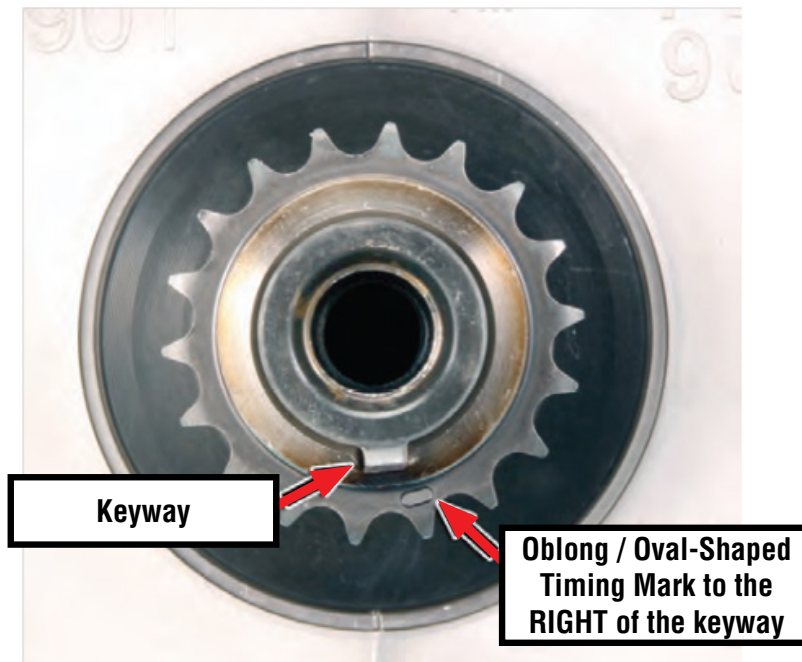
- To begin timing chain re-installation, turn the crankshaft **COUNTER-CLOCKWISE** until the crankshaft sprocket keyway is back to the 6:00 position. This positions the pistons away from TDC and prevents accidental contact with the valves. **NOTE:** The keyway is **NOT** a timing mark. The oblong / oval-shaped timing mark must face front and be to the **RIGHT** of the keyway as shown below. Do not confuse this mark with a mark which may be found on the back side of the sprocket.

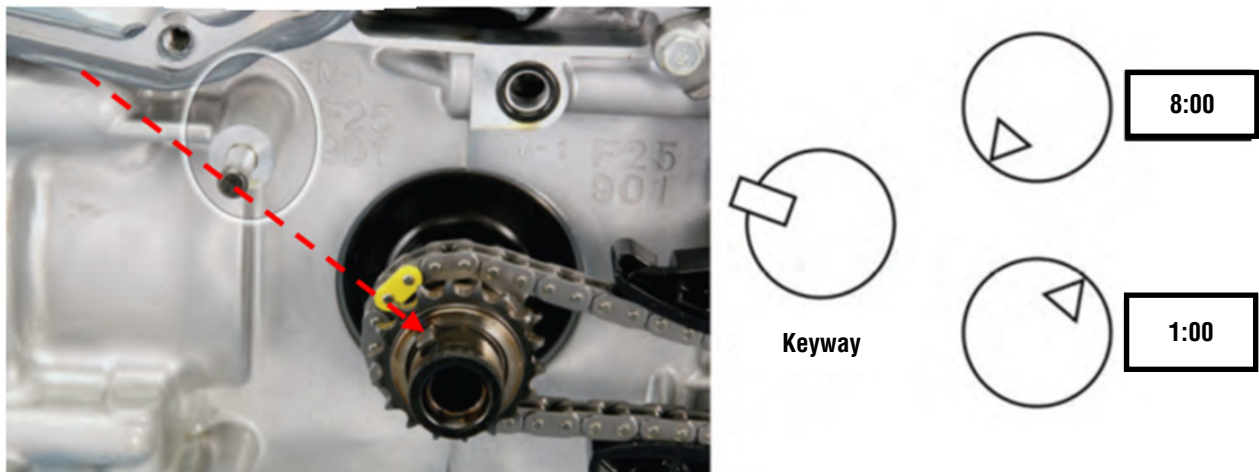
- Arrange the timing marks as shown below, turning the crankshaft **CLOCKWISE** into position. Align the indicator link with the timing mark on the crankshaft sprocket, keyway with the dowel pin.

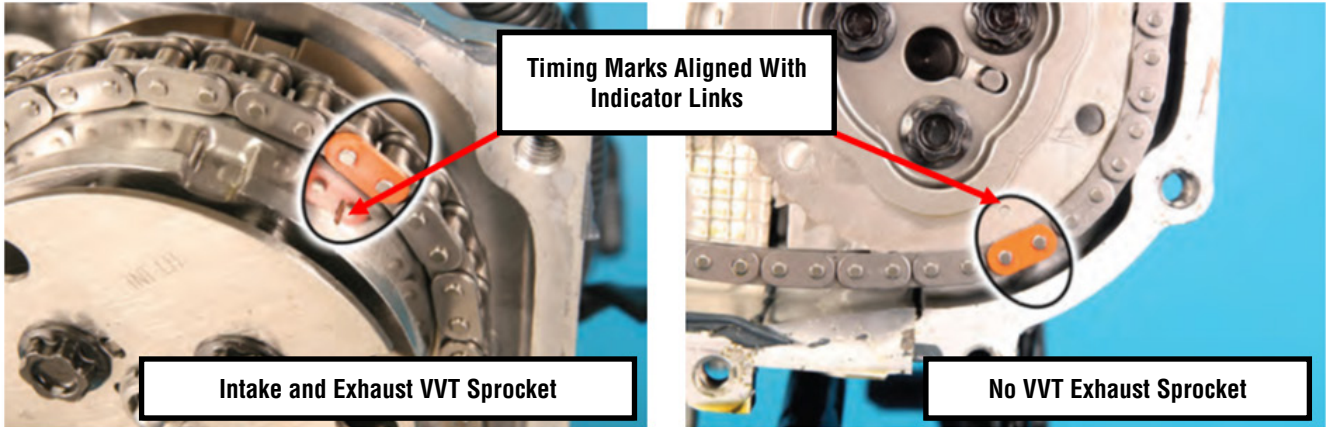
- Align the indicator links to the timing marks found on the outside of the sprocket assemblies as shown in the photos below (Exhaust sprocket face images vary with / without exhaust VVT).

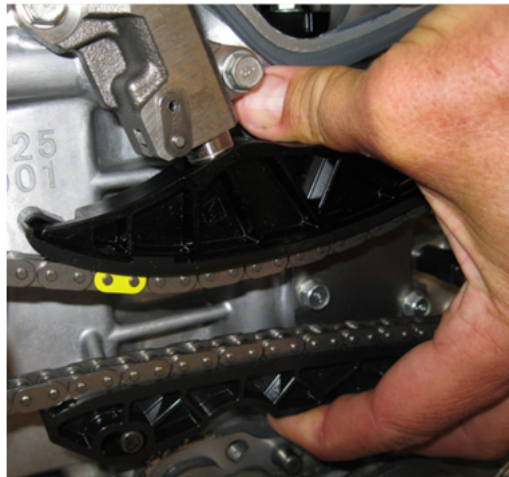
- Install the chain guides and tensioner. Once proper positioning has been confirmed, pull the pin to release the tensioner. With your hand, grab and squeeze the upper and lower chain / guides together as shown in the reference photo below to allow the plunger in the tensioner to fully extend and click into its furthest notch.

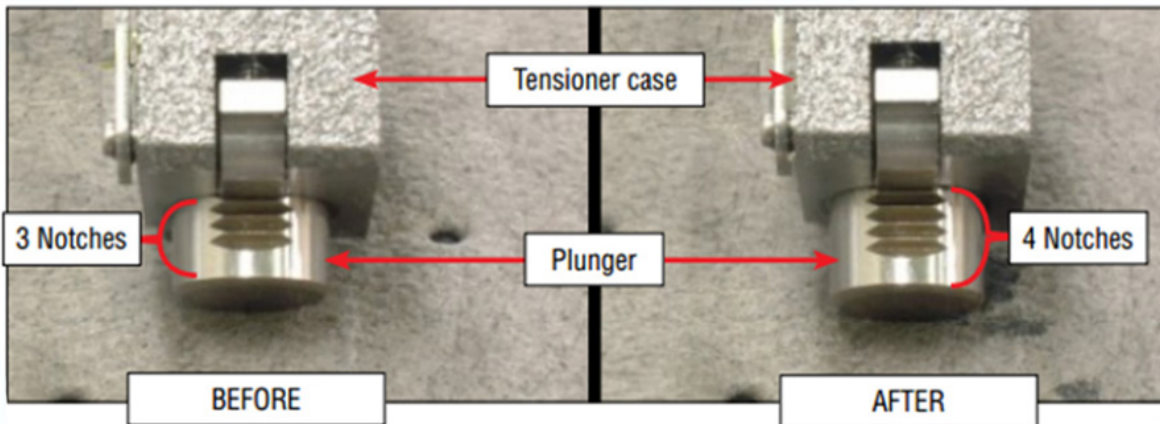
- If you have 3 notches showing, you want to get one more “click” so that 4 notches are visible as shown in the photos below. If you have 4 showing, you want to end up with 5. Whether you start with 3 or 4 will depend on the amount of wear present on the chains and guides. The number of clicks listed here is simply a guide. The point is to ensure proper initial chain tension is applied to avoid creating a brief rattle sound at engine start.

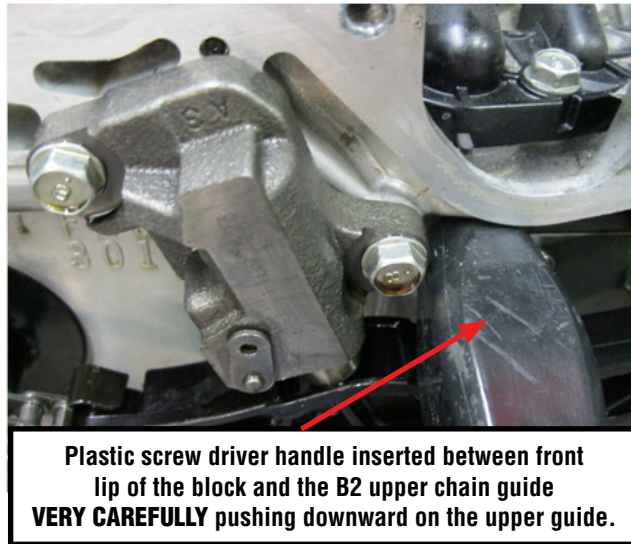
- If necessary, insert a plastic screwdriver handle between the lip of the block and the left side (B2) guide. Then, **VERY CAREFULLY** push down on the guide just enough to get the extra tensioner notch / “click”. When using this method, always make sure you are using plastic on plastic and NOT metal on plastic to avoid damaging the chain guides.

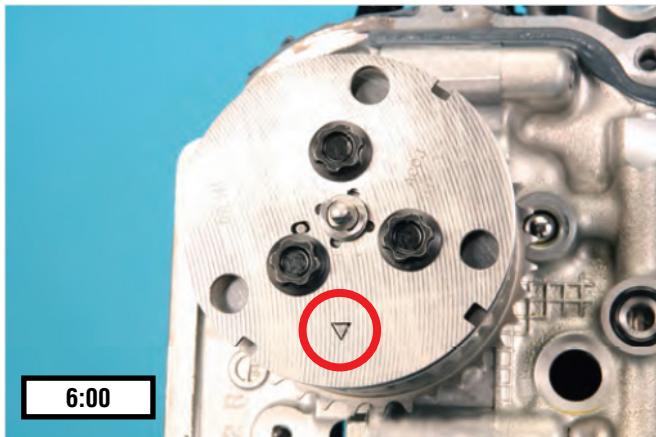
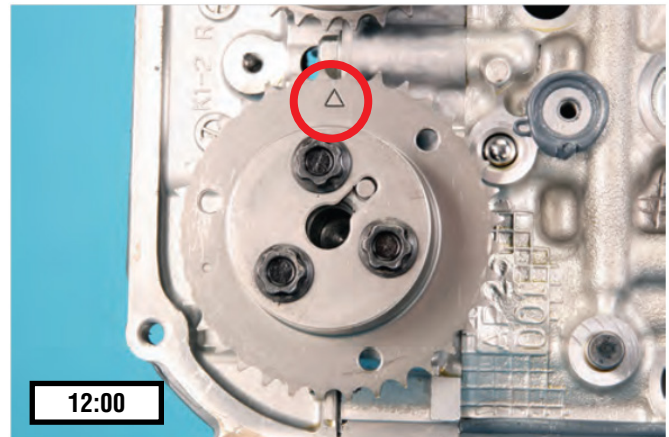
- Rotate the crankshaft **COUNTER-CLOCKWISE** until the crankshaft sprocket timing mark is at the 6:00 position. Position the cam sprocket timing marks as shown below; intake 6:00, exhaust 12:00.

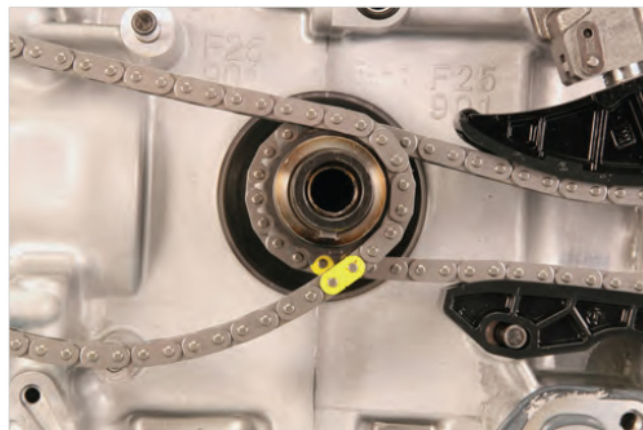
- Align the indicator link with the timing mark on the crankshaft sprocket as shown below.

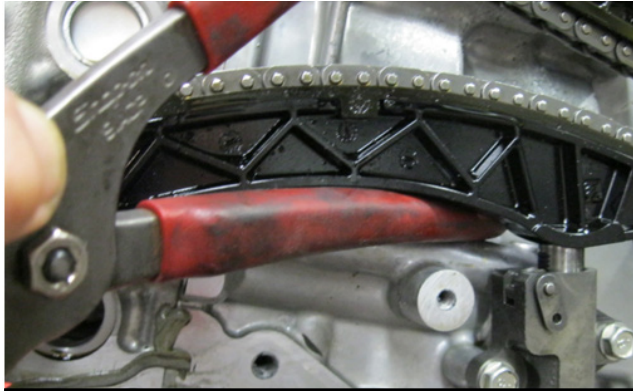
- Same as the left side, align the indicator links to the timing marks found on the cam sprocket assemblies. Install the chain guides and tensioner. Once proper positioning has been confirmed, pull the pin to release the tensioner. With your hand, grab and squeeze the upper and lower left side chain / guides together to allow the plunger in the tensioner to extend fully and click into its furthest notch as shown in the previous (right side) photo. If necessary, insert a rubber-coated plier handle between the ledge area on the front of the block and the right side (B1) lower chain guide. Then, **VERY CAREFULLY** lift up on the guide just enough to get the extra “click” on the tensioner as shown in the photo below.

Rubber-coated plier handle inserted between a ledge area on the front of the block and the B1 lower chain guide **VERY CAREFULLY** lifting upward on the lower guide.

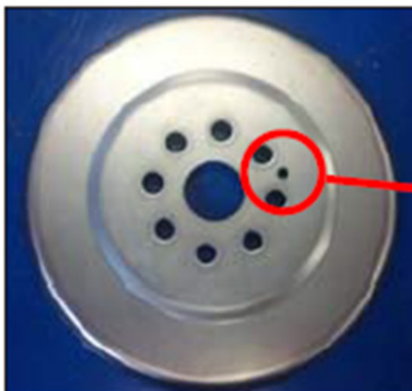
- **REMINDER:** When replacing the short block, in addition to transferring the crankshaft position sensor, be sure to index the reluctor properly onto the crankshaft as shown in the photos below. The reluctor is indexed by a dowel pin in the rear crankshaft flange which aligns with a corresponding hole in the reluctor. It is possible to install the reluctor without indexing it correctly. Failure to index the reluctor correctly will result in a no-start condition due to an out of time crank position signal to the ECM.
