Technical Service Bulletin

96 False warning by lane change assistant (Audi Side Assist)

96 13 56 2030583/2 May 2, 2013. Supersedes Technical Service Bulletin Group 96 number 12-42 dated September 5, 2012 for reasons listed below.

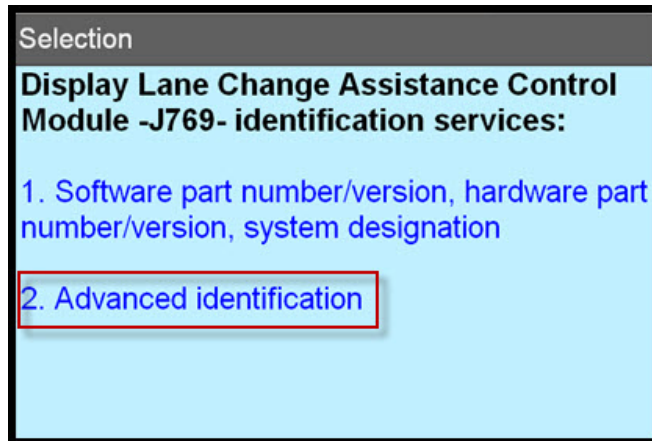
Use option 2, labeled “Advanced identification”, for finding the production date of each control unit (Figure 4).

Figure 4. Advanced identification option in VAS_PC
