Reference:

ITB15-035

VOLUNTARY SERVICE CAMPAIGN 2014 - 2015 Q50 HYBRID; DIRECT ADAPTIVE STEERING REPROGRAM AND 12 VOLT BATTERY REPLACEMENT

CAMPAIGN ID #: P5323

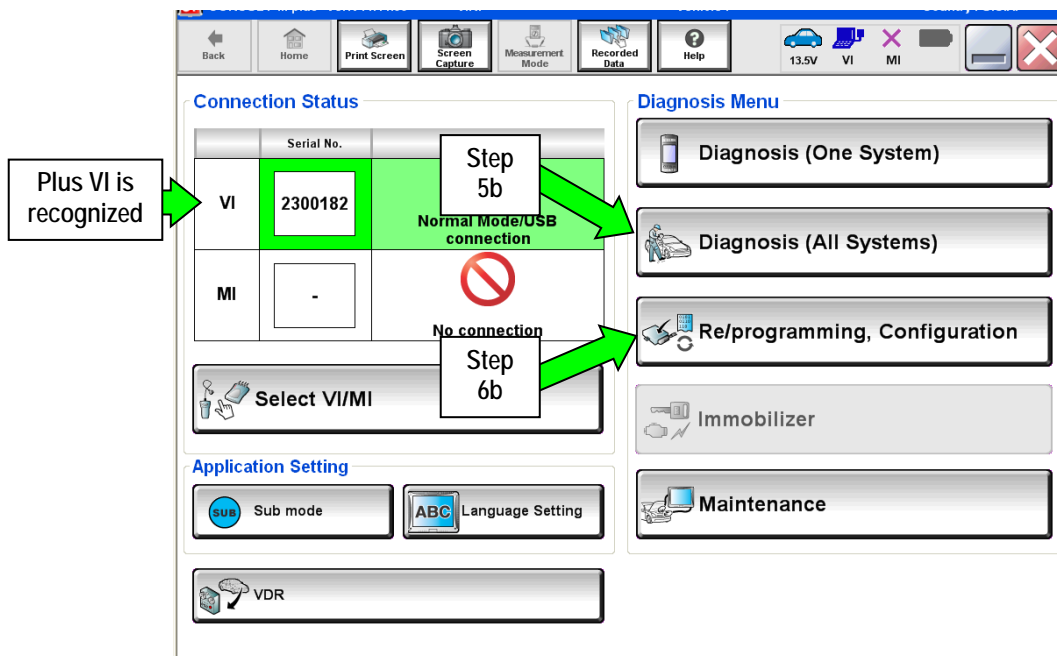
Figure 1

- Select the Home button and then YES to return to the screen shown in Figure 1.
- Select Re/programming, Configuration.

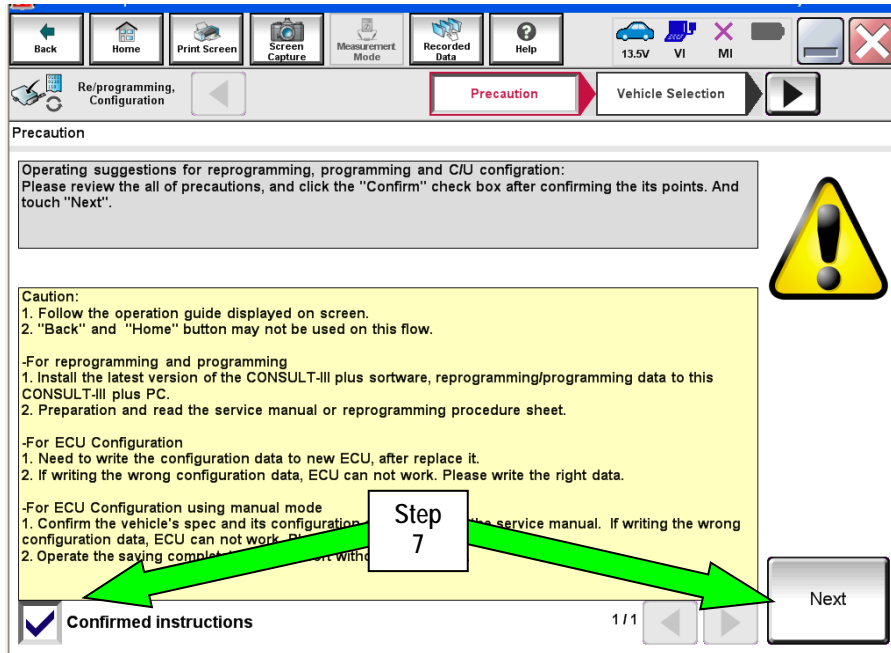
Figure 2

7. Check the box for Confirmed Instructions, and then select Next.

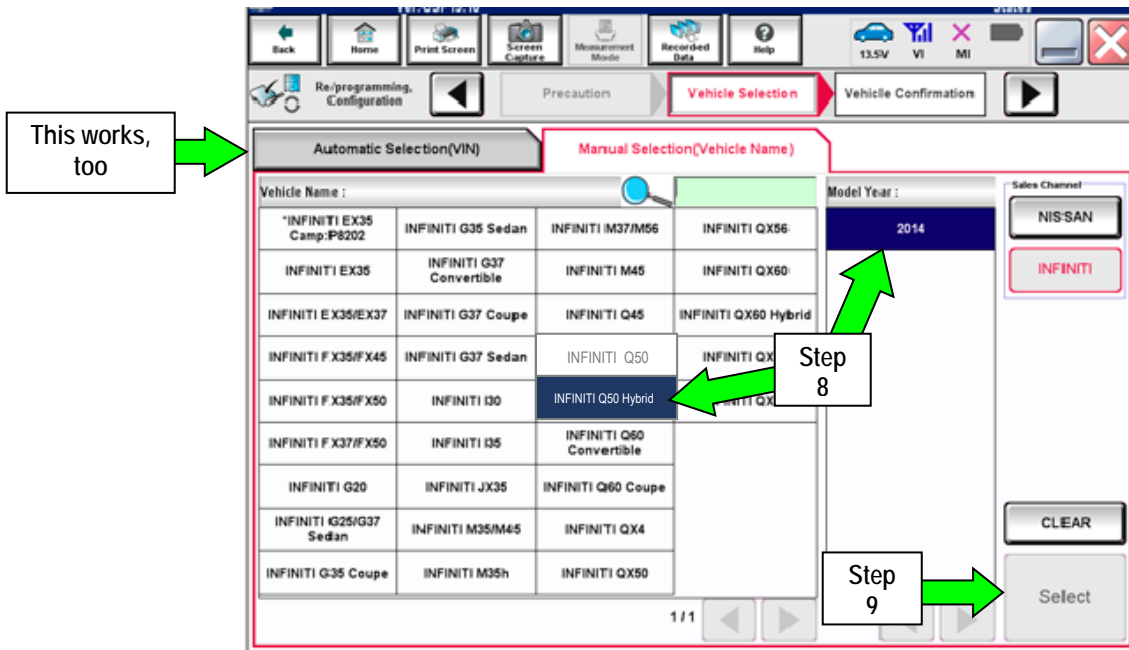
8. Select Q50 Hybrid and 2014 or 2015, or Automatic Selection(VIN).

- If Automatic Selection (VIN) is selected, or the screen in Figure 3 does not display, skip to step 10.

9. Select Select.

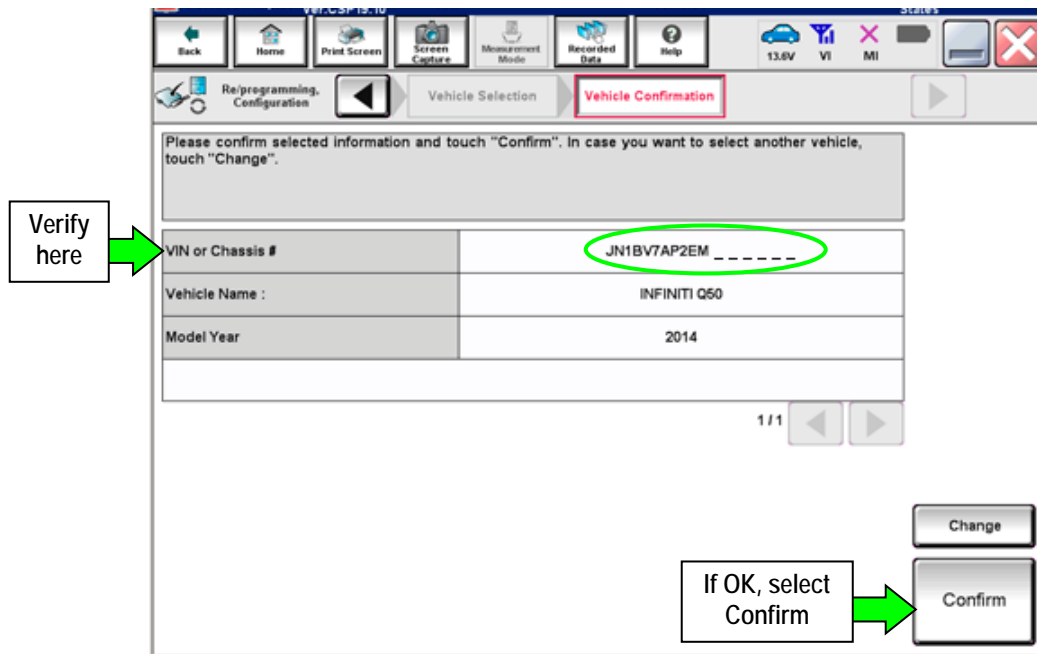
Figure 4

10. Verify the VIN or Chassis # matches that of the vehicle.

- If the correct VIN is displayed, select Confirm.

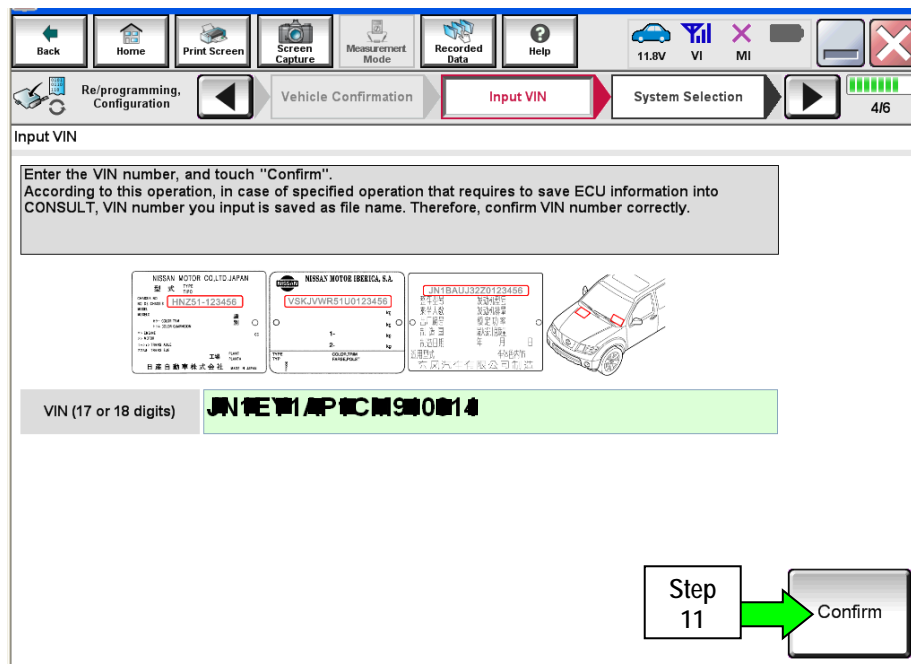
Figure 5

11. Select Confirm again.

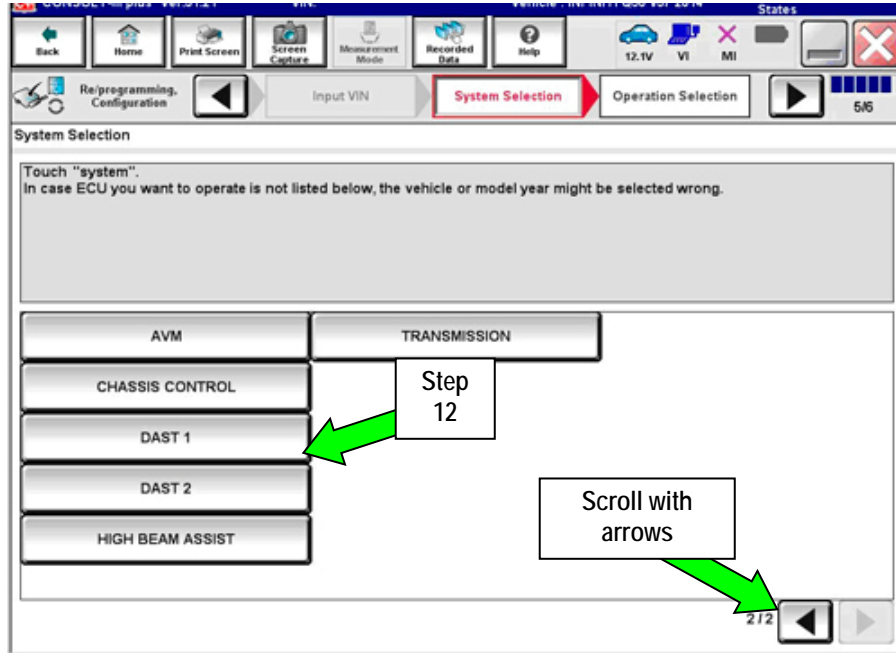
Figure 6

12. Use the page arrows to scroll and select the correct control module to be reprogrammed.

Make sure to reprogram the control modules in this order:

DAST 1, then DAST 2, and then EPS/DAST 3

NOTE: DAST 1 and DAST 2 are shown in Figure 6; EPS/DAST 3 is not shown.

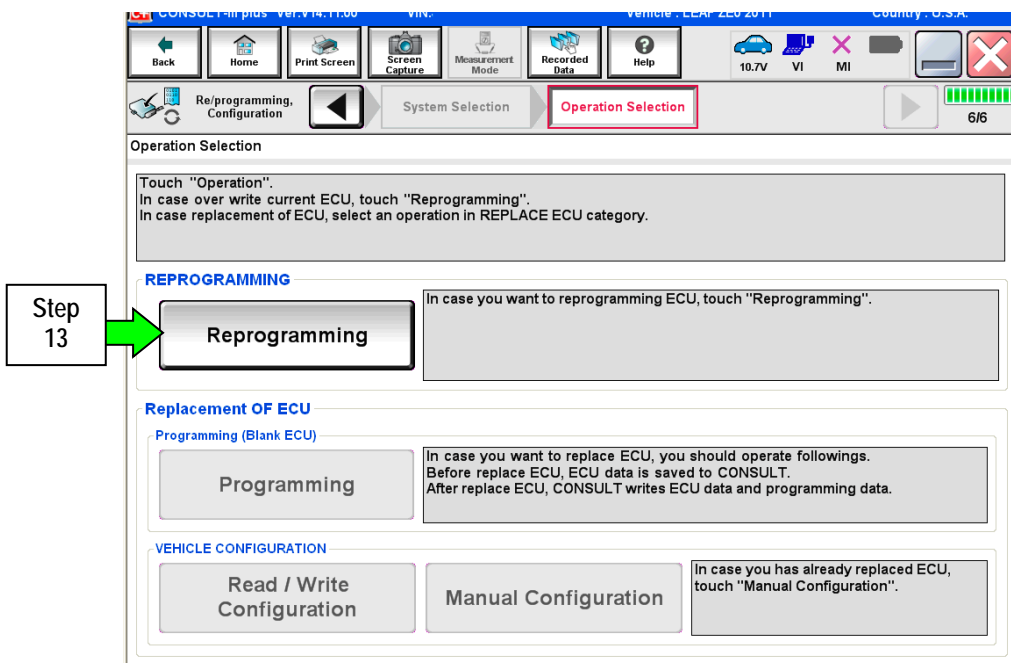
Figure 7

13. Wait for System Call to complete and then select Reprogramming.

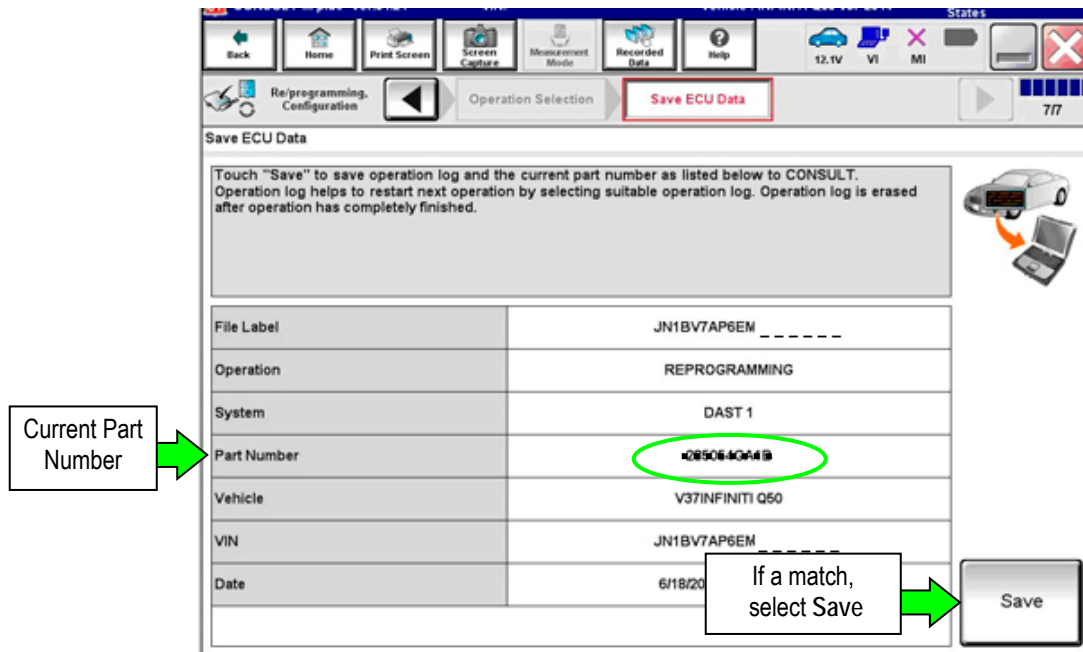
Figure 8

14. When you get to the screen shown in Figure 8, confirm reprogramming applies as follows:

A. Find the DAST Part Number and write it on the repair order.

NOTE: This is the current DAST Part Number. DAST 1 is shown; DAST 2 and DAST 3 are similar.

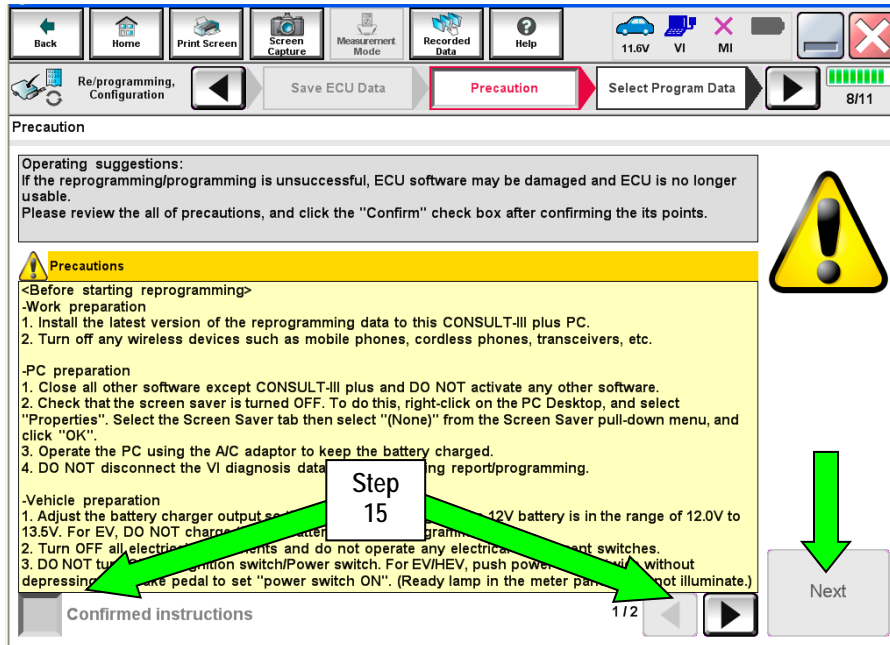
Figure 9

- Read the precautions on the C-III plus screen (use page arrow as needed). After reading, select Confirmed instructions, and then select Next.

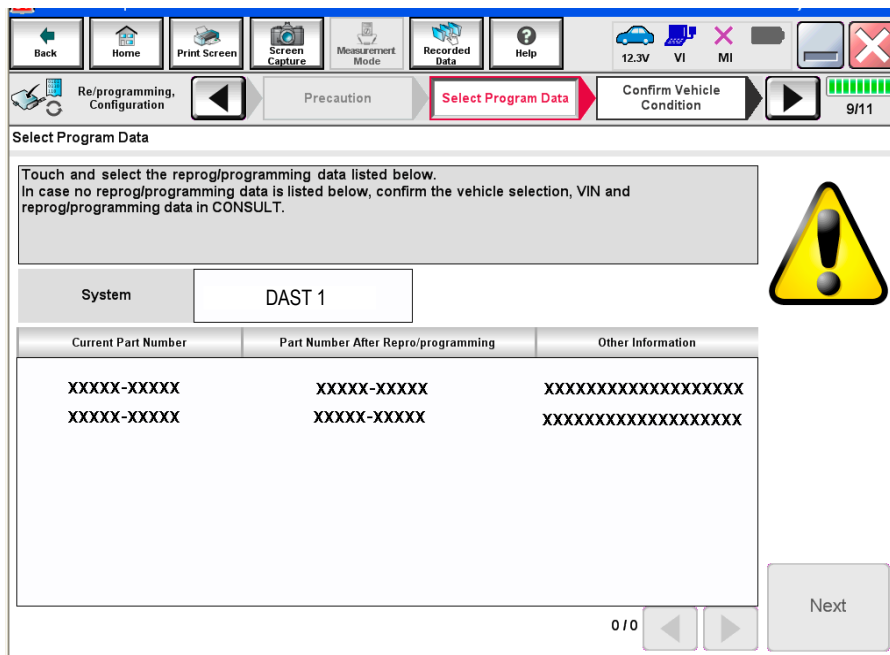
- In some cases, more than one new P/N for reprogramming is available.
 - If more than one P/N is available, the screen in Figure 10 will display.
 - Select and use the reprogramming option that does not have the message "Caution! Use ONLY with ITBXX-XXX".
- If you get this screen and it is blank (no reprogramming listed), it means there is no reprogramming available for that control module.

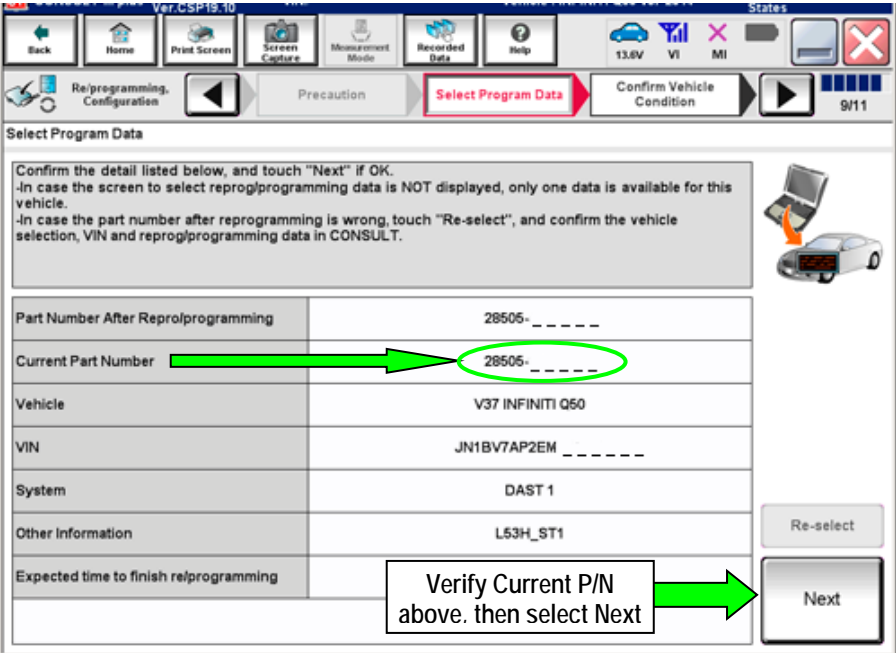
Figure 11

16. Verify the Current Part Number matches the Part Number written down in step 14, and then select Next.

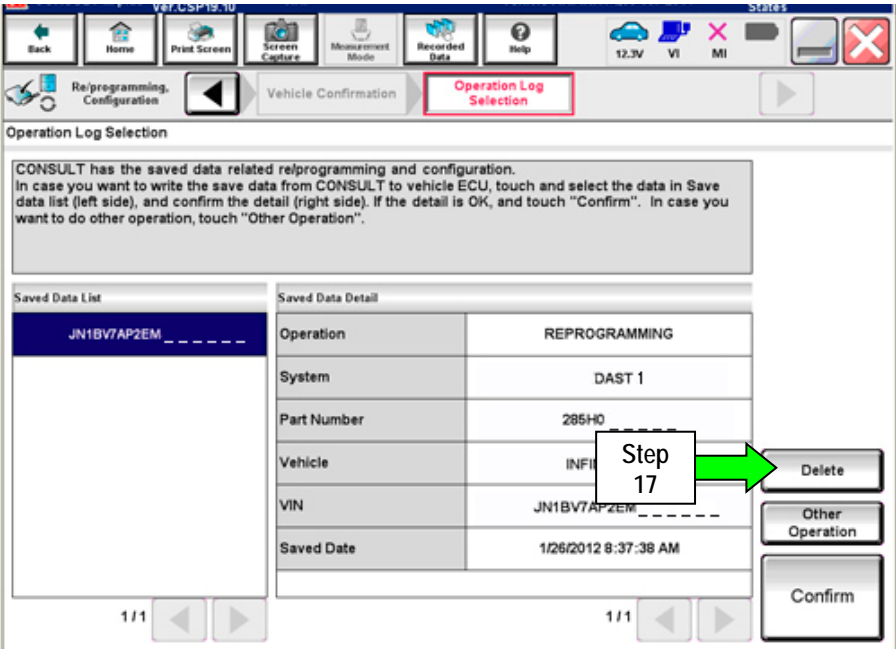
17. If the screen in Figure 12 appears, first select Delete then Confirm, and then Other Operation.

- This will erase the Saved Data List and restart the reprogram from step 12. You must go back to step 12.
- If no Saved Data List is stored, Figure 13 on the next page will be displayed.

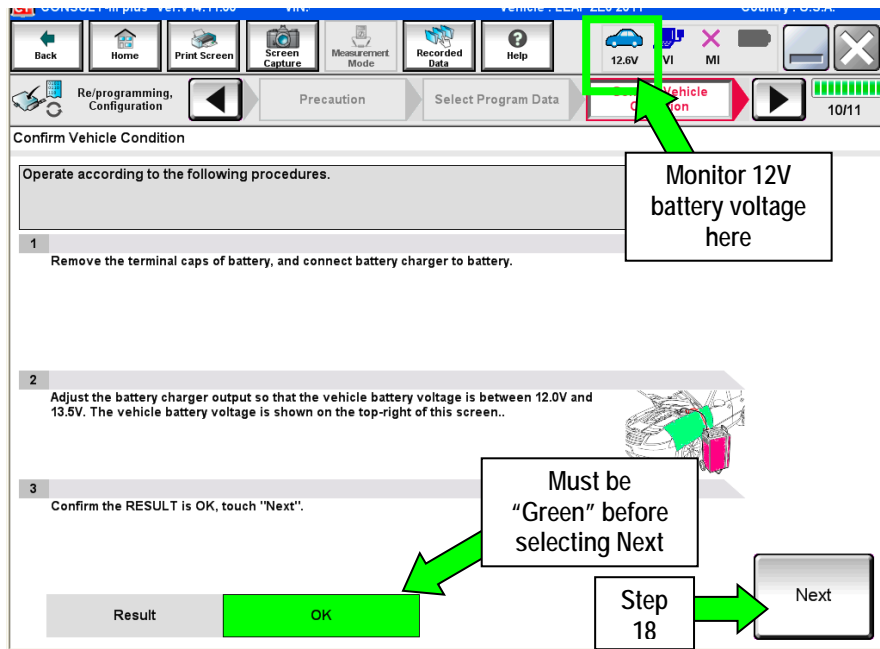
Figure 13

18. Confirm battery voltage is correct, and then select Next.

NOTE: Battery voltage must stay within the specified range to make the indicator turn green.

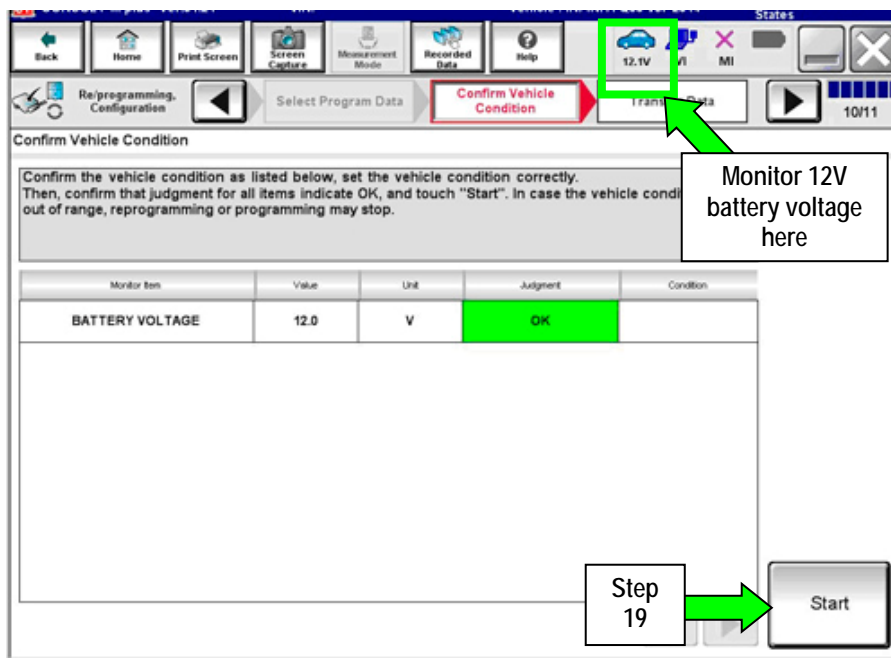
Figure 14

19. With battery voltage OK (green), select Start.

- The reprogramming process begins when Start is selected.

NOTE: For reprogramming to continue, the vehicle 12V battery voltage must stay within 12 volts and 13.5 volts. .

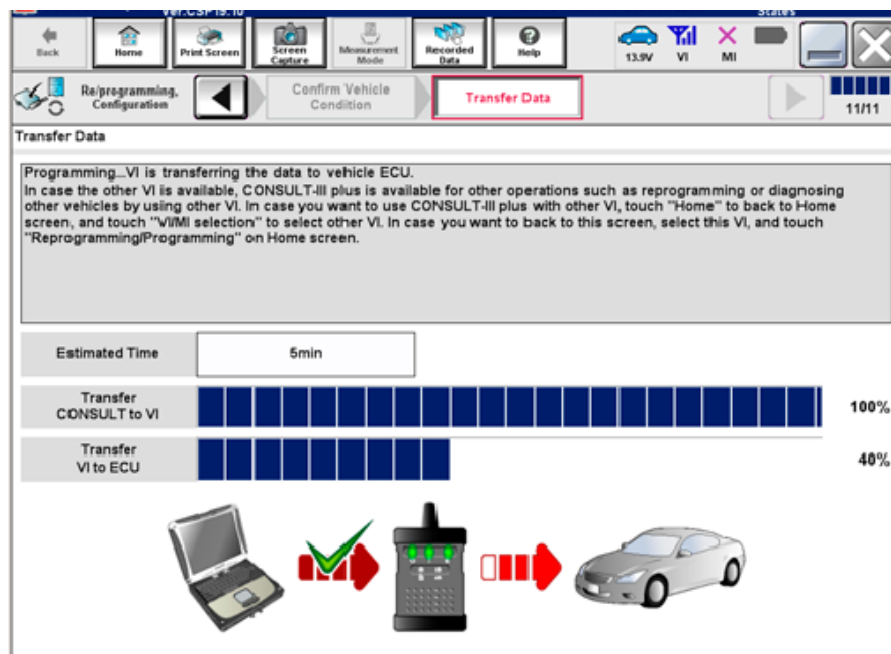
Figure 15

20. Wait for both bar graphs to complete.

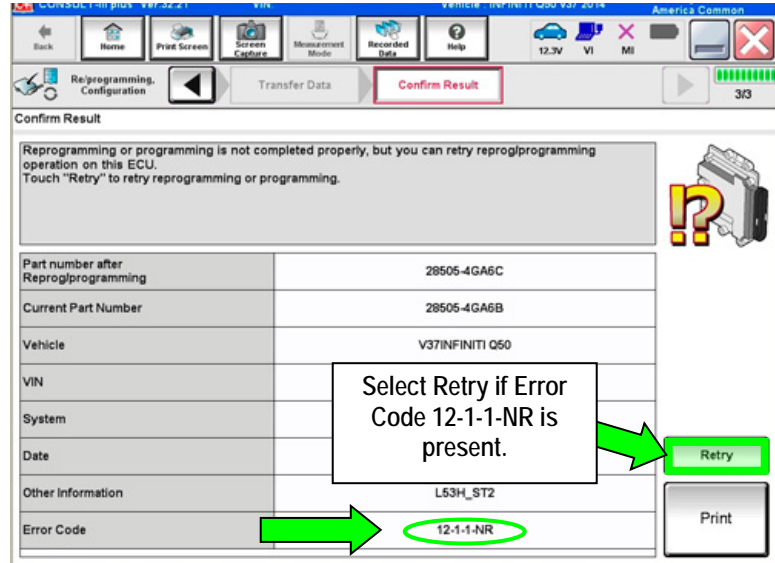
If reprogramming does not complete and the “!?” icon displays as shown in Figure 16:

- Check battery voltage (12.0–13.5 V).
- Ignition is ON, engine OFF (not READY).
- External Bluetooth® devices are OFF.
- All electrical loads are OFF.
- Select retry and follow the on screen instructions.
- “Retry” may not go through on the first attempt and can be selected more than once.

- If the progress bar freezes at 90% of a complete transfer to the VI and error code “12-1-1NR” is displayed (see Figure 16 on the next page), turn the ignition OFF, then ON, and then refer to Control Module Recovery on the next page.
- If the progress bar freezes at 90% more than 3 times “on the same DAST control module” but without Error Code “12-1-1NR”, the DAST control module that is currently being reprogrammed will need to be replaced.
- If the reprogramming does not complete, refer to Control Unit Recovery on the next page.

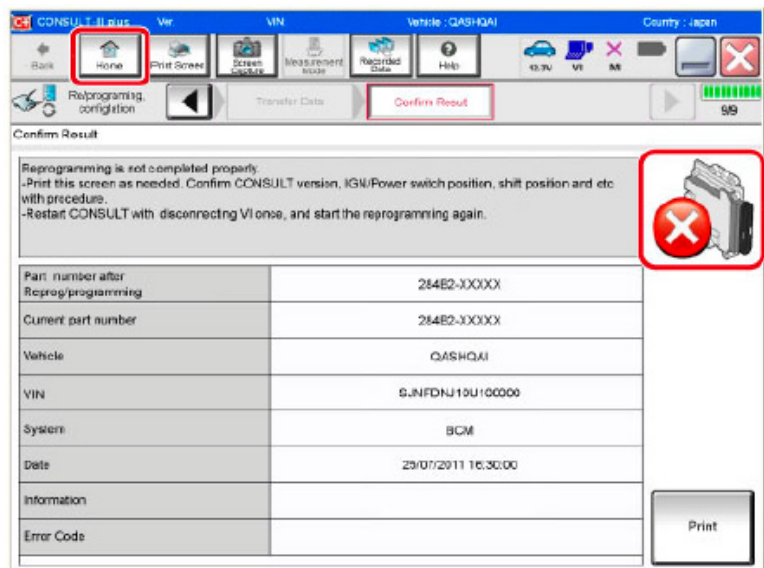
Figure 17

If reprogramming does not complete and the “X” icon displays as shown in Figure 17:

- Check battery voltage (12.0 – 13.5 V).
- CONSULT A/C adapter is plugged in.
- Ignition is ON, engine OFF (not READY).
- Transmission is in Park.
- All C-III plus / VI cables are securely connected.
- All C-III plus updates are installed.
- Select Home, and restart the reprogram procedure from the beginning.

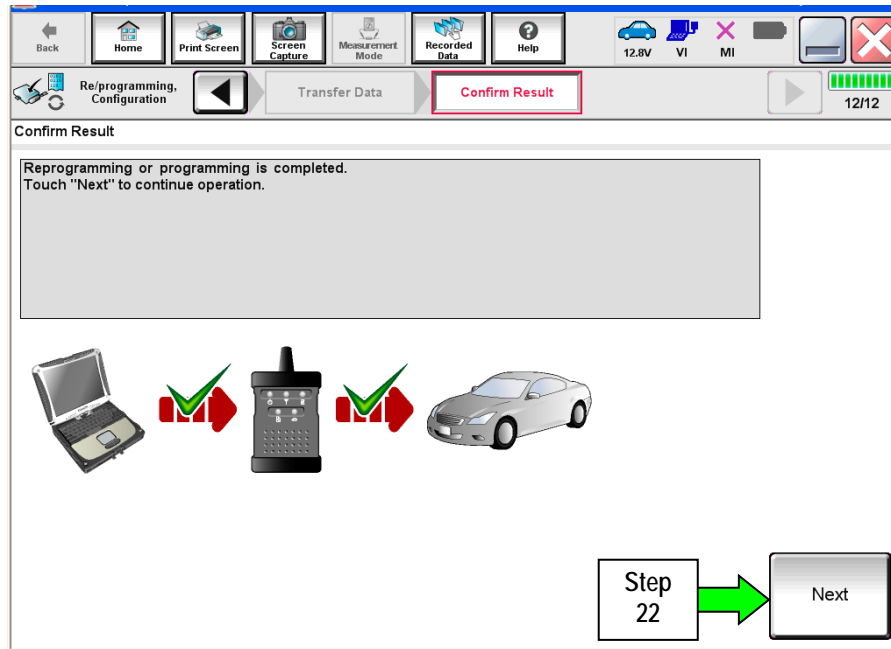
21. When the screen in Figure 18 appears, reprogramming is complete.

22. Select Next.

23. Wait for System Call to complete.

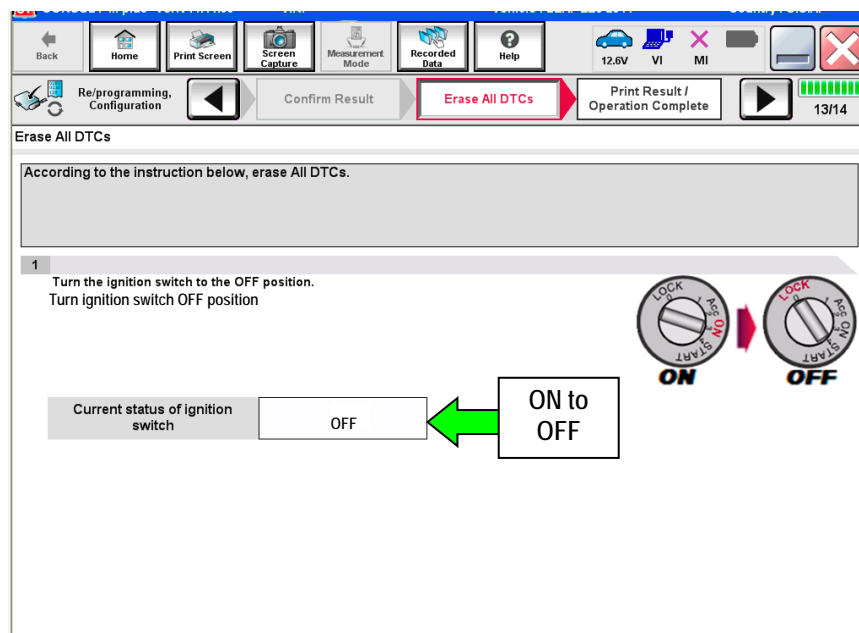
a. Turn the ignition OFF.

- The screen in Figure 19 will read OFF after pressing the power/ignition switch once.

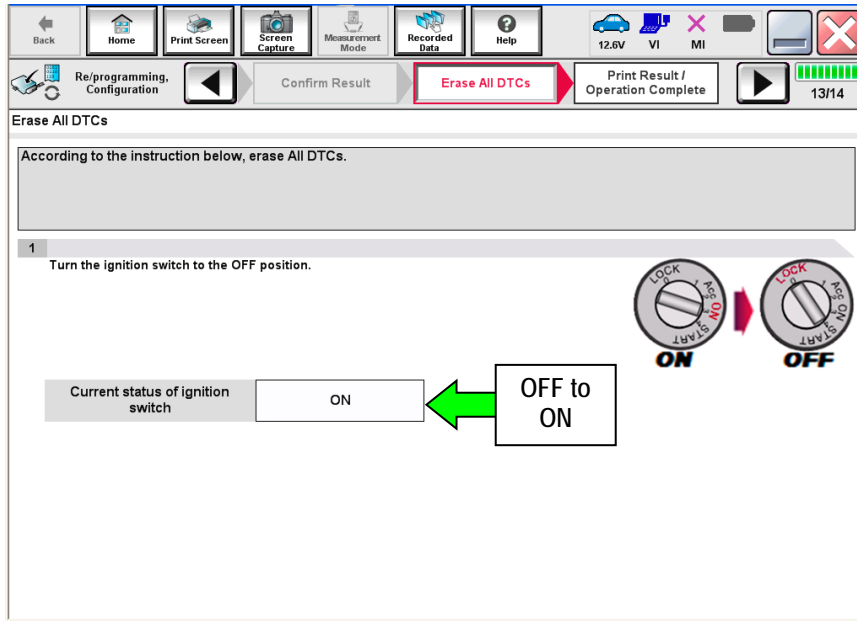
Figure 20

- b. Turn the ignition ON with engine OFF (press switch twice, foot off brake).
 - The screen in Figure 19 will read ON after pressing the power/ignition switch twice.
- NOTE: Do not be confused by any screen messages. At this point, simply turn the ignition ON.

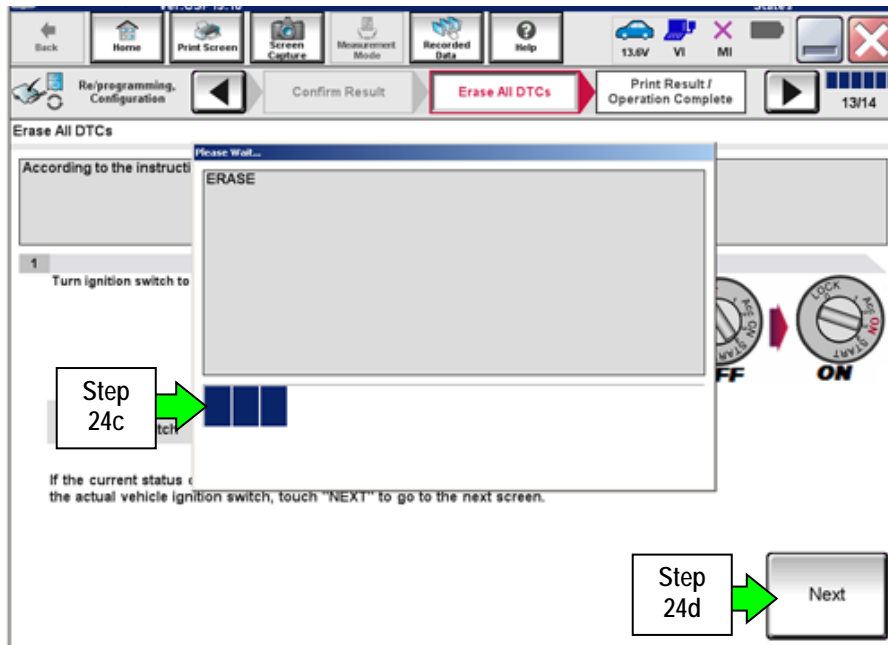
Figure 21

- c. Wait for the bar graph in the ERASE window to complete 100%.
- d. Select Next.

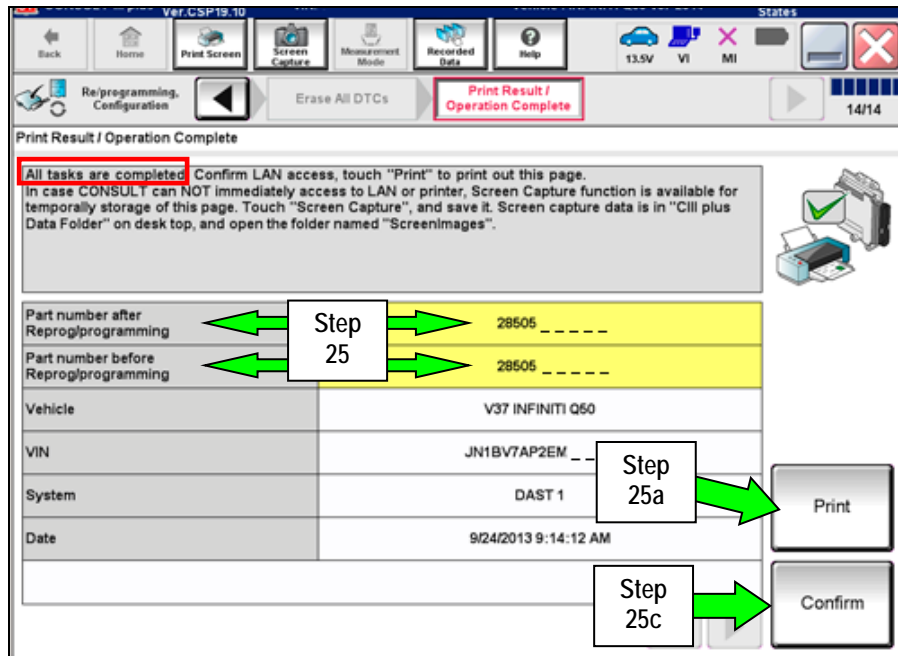
25. Verify the part number has changed (before and after reprogramming part numbers should be different).

- a. Print a copy of the screen in Figure 22 by selecting Print.
- b. Attach a copy to the repair order.
- c. Once a copy has been printed, select Confirm.

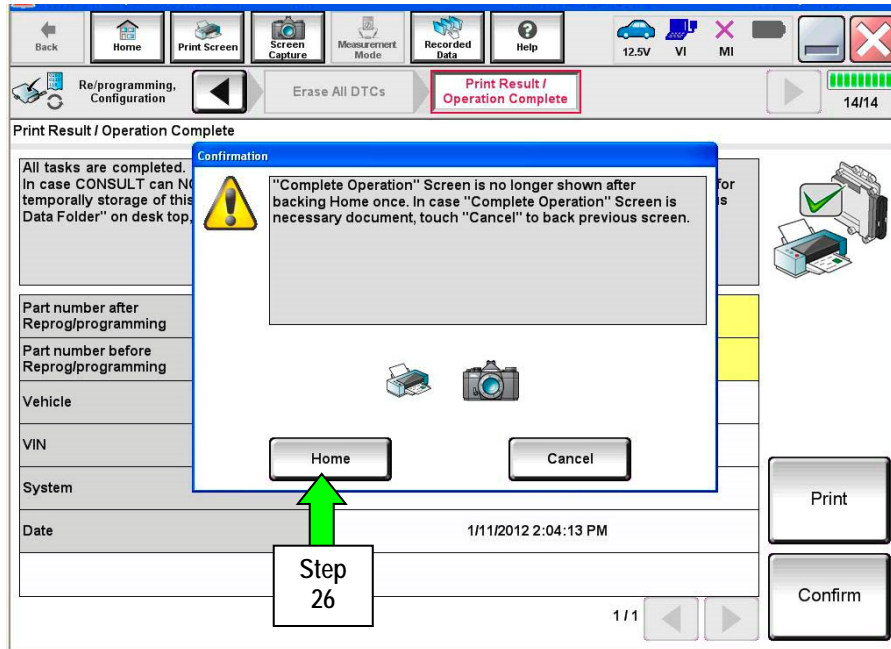
Figure 23

26. After Confirmation has completed, select Home.
