WF86 - Re-programming DME Control Unit (Worksohp Campaign)

Subject: **DME control unit**

Issue: **Due to a software error in the DME control unit, there is a possibility that diagnostic information for the PDK control unit will not be further processed correctly by the DME control unit on the affected vehicles.**

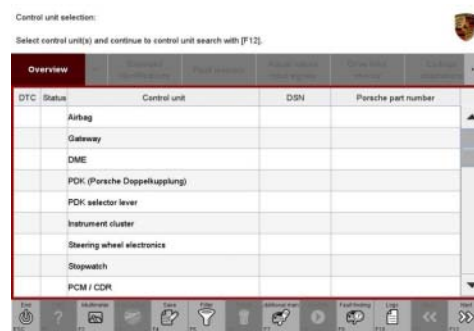
Control unit selection

5 Once you have erased the fault memories, select the ⇒ '**Overview**' menu to return to the control unit selection screen ⇒ *Control unit selection*.

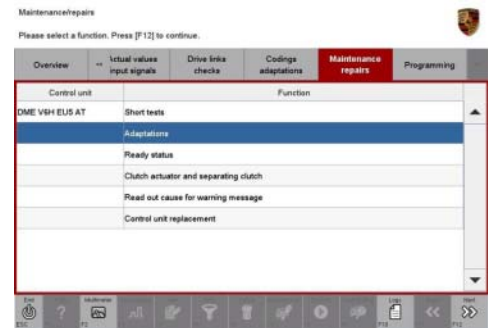
*DME - Adaptations*

- 2 Once the DME control unit has been found and is displayed in the overview, select the ⇒ **'Maintenance/repairs'** menu.
- 3 Select menu item ⇒ **'Adaptations'** and press **•>>** to confirm your selection ⇒ *DME - Adaptations*.

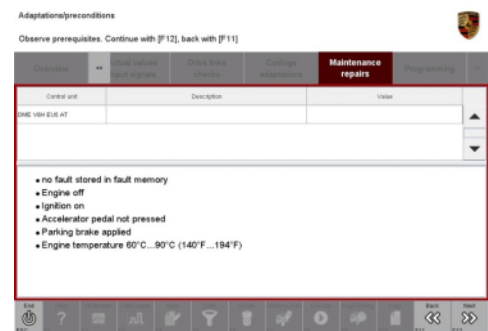
*Adaptation preconditions*

- 4 Comply with the displayed preconditions and press **•>>** to confirm ⇒ *Adaptation preconditions*.

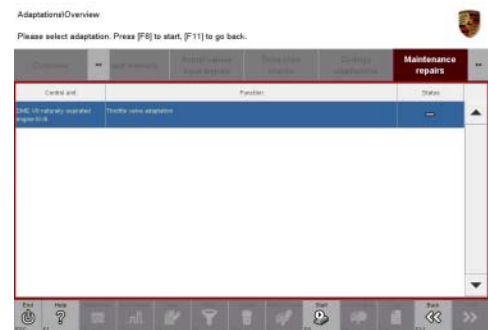
*Throttle valve adaptation*

- 5 Select the ⇒ **'Throttle valve adaptation'** function so that the corresponding text line turns blue and press **•F8** to start the throttle valve adaptation ⇒ *Throttle valve adaptation*.

- 6 Follow the instructions on the PIWIS Tester while throttle valve adaptation is being performed.
Once throttle valve adaptation is complete, a tick will appear in the "Value" field in the PIWIS Tester display.
If throttle valve adaptation is **not** completed successfully, adaptation must be **repeated**.
- 7 Press **•F8** ("Stop") to end throttle valve adaptation.
- 8 Press **•<<** to return to the start page of the ⇒ **'Maintenance/repairs'** menu.
- 9 Select the ⇒ **'Overview'** menu and press **•<<** to return to the control unit selection screen.
