MODEL
2014~2015MY
Forte (YD)
2014MY
Sportage (SL)

NUMBER
065 (REV 1, 02/18/2016)

TECHNICAL SERVICE BULLETIN

SUBJECT: COMBINED TSB /SERVICE ACTION: MIL ON WITH DTC C1212 - LOGIC IMPROVEMENT (SA 216)

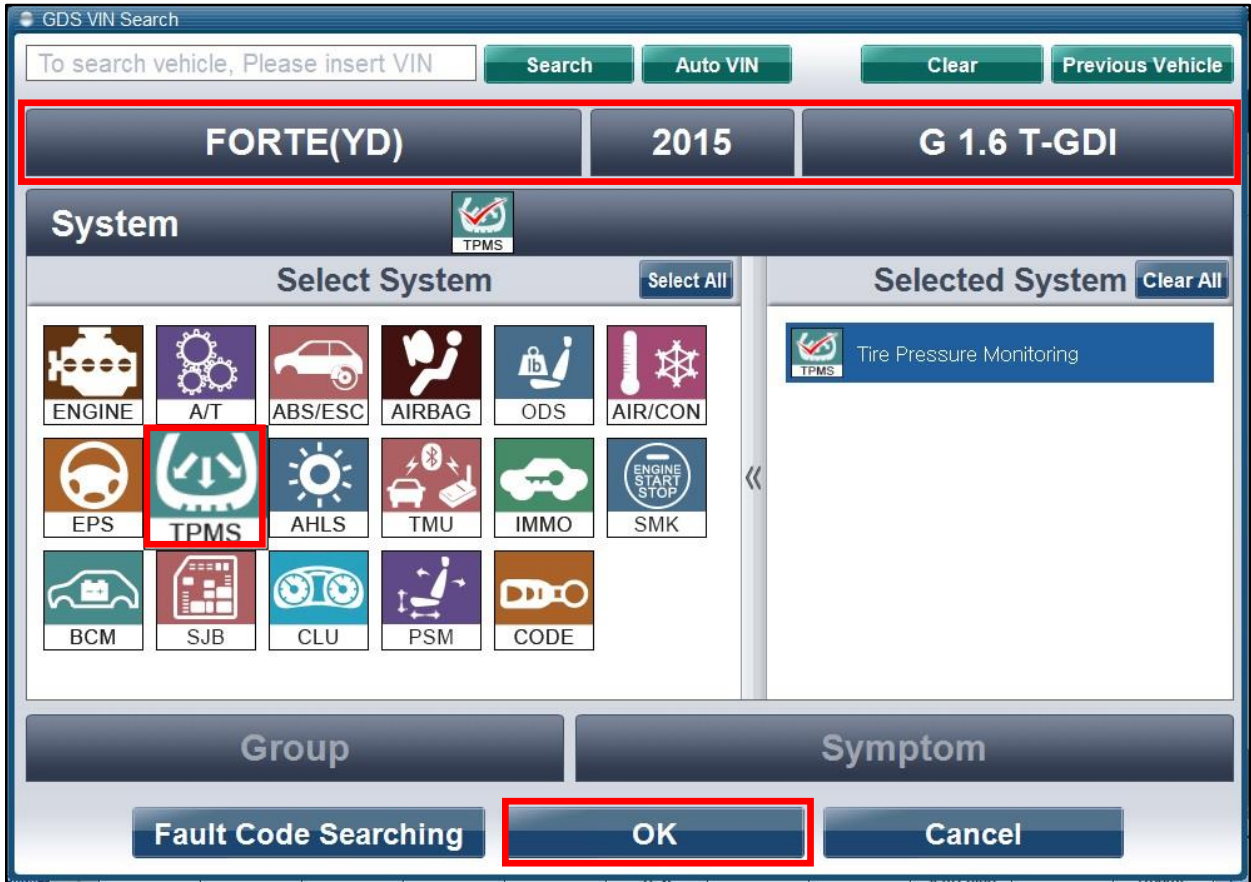
6. Select **TPMS** system and click **OK**.

Display screen above is for demonstration only purposes and will vary depending on model.

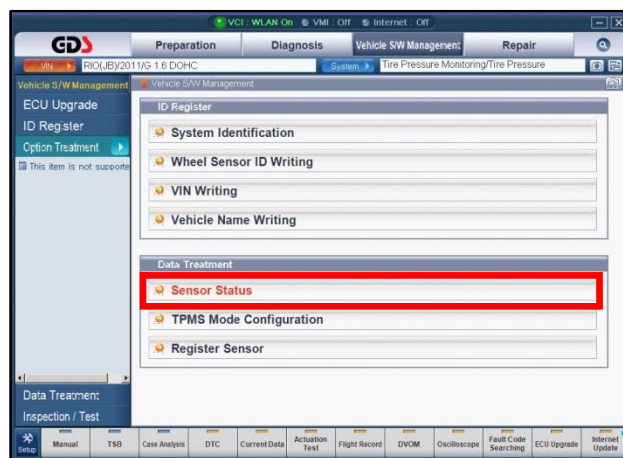
8. After performing the **Vehicle Name Writing** operation, verify the TPMS sensors IDs are registered in the system by running **Sensor Status**.
