| <b>HYUNDAI</b> NEW THINKING.<br>NEW POSSIBILITIES. | GROUP<br><b>CAMPAIGN</b> | NUMBER<br><b>16-01-032</b> |
| <b>SUBJECT:</b> | TCU UPDATE – SHIFT HESITATION AND SHOCK IMPROVEMENT<br>(SERVICE CAMPAIGN TJJ) | |

This bulletin provides information related to the TCU software update for certain 2017 Santa Fe vehicles that may experience a transmission hesitation or shift shock when accelerating at slow speeds.

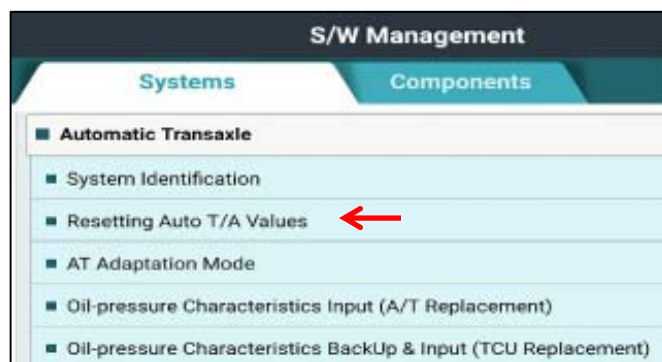
1. Check for Diagnostic Trouble Codes in the **ABS/ESC** and **BCM** menus and erase any DTC.
2. Erase the DTC in the BlueLink system according to TSB 12-BE-005-2.
3. Reset the automatic transmission adaptive values using GDS, **S/W Management** menu and **Resetting Auto T/A Values**. Follow the prompts on the GDS.

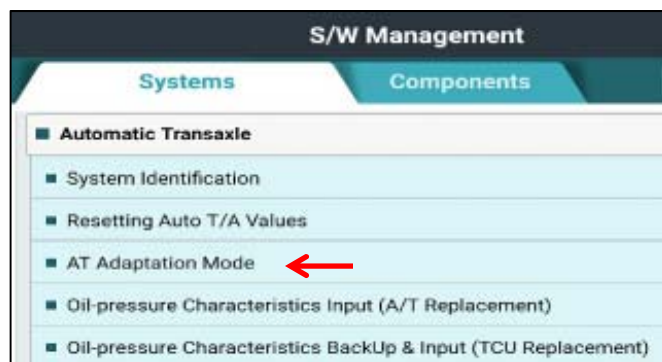
4. Relearn the adaptive values using GDS, **S/W Management** menu and **AT Adaptation Mode**. Follow the prompts on the GDS.
