# ISB4.5 CM2350 B104 - Variable Geometry Turbocharger Actuator Casting Porosity Campaign

# ISB4.5 CM2350 B104 TurboCharger Actuator Replacement Procedure

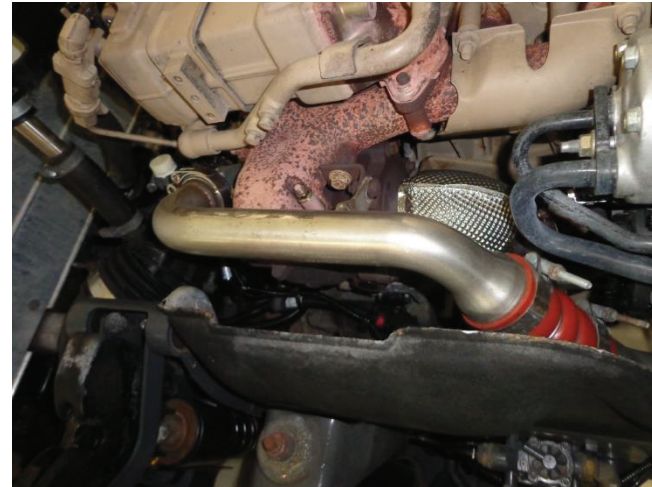
- The heat shield (where fitted), compressor outlet pipe work and turbine downpipe must be removed in order to gain access to the electronic actuator.

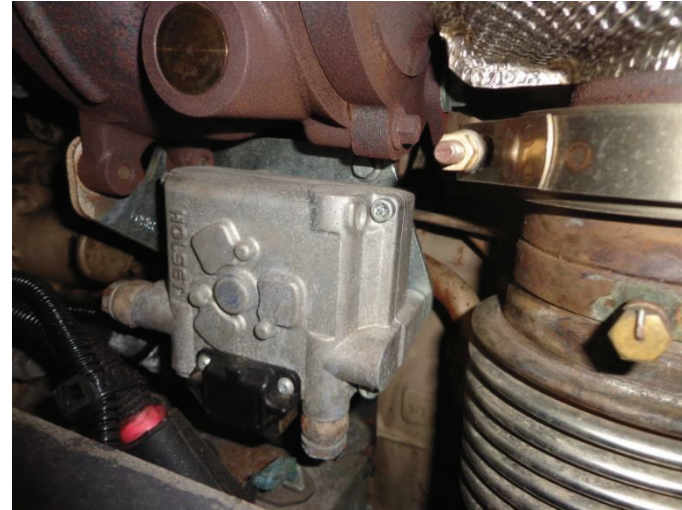
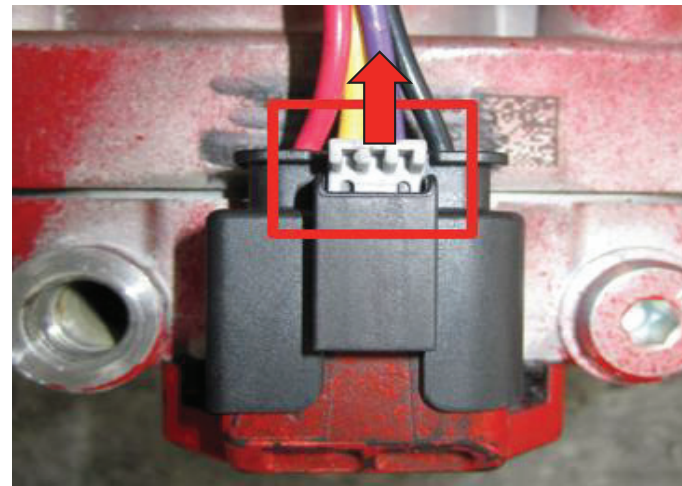
# Actuator – Connections

- The electrical connector should then be removed from the actuator. Disengage the secondary latch and remove the connector (see picture below)
- Next drain the engine coolant to a level allowing for the coolant pipes to be disconnected from the actuator. [Refer to procedure 008-018.](#)
- Remove the coolant supply and return banjo fittings from the VGT Actuator, [Refer to procedure 010-041.](#)

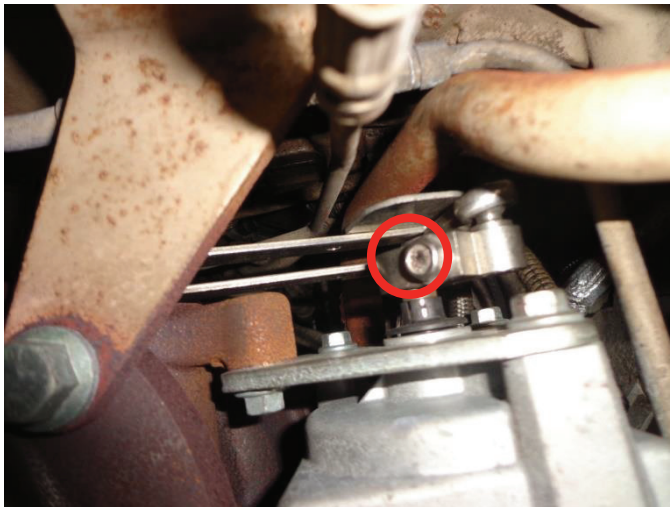
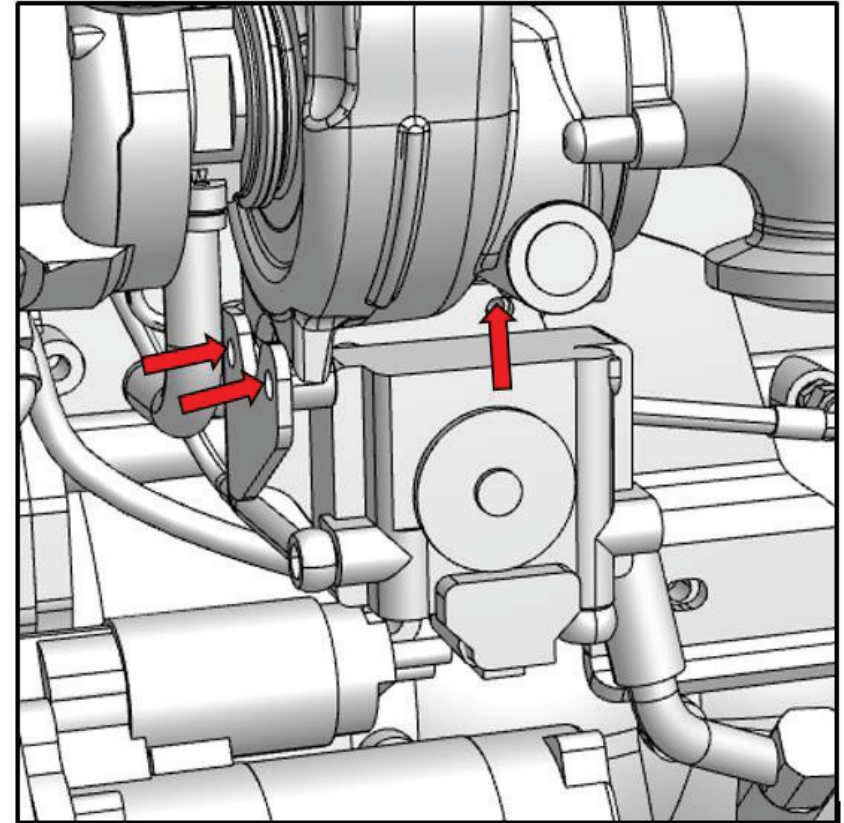
# Actuator - Mountings

- The image below shows the bolt retaining the linkage to the actuator output, this should be loosened but not removed.
- The 3 bolts retaining the actuator bracket to the turbine housing should also be removed. This should then allow the actuator and bracket to be removed from both the turbine housing and the VG linkage.

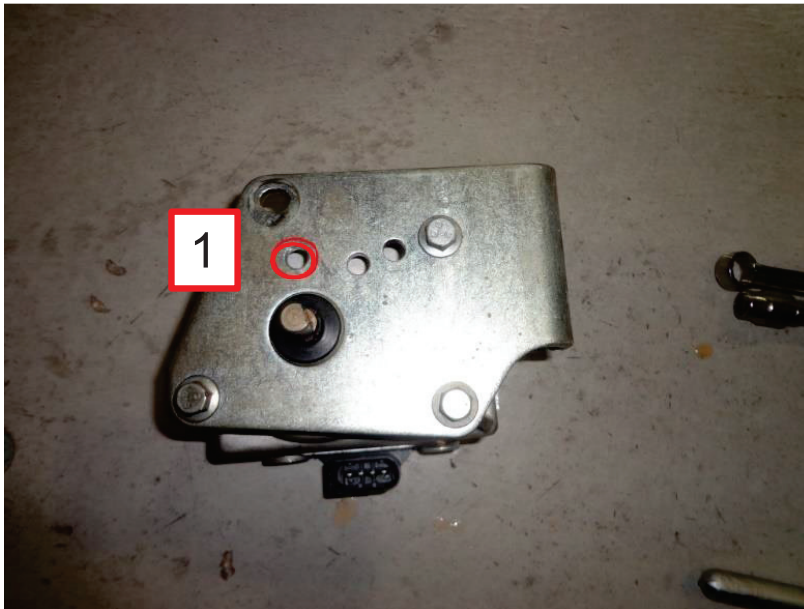
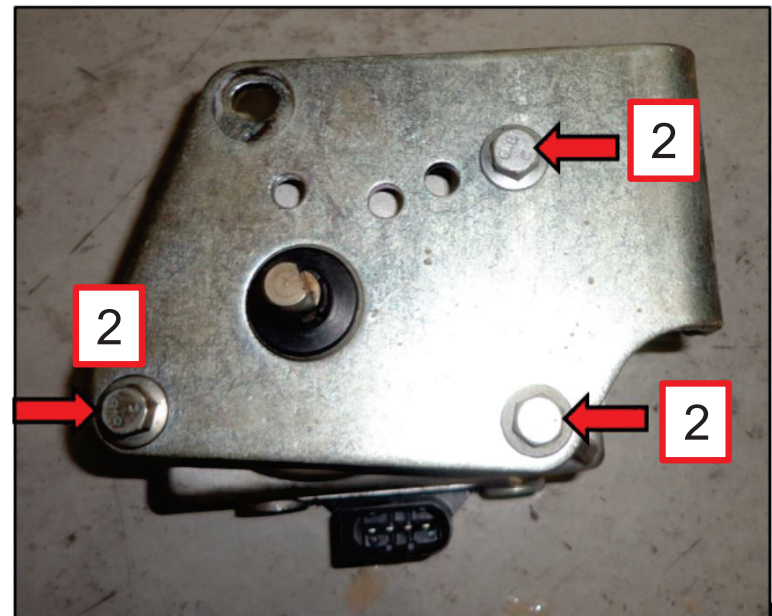
# Actuator carrier bracket change

- A M8 stud is fitted to the highlighted hole during actuator recalibration. Run a stud through the threaded hole to ensure the threads are clean. [1]
- The actuator should then be removed from the bracket.
- Fit the replacement actuator to the actuator carrier bracket [2]. **Torque value 18Nm [159 In-lb]**

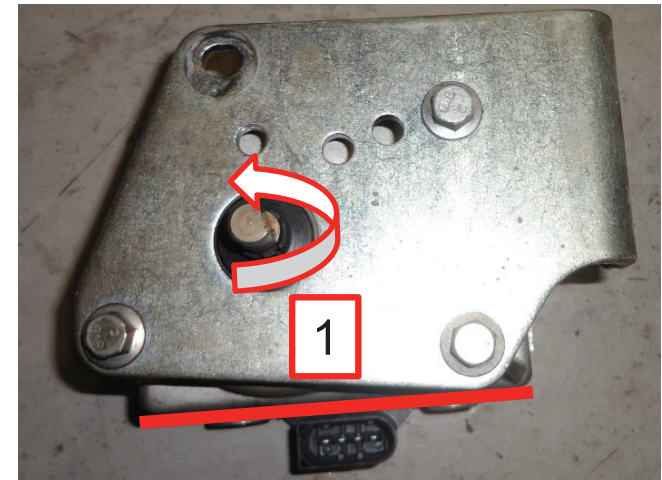
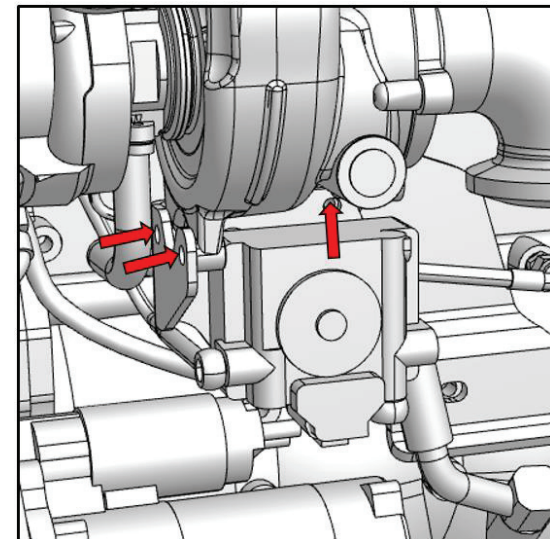
- The linkage is shaped so that it will only fit in 1 way. To aid installation, rotate the shaft on the replacement actuator by hand so that the flat is approximately parallel with the actuator's electrical connector [1].
- When refitting the actuator bracket to the turbo housing, slide the actuator linkage over the actuator shaft before installing any bolts.
- Pull the linkage towards the actuator to ensure it is fully engaged.
- The linkage bolt can now be tightened. **Torque value 9Nm [80 In-lb]**.
- NOTE: Do not use the retaining bolts to pull the actuator onto the linkage, this will cause damage to the linkage and / or the VGT actuator.
- Check the VG mechanism for full travel by hand.
- When the linkage is installed and the actuator is located, install the retaining bolts and torque to **23Nm [204 In-lb]**.

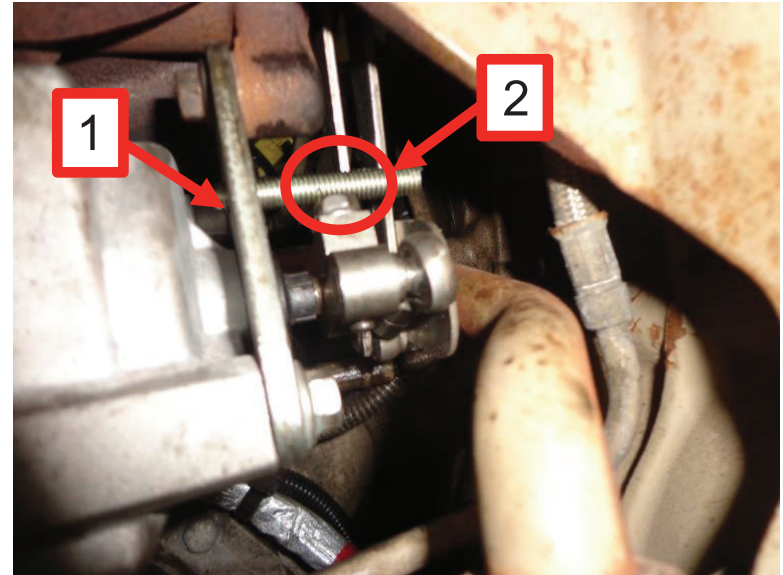
# Calibration and reassembly

NOTE: fitment of the calibration stud is aided by removing the oil feed pipe.

- Fit the Calibration stud [1].
- Reconnect the electrical connector, make sure to engage the secondary latch.
- NOTE: Where using a bolt in place of the calibration stud, care **must** be taken to ensure that during calibration the linkage bolt contacts the threaded section of the calibration bolt, not the head [2]
- Run the actuator calibration routine using INSITE™ (See Appendix A)
- **Once the actuator is calibrated, the calibration stud/bolt must be removed**
- Refit the turbo oil feed pipe, [refer to procedure 010-046](#).
- Refit the actuator coolant pipes, [refer to procedure 010-041](#).
- Refill the cooling system, [refer to procedure 008-018](#).
