MODEL
2016MY
Soul (PS)
w/2.0L GDI engine

NUMBER
151 (REV 1, 11/04/2015)

TECHNICAL SERVICE BULLETIN

SUBJECT: SERVICE ACTION: ECM/TCM SHIFT LOGIC
IMPROVEMENT (SA 207)

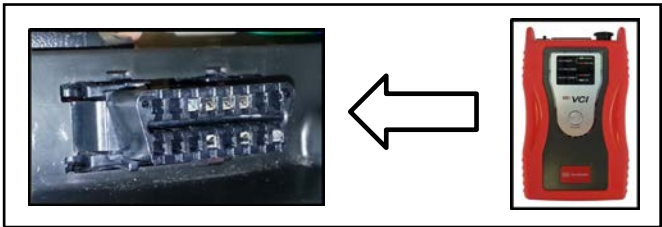
- 4. Connect the Main 16-pin DLC cable (GHDM – 241000) to the OBD-II connector, located under the driver's side of the instrument panel.

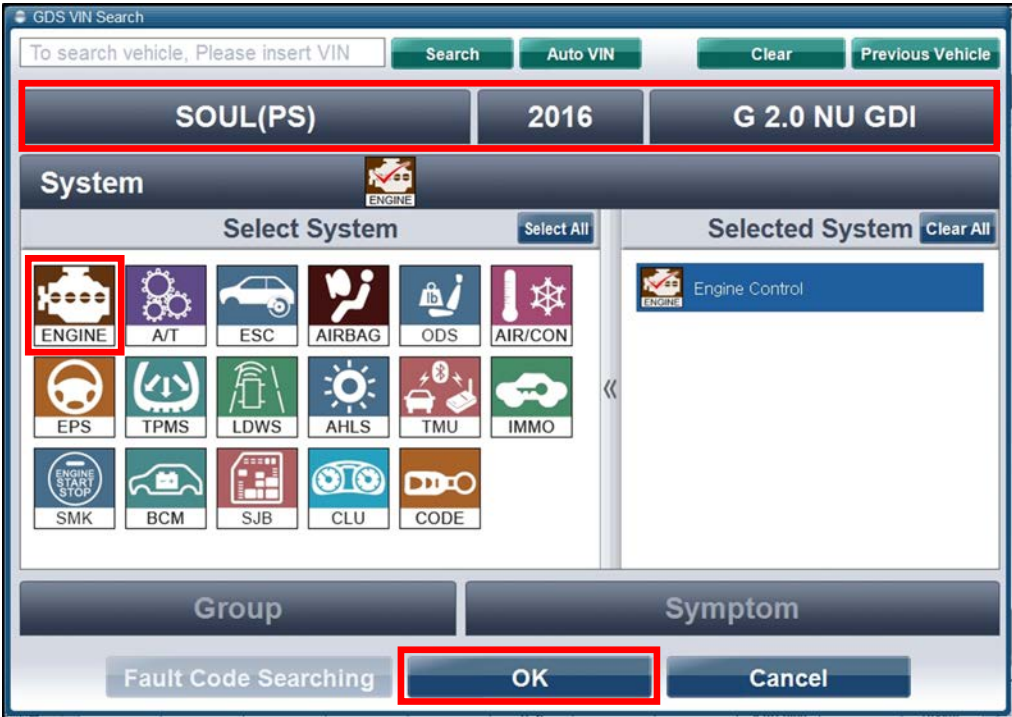
- 5. With the ignition key ON, turn ON the VCI and GDS. Access the GDS vehicle identification number (VIN) screen and configure the vehicle using the **VIN AUTO DETECT** Function.
- 6. Select **ENGINE** system and click **OK**.

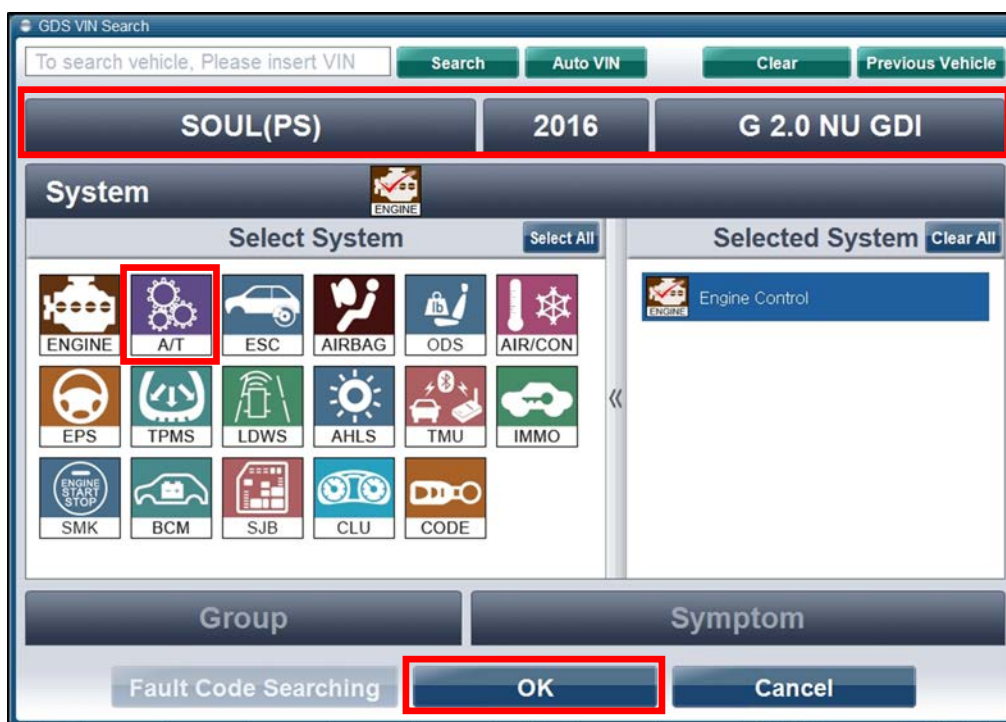
8. After performing event #266, return the GDS home screen, select **A/T System** and click **OK**.
