# SERVICE BULLETIN

Classification: AT16-004	Reference: NTB16-068	Date: July 20, 2016
-----------------------------	-------------------------	------------------------

## 2016 TITAN XD; ENGINE RPM FLARE DURING UP SHIFT AND/OR DOWN SHIFT BUMP

**APPLIED VEHICLES:** 2016 Titan XD (A61)  
**APPLIED ENGINE:** Cummins 5.0L V8 Diesel  
**APPLIED TRANSMISSION:** 6AT: RE6R01A

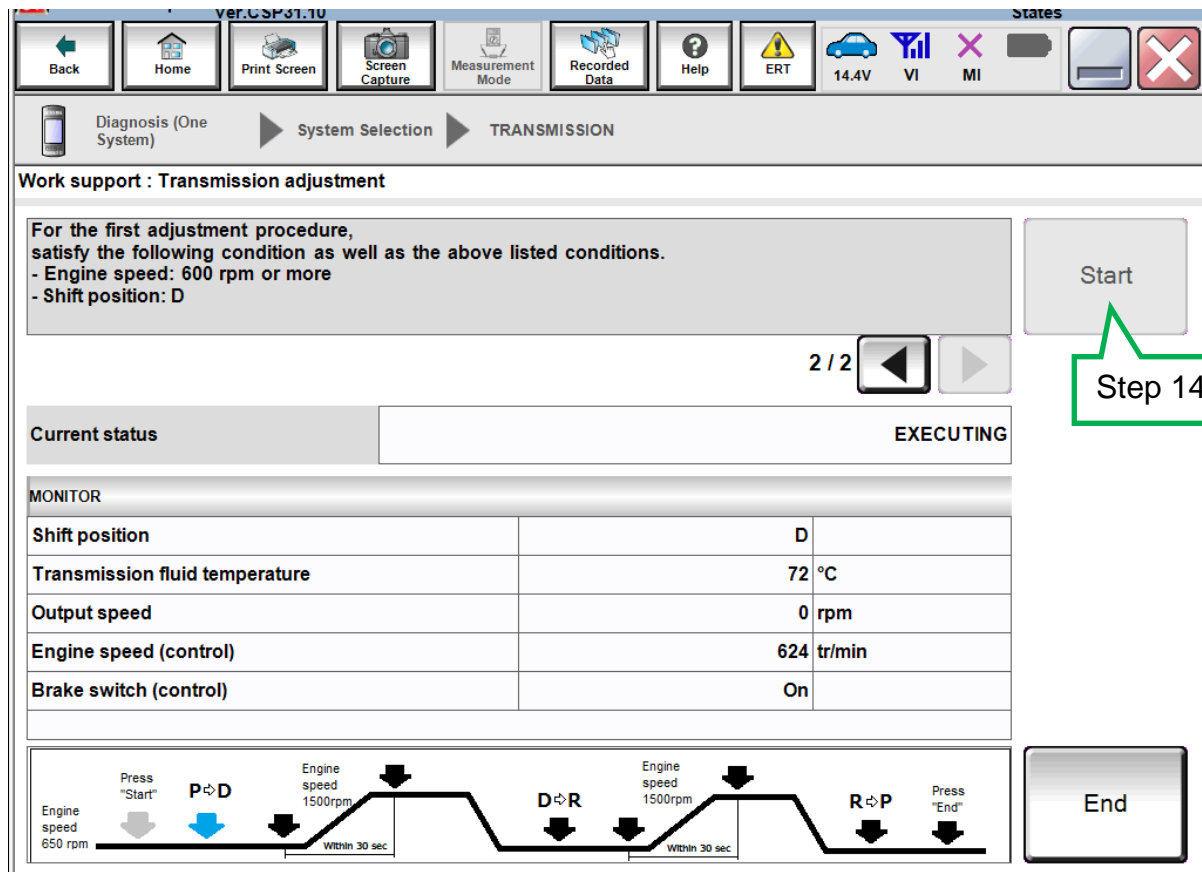
Figure 4

15. Wait for the first adjustment procedure to complete (about 3 minutes).

- When complete, current status will change to **Waiting**.

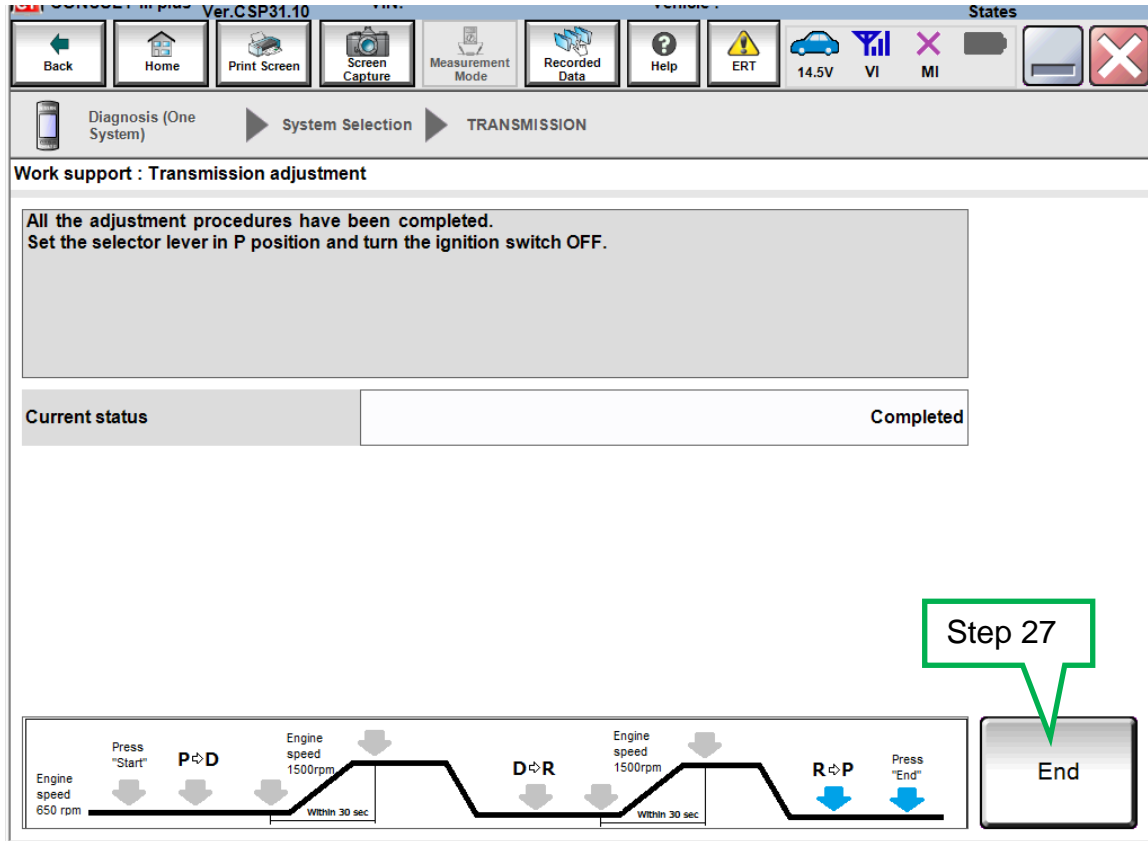
25. When the Transmission Adjustment has completed (see Figure 8), shift the transmission to Park.

- When complete the screen in Figure 8 (next page) will display.
