GROUP Electrical	MODEL 2014MY Soul (PS) 2014MY Sorento (XMa) 2014MY Optima (TF/QF) 2014MY Forte (YD) 2014MY Sportage (SL) 2014MY Rio (UB)
	NUMBER 101	DATE March 2016

TECHNICAL SERVICE BULLETIN

SUBJECT: COMBINED TSB/SERVICE ACTION: BASE AUDIO SYSTEM UPGRADE (SA 223)

This bulletin provides the procedure for upgrading the base audio system software of some 2014MY Soul (PS), Optima (TF/QF), Sorento (XMa), Sportage (SL), Rio (UB), and Forte (YD) vehicles, to improve Bluetooth® connectivity, Phonebook Download, Audio Streaming and Call History Download.

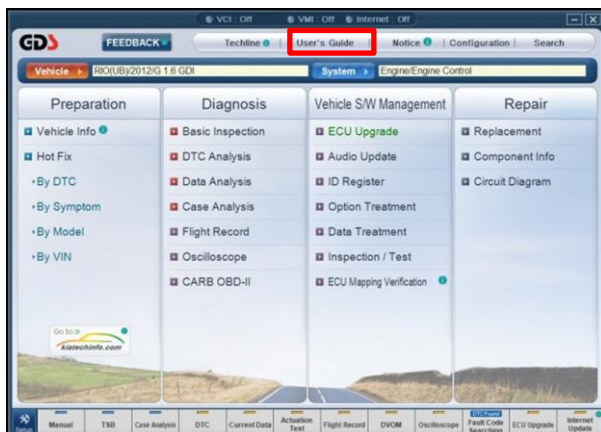
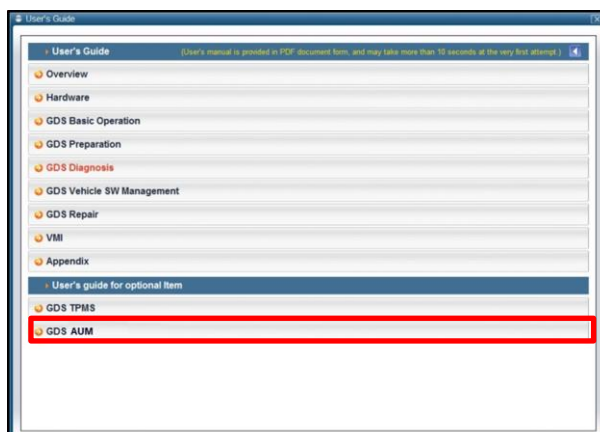
4. If performing the update using the GDS AUM, refer to TSB SST 032 or click on **User's Guide > GDS AUM** on the GDS main screen, as shown below, and follow the on-screen instructions.

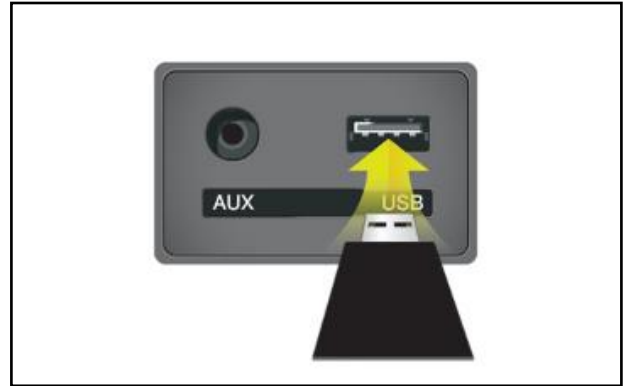
- Turn the head unit ON and wait until booting is finished (approx. 10 seconds) before proceeding to the next step.
- If performing the update using a USB stick, obtain the correct **14MY Audio Upgrade USB Drive (yellow or green)** from your Service Manager and insert it in the vehicle's USB port. **NOTE: Make sure to allow for the sound file to play for one second before proceeding to the next step.**

Images shown are for demonstration only purposes and will vary by model.

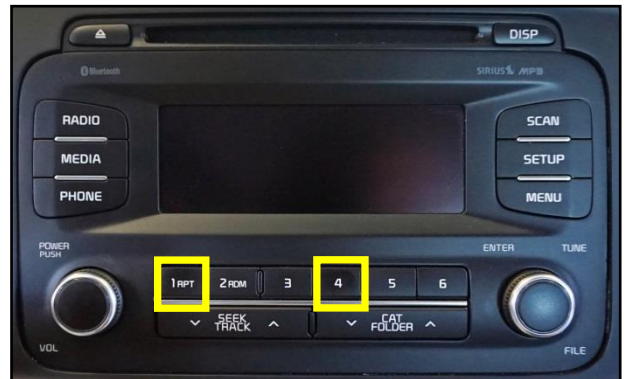
- Press and hold preset button "1" and then preset button "4" at the same time for five (5) seconds.

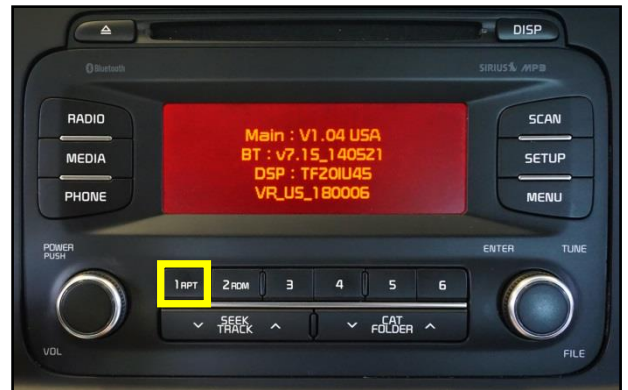
9. Immediately after releasing preset buttons "1" and "4", press preset button "1" four (4) times in a row within half a second each.

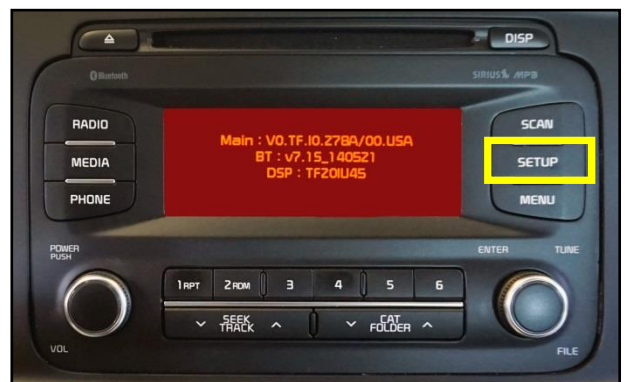
10. If the S/W version screen displays correctly, press the **SETUP** button.

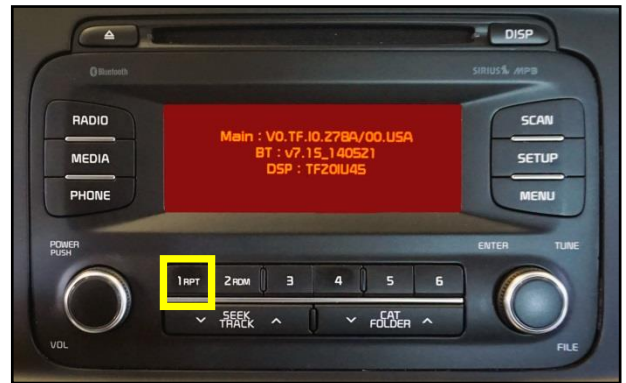
11. Press preset button “1” to display the firmware upgrade menu.

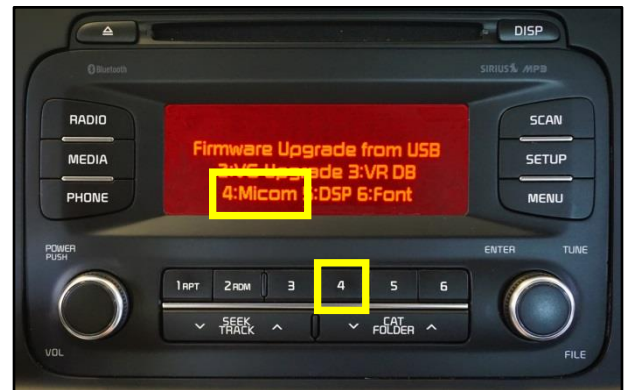
12. Once the Firmware upgrade menu is displayed, press preset button “4” to update MICOM.

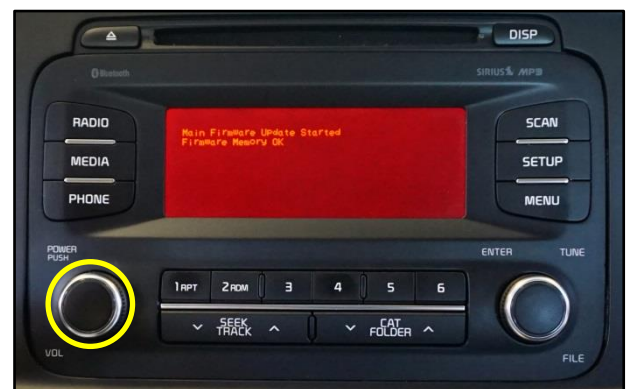
13. The upgrade will begin and system will display the progress on the screen. Once the upgrade is complete, turn the head unit OFF.

- The update will take approximately three (3) minutes to complete and the system will restart.
- If the system restarts immediately and the power stays off, the update may have failed. Restart the procedure from step 4.

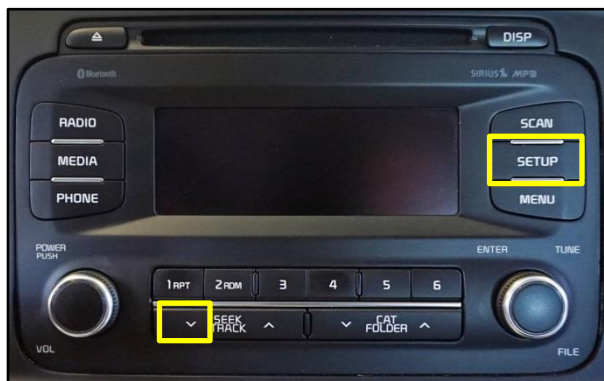
- Make sure audio unit is powered **OFF**. First press button “**Seek Down**”. Then press “**SETUP**” button and hold both for four seconds prior to releasing.

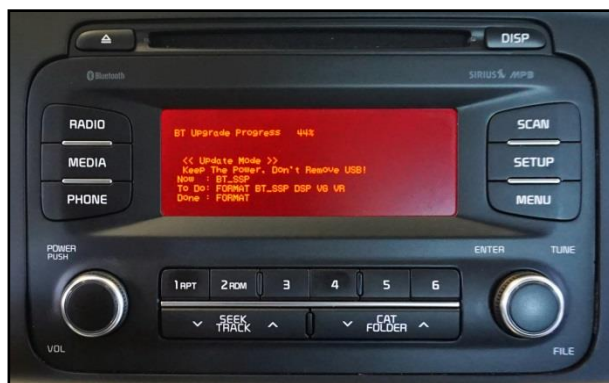
- The upgrade will proceed to “Format -> Font -> BT -> DSP -> VG -> VR”

- The update will take approximately twenty (20) minutes to complete and the system will restart.
- If the system restarts immediately and the power stays off, the update may have failed. Restart the procedure from step 7.

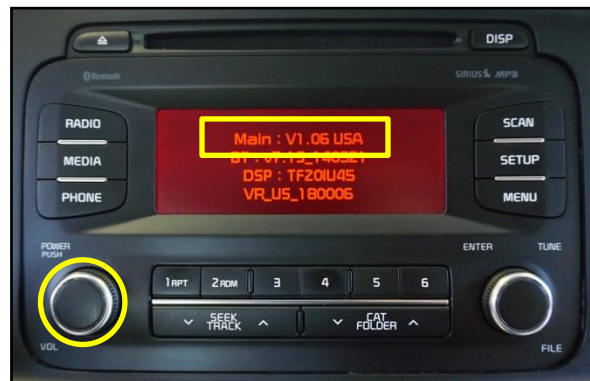
- Power up the head unit and repeat steps 7~10 to check the new software versions, as shown in the table on Page 8.

Confirm that software levels for each system; Main, Bluetooth, Voice Recognition (VR) and DSP have updated. If a system is NOT showing as updated, the software upgrade will need to be performed again.
