Surge, Hesitation, or Judder on Light Acceleration from a Stop (Supersedes 13-053, dated June 6, 2014, to revise the information marked with black bars.)

The continuously variable transmission (CVT) needs hardware and software updates.

Install the updated transmission valve body kit, and update the PGM-FI software.

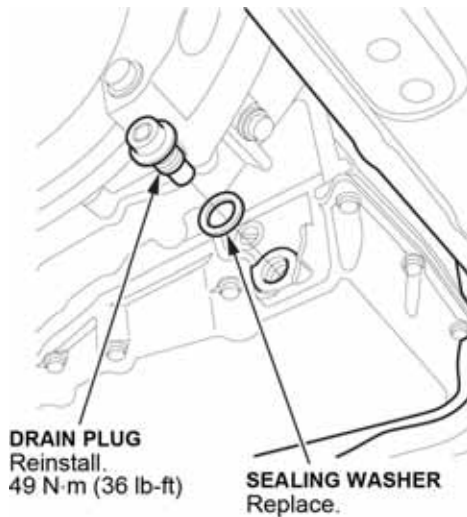
3. Remove the transmission drain plug, and drain the CVT fluid.

NOTE: Clean and remove any metal particles from the magnetic drain plug.

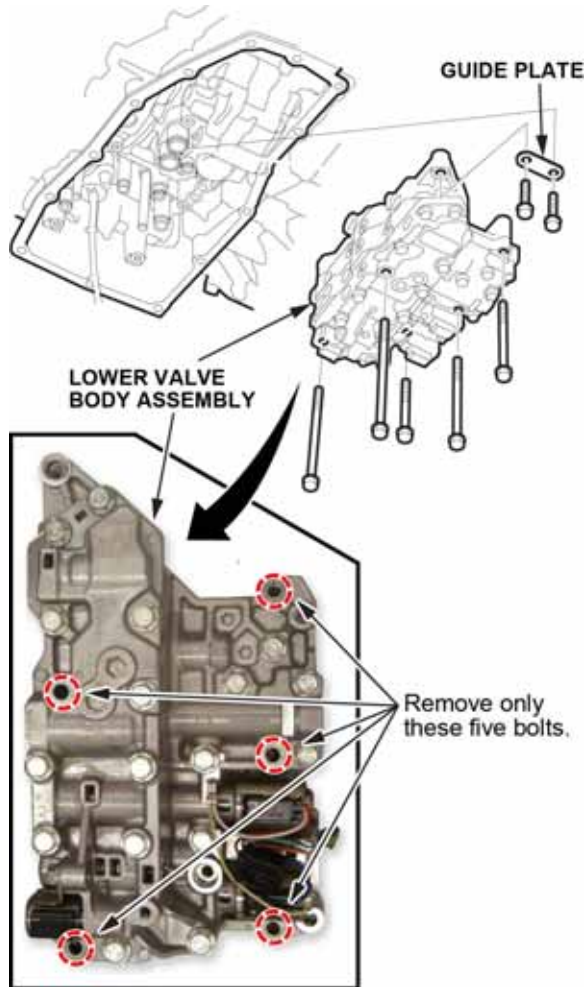
- Remove the guide plate, then remove the lower valve body assembly.

- When removing the valve body assembly, do not damage solenoid wire harnesses A and B.
- Remove only the five valve body bolts and the two guide plate bolts shown. If an incorrect bolt is removed, you may be unable to remove the valve body.

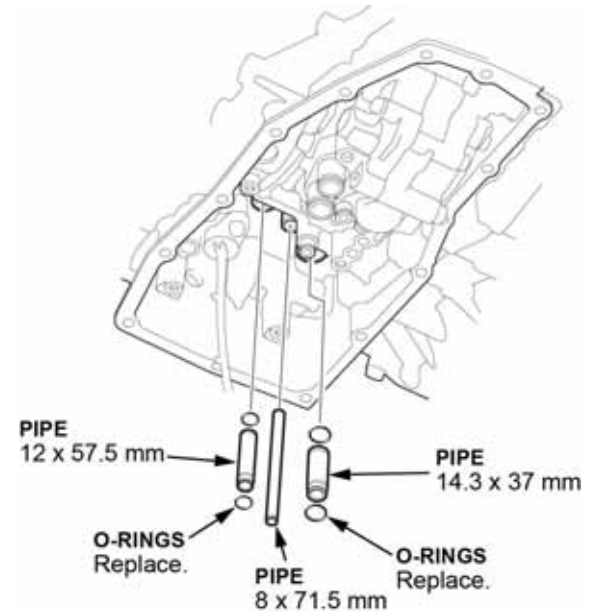
- Remove the 12 mm x 57.5 mm pipe and the O-rings.

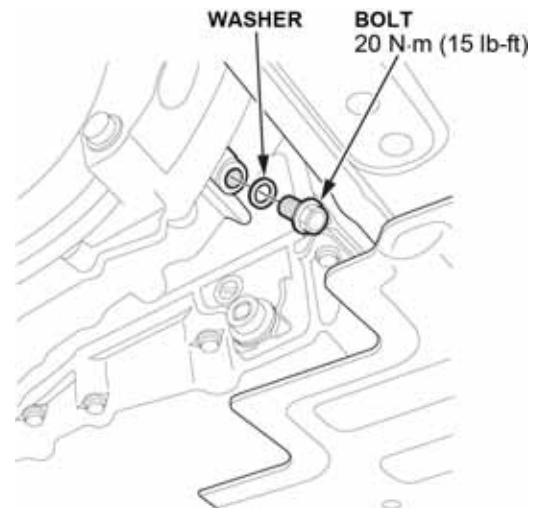
17. Reinstall the check bolt with a new sealing washer.
