February 9, 2017

05749 Version 5

Product Update: Audio-Navigation Unit

(Supersedes 15-072, dated February 25, 2016, to revise the information highlighted in yellow)

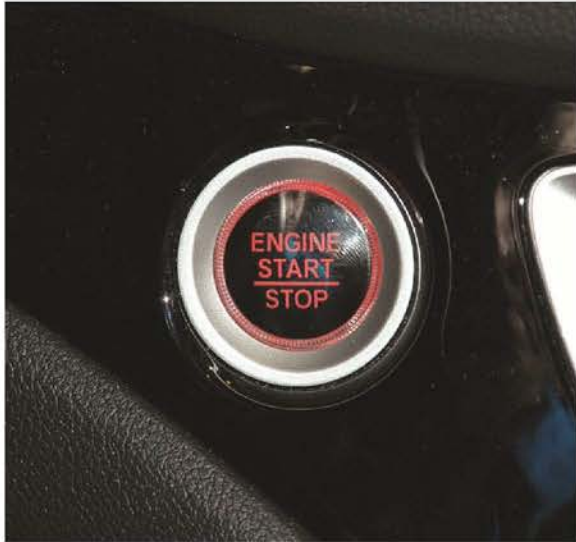
- Do not install the USB update device into a PC, as it will no longer function correctly.
 - If the vehicle arrives at the dealership with a blank screen, do a battery cable reset before doing the update.
1. Connect a battery charger or a fully charged jumper battery to the vehicle, and leave it connected during the entire update procedure to maintain a steady voltage.
 2. Turn the ignition to ON.

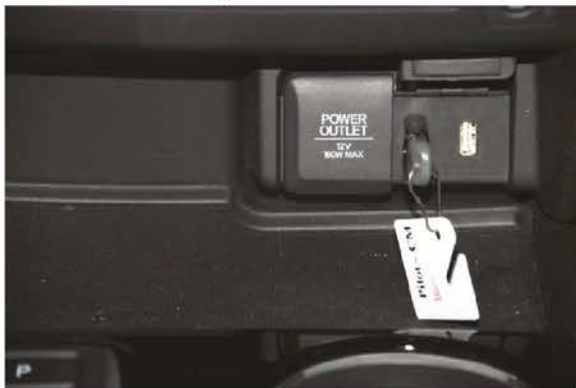
3. Insert the USB update device into the USB port.

NOTE: If the screen goes blank after the USB update device is inserted, turn the ignition to OFF for 1 minute, then back to ON. The update should restart automatically.

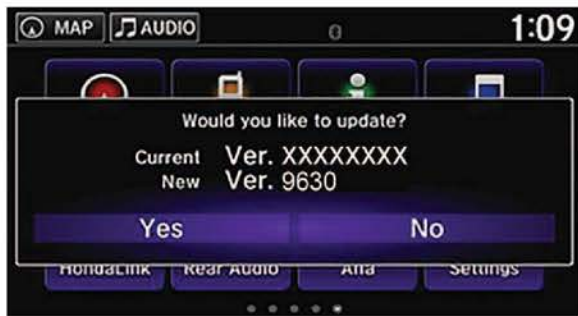
- When you see the message **Would you like to update**, select **Yes**.

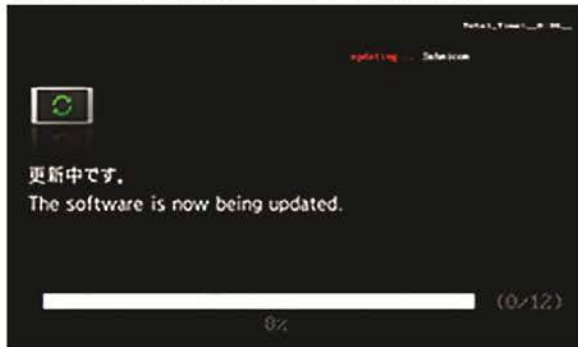
This screen will show after 1–2 minutes.

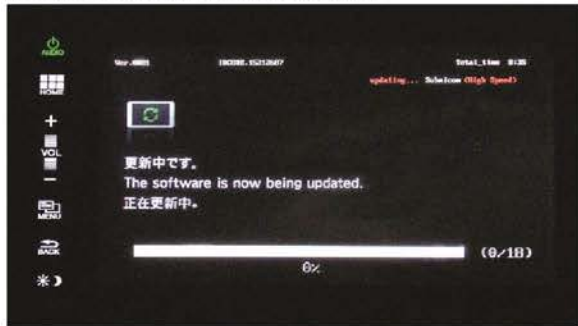
This screen will show 0% for about 20–25 minutes without updating. However, the update is still working and you do not have to oversee the update.

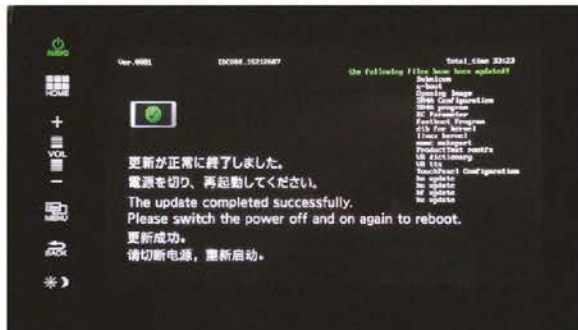
- When the screen shows **The update completed successfully**, turn the ignition OFF and remove the USB update device.

NOTE: You may hear a pop when you remove the device.

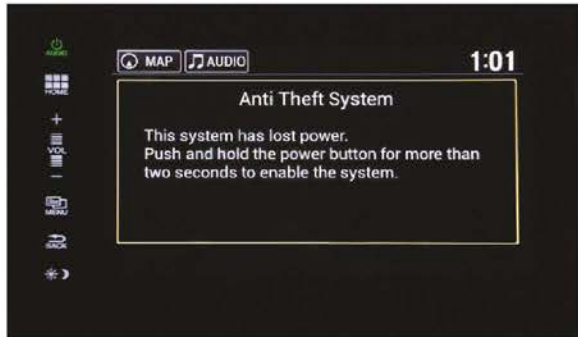
6. Start the engine, and wait until the **Anti-Theft System** screen appears. Then, press and hold the audio power button for more than 5 seconds. The update is complete.

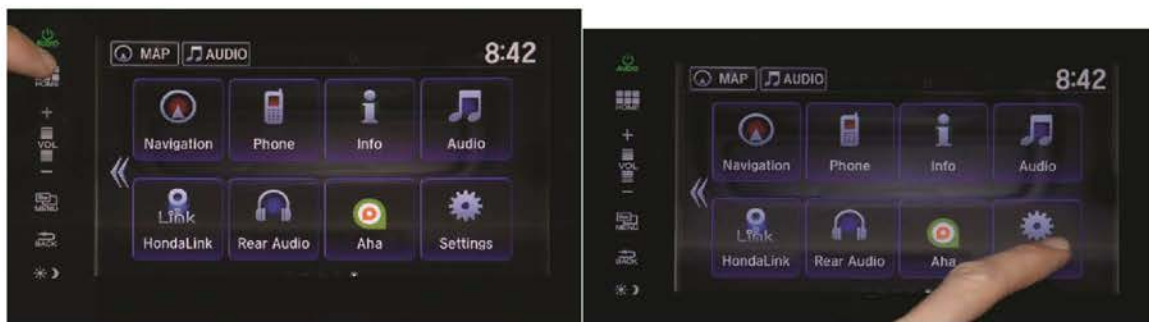
1. Select **HOME**, then **Settings**.

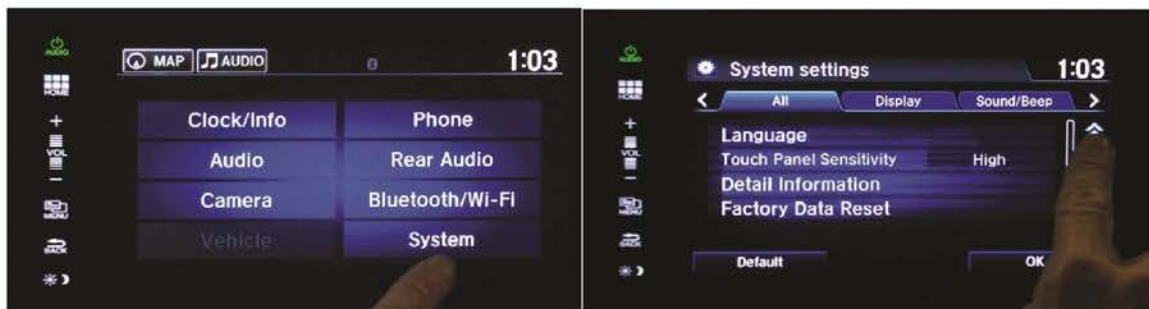
2. Select **System**, then scroll up until you see **Factory Data Reset**.

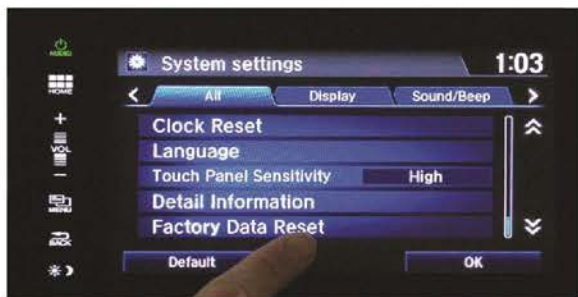
3. Select **Factory Data Reset**.

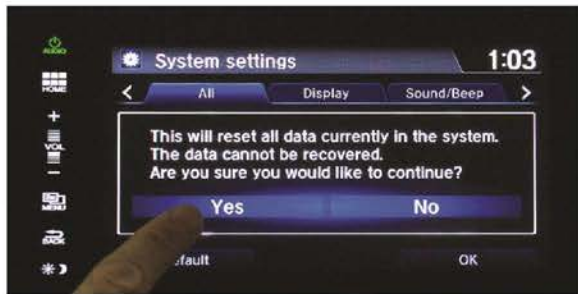
4. Select **Yes** on the pop-up screen. The system will reboot and return to normal. The phone now can be paired using the phone setup in the owner's manual.

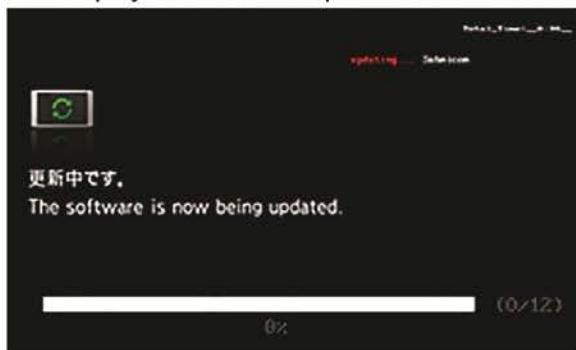
1. Turn the ignition to OFF.
2. Remove the USB update device.
3. Disconnect the negative battery cable for 2 minutes.
4. Connect the negative battery cable.
5. Turn the ignition to ON.
6. Insert the USB update device into the USB port. The display screen will continue to be blank for up to 10 minutes.

The display will show the update screen start back at 0 %.

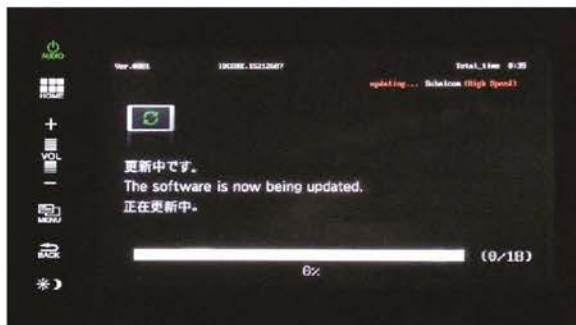
The screen will show 0% for about 20–25 minutes without updating. However, the update is still working.

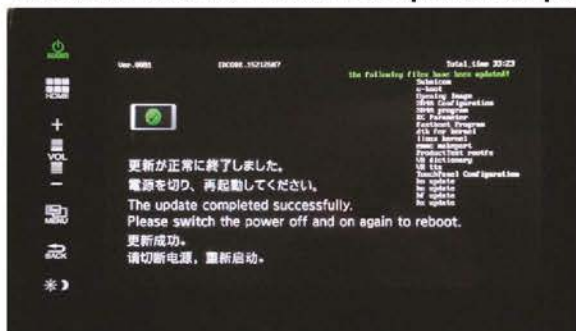
Wait until the screen shows **The update completed successfully.**

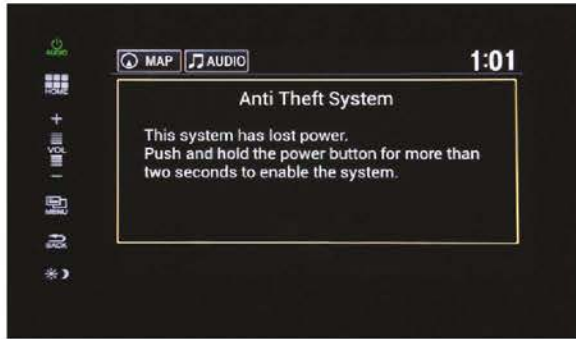
7. Turn the ignition to OFF, and remove the USB update device. You may hear a pop when you remove the device.
8. Start the engine and wait until the **Anti-Theft System** screen appears. Then, press and hold the audio power button for more than 5 seconds. The update is complete.
