06001 Version 3

Audio Unit and Navigation Unit Software Update

Year	Model	Trim	VIN Range
2016	Pilot	EX and above	ALL

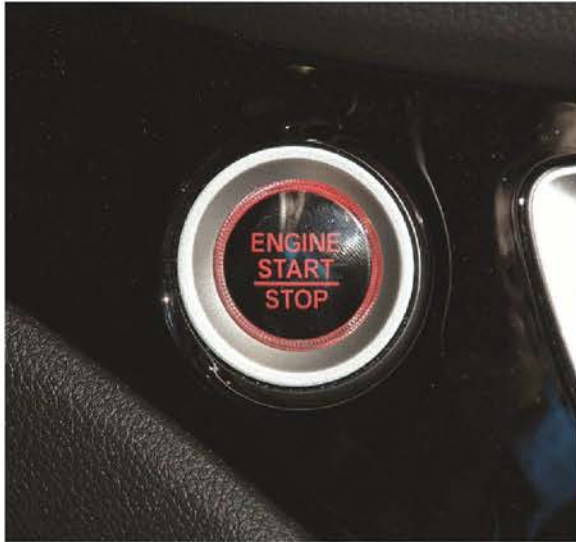
- If the vehicle arrives at the dealership with a blank screen, do a battery cable reset before doing the update.
1. Connect a battery charger or a fully charged jumper battery to the vehicle, and leave it connected during the entire update procedure to maintain a steady voltage.
 2. Turn the ignition to ON.

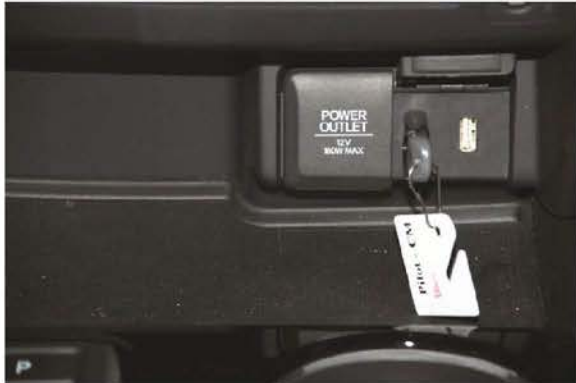
3. Insert the USB update device into the USB port.

NOTE: If the screen goes blank after the USB update device is inserted, turn the ignition to OFF for 1 minute, then back to ON. The update should restart automatically.

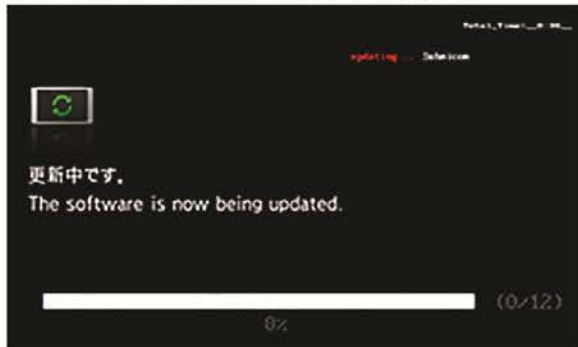
This screen will show after 1–2 minutes.

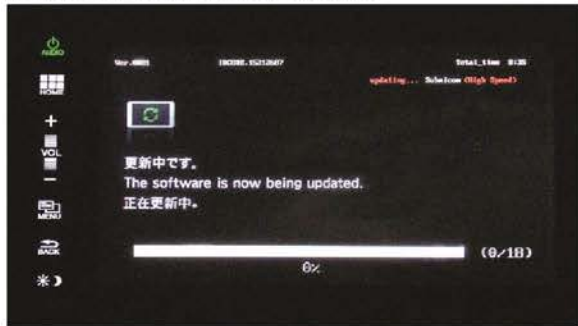
This screen will show 0% for about 20–25 minutes without updating. However, the update is still working and you do not have to oversee the update.

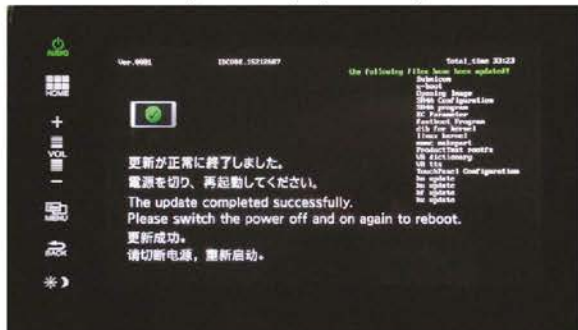
- When the screen shows **The update completed successfully**, turn the ignition OFF and remove the USB update device.

NOTE: You may hear a pop when you remove the device.

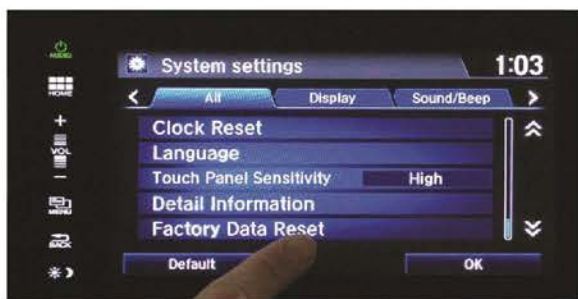
3. Select **Factory Data Reset**.

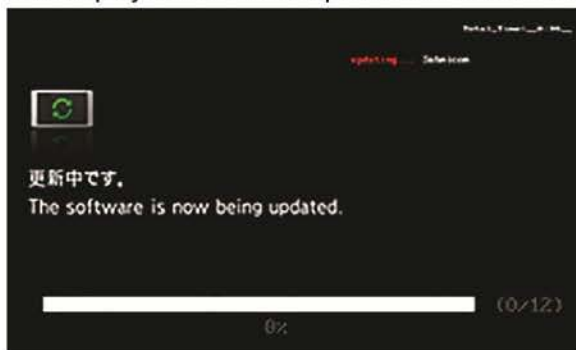
1. Turn the ignition to OFF.
2. Remove the USB update device.
3. Disconnect the negative battery cable for 2 minutes.
4. Connect the negative battery cable.
5. Turn the ignition to ON.
6. Insert the USB update device into the USB port. The display screen will continue to be blank for up to 10 minutes.

The display will show the update screen start back at 0 %.

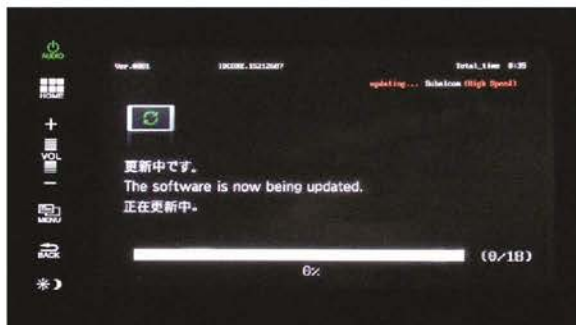
The screen will show 0% for about 20–25 minutes without updating. However, the update is still working.

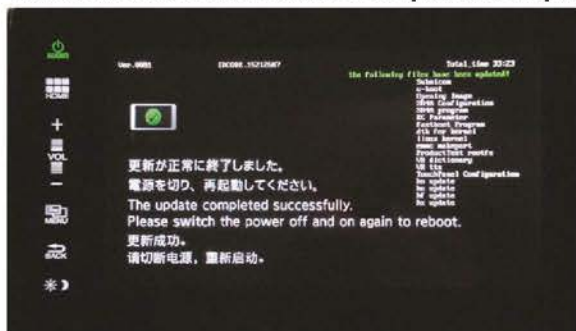
Wait until the screen shows **The update completed successfully.**
