05972 Version 7

Firm 2nd to 3rd Gear Upshifts Under Certain Driving Conditions

Supersedes 15-040, dated July 19, 2016, to revise the information highlighted in yellow

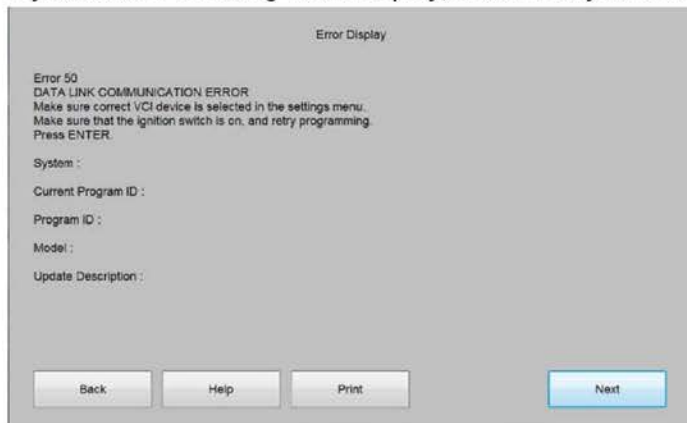
- You can't update the vehicle using the MVCI as a standalone tool.
- **Do not** use the MongoosePro VCI tool.
- Make sure the 12 volt battery is fully charged before starting an update.
- Connect a fully charged jumper battery to the vehicle and leave it connected during the entire procedure to maintain steady voltage.
- Never turn the ignition to OFF or ACCESSORY during the update. If there is a problem with the update, leave the ignition turned to ON.
- To prevent transmission control unit damage, do not operate anything electrical (headlights, audio system, brakes, A/C, power windows, door locks, etc.) during the update.
- If you see the following Error Display, check that you are using the correct tool (MVCI or DST-i) with the i-HDS.

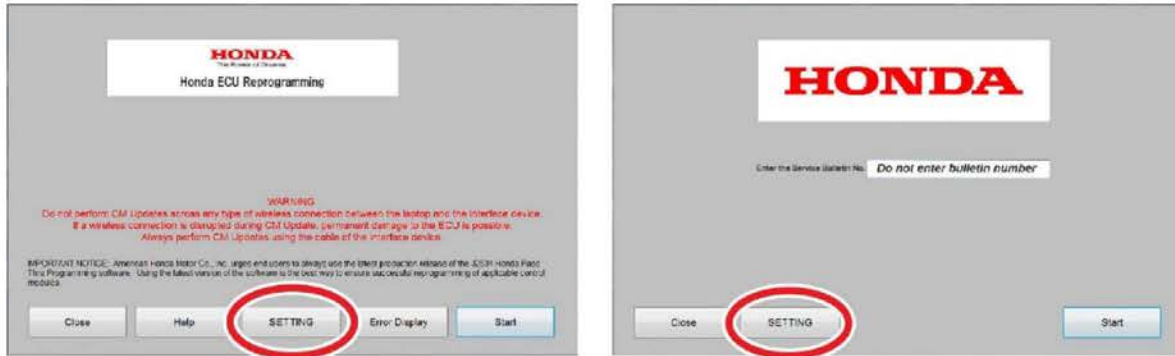
To change this, click on either of the SETTING selection buttons at the bottom of the J2534 initial screens as shown.

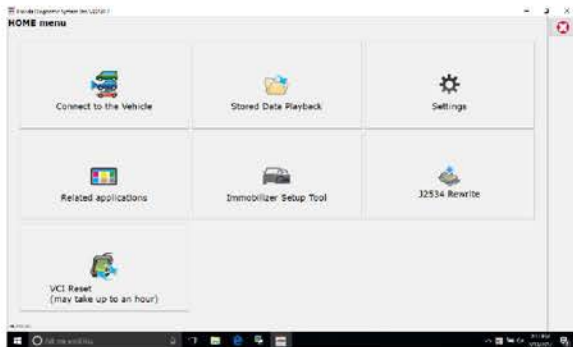
4. Select **J2534 Rewrite**.

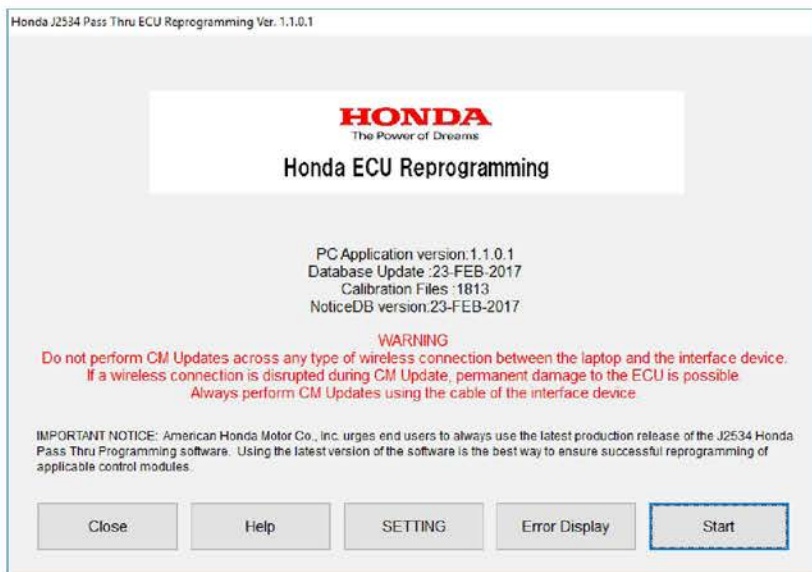
5. Confirm the software is the same **or later** as listed in SOFTWARE INFORMATION.

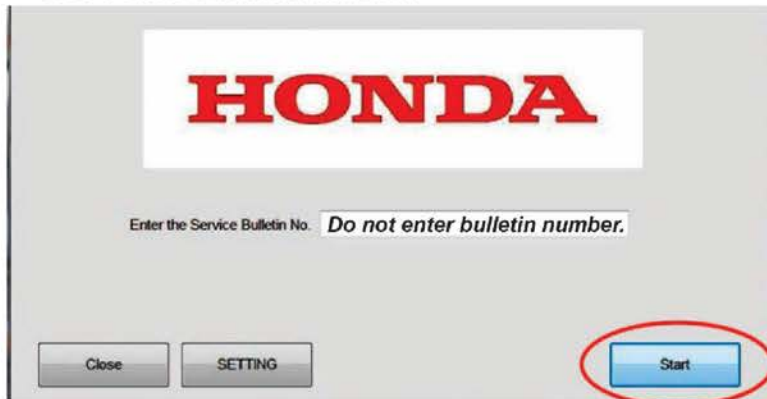
6. Select **Start**, then follow the screen prompts.

- **Don't enter a bulletin number.**
