Emissions Service Action

Code: 24DR

Subject	Engine Control Module (ECM) Software
Release Date	November 20, 2018
REVISION SUMMARY	<p>Updated Work Procedure:</p> <ul style="list-style-type: none">• Added note to address possible change to driver assist selections (pages 8 and 11).• Added note to address possible faults stored after the flash (page 11).
Affected Vehicles	<p>U.S.A.: 2013-2017 MY Beetle Convertible, Beetle, Jetta and 2014-2017 MY Passat</p> <p>CANADA: 2013-2017 MY Beetle & Jetta and 2014-2017 MY Beetle Convertible & Passat</p> <p>Check Campaigns/Actions screen in Elsa on the day of repair to verify that a VIN qualifies for repair under this action. Elsa is the <u>only</u> valid campaign inquiry & verification source.</p> <ul style="list-style-type: none">✓ Campaign status must show "open."✓ If Elsa shows other open action(s), inform your customer so that the work can also be completed at the same time the vehicle is in the workshop for this campaign.

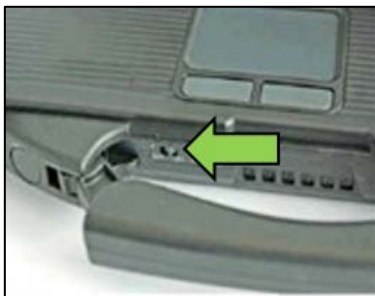
VAS 6150 & VAS 6150A
(Front panel behind handle)

- ✓ **The Bluetooth function of the scan tool is physically switched off <see pictures below>.**

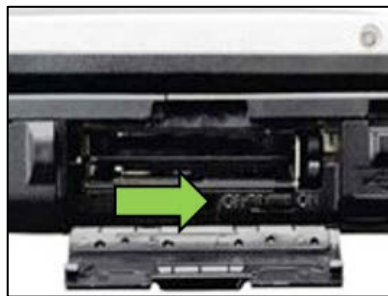
VAS 6150B
(Right side behind WIRELESS door)

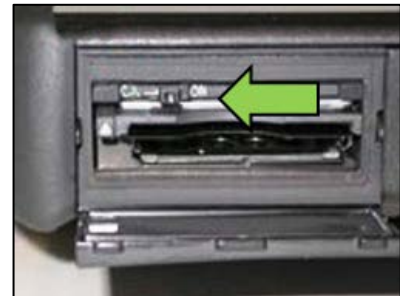
VAS 6150C/D
(Left side behind SC/EX door)

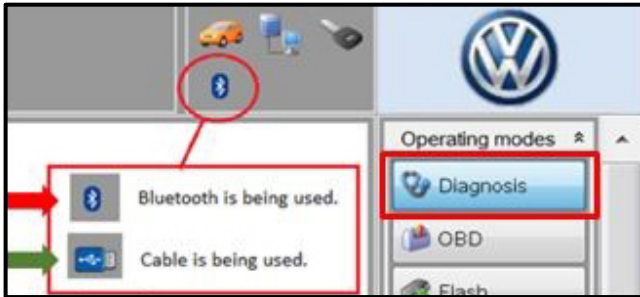
- Confirm that scan tool is communicating with the diagnostic head by USB <Green Arrow>.
 - If the Bluetooth symbol is shown <Red Arrow> then disconnect the diagnostic head from the vehicle and reconnect the USB cable to the diagnostic head and then reattach to the vehicle.
- Upon ODIS startup, verify the "Diagnosis" operating mode is selected <as shown>.
- Once the GFF scan is complete, select "Special functions" <arrow 1>, then "Adapting software" <arrow 2>, then select "Perform test" <arrow 3>.

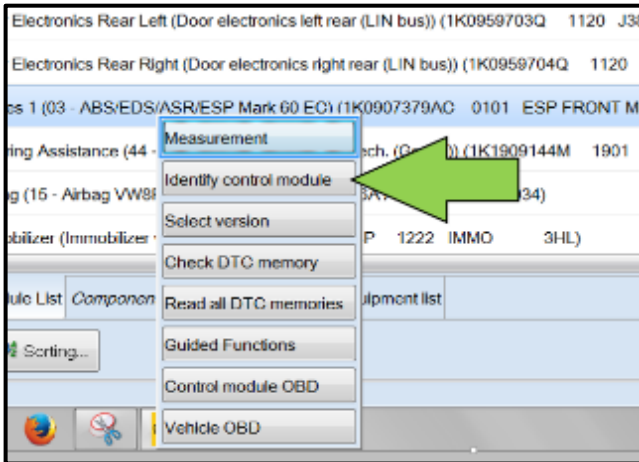
- After the software update is completed and before sending the GFF Log Online:
 - Select the “Control Module” tab.
 - Scroll down and right click on the module that was updated (0001).
 - Select “Identify Control Module” <arrow>.
