VOLUNTARY RECALL CAMPAIGN

Classification: AN22-022	Reference: NTB22-062	Date: July 21, 2022
-----------------------------	-------------------------	------------------------

VOLUNTARY SAFETY RECALL CAMPAIGN INFOTAINMENT SYSTEM REBOOTS EVERY 4-5 MINUTES

CAMPAIGN ID #: R22A5
APPLIED VEHICLES: 2021-2022 Rogue (T33)

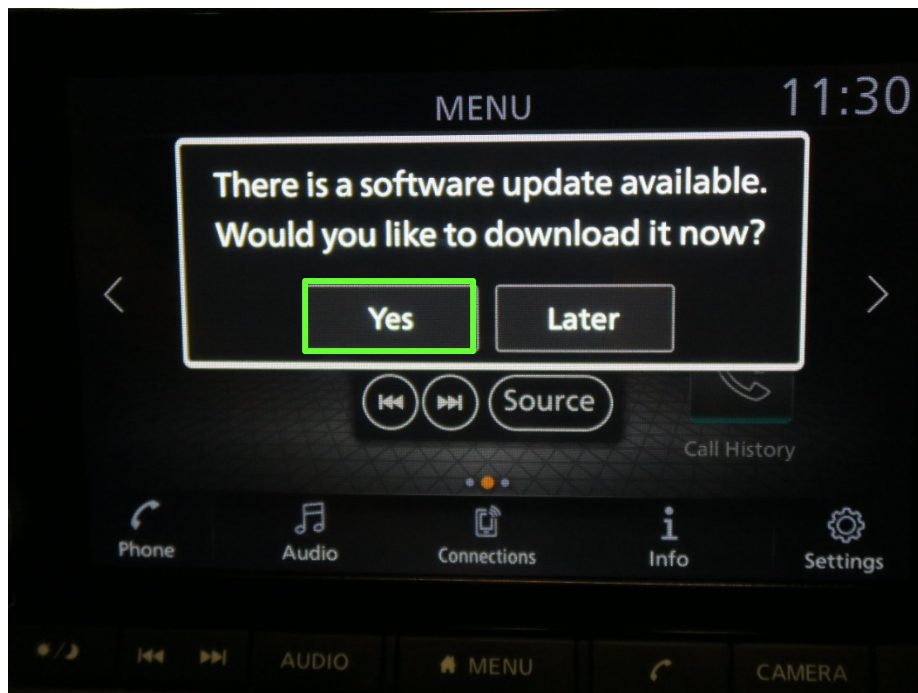
- If at any time during the following procedure the pop-up screen shown in Figure 1 **APPEARS**, then:
 - Select “Yes” and the Over-The-Air (OTA) download will complete using screen prompts.
 - **In this case, the UPDATE PROCEDURE is complete, no further action is required.**
 - Go to **CLAIMS INFORMATION** to submit a claim for the completion of the OTA download.
- If the Over-The-Air (OTA) pop-up screen in Figure 1 **DOES NOT APPEAR**, then :
 - **Continue to step 2 on page 3 to put the AV Control Unit into System Diagnostic Menu.**

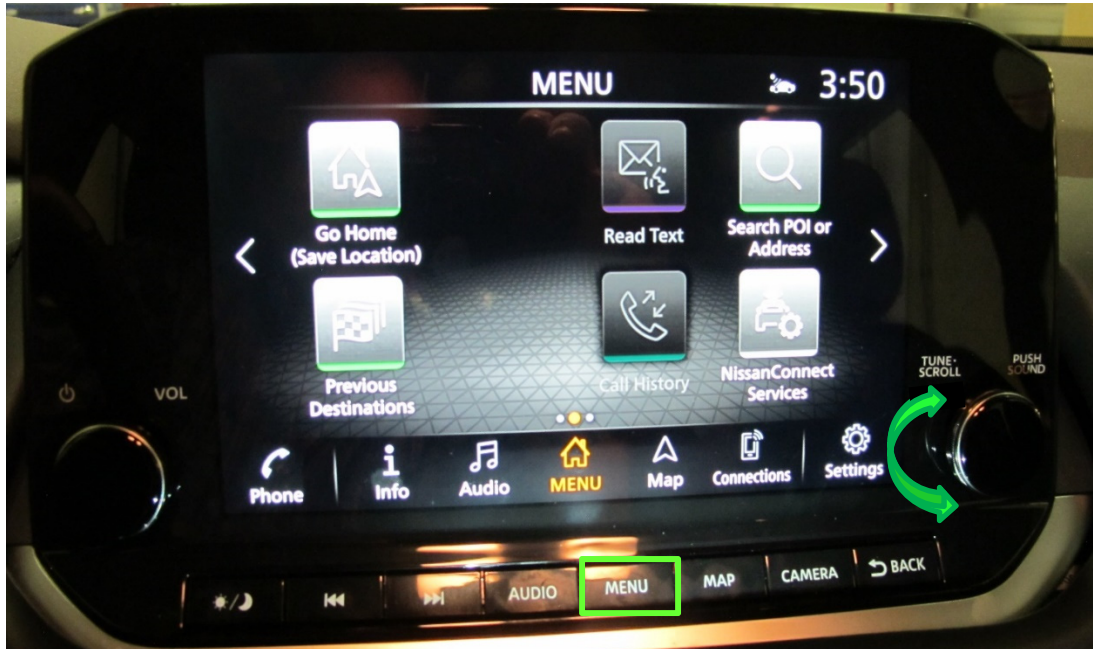
Figure 2

2. Put the AV Control Unit into System Diagnostic Menu.
 - Push the MENU button while turning the Tune/Scroll button at least three (3) clicks counter clockwise, then three (3) clicks clockwise, then three (3) clicks counter clockwise.

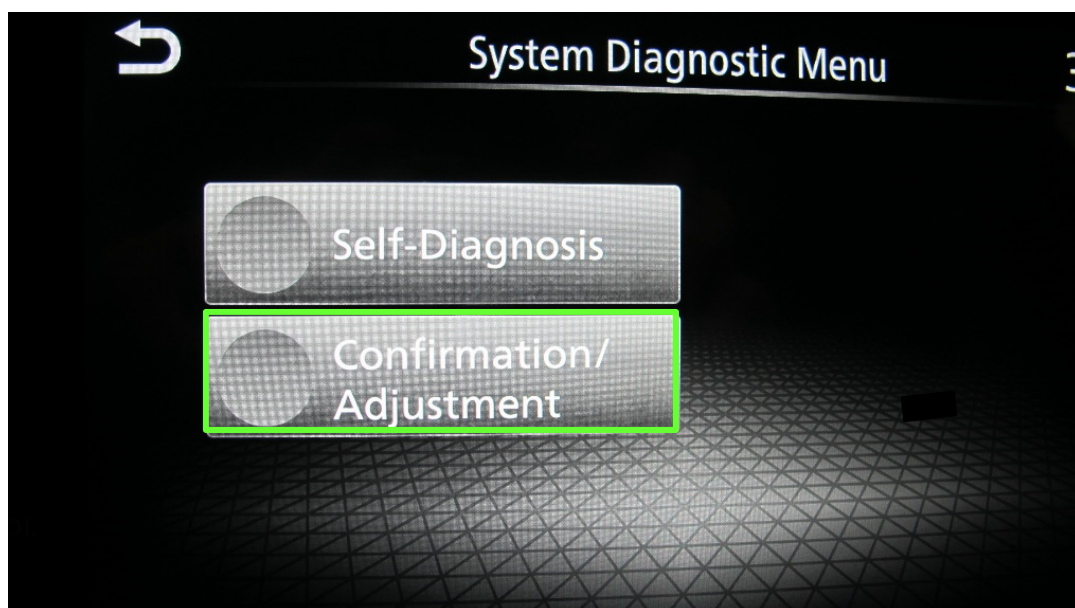
Figure 3

3. Select **Confirmation/Adjustment** on the **System Diagnostic Menu**.

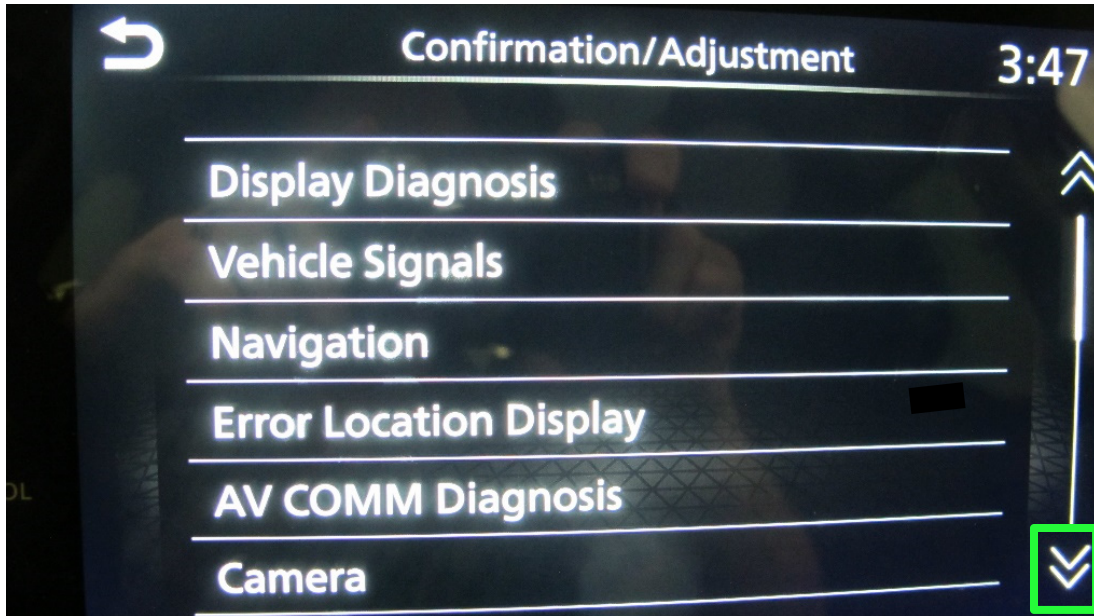
Figure 4

4. Select down arrow on the bottom right corner of the screen to move to the next screen.

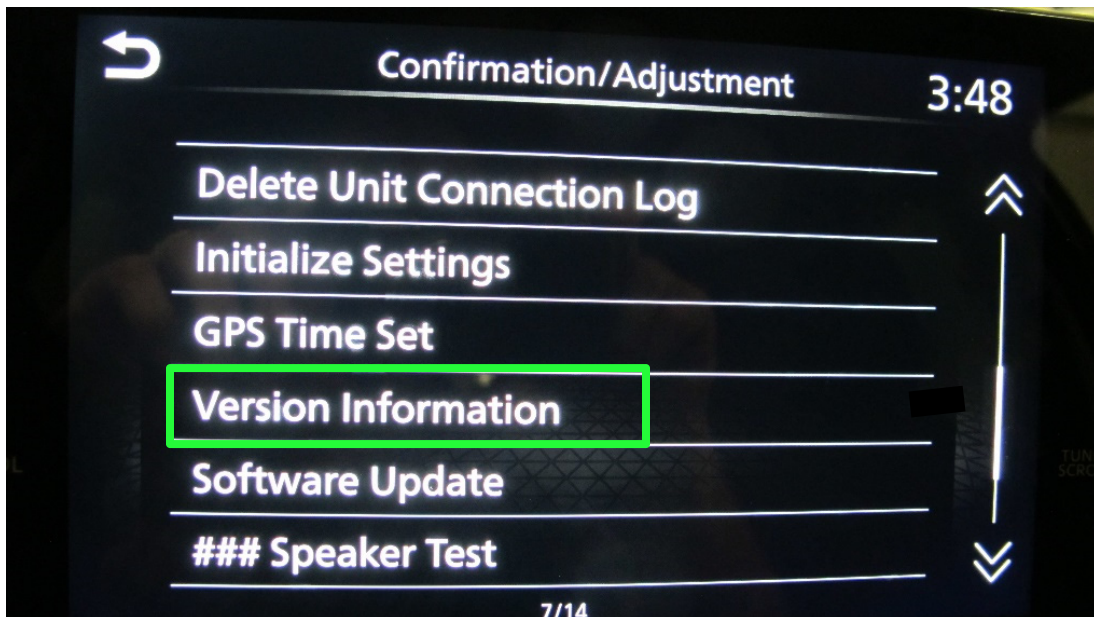
Figure 5

5. Select **Version Information**.

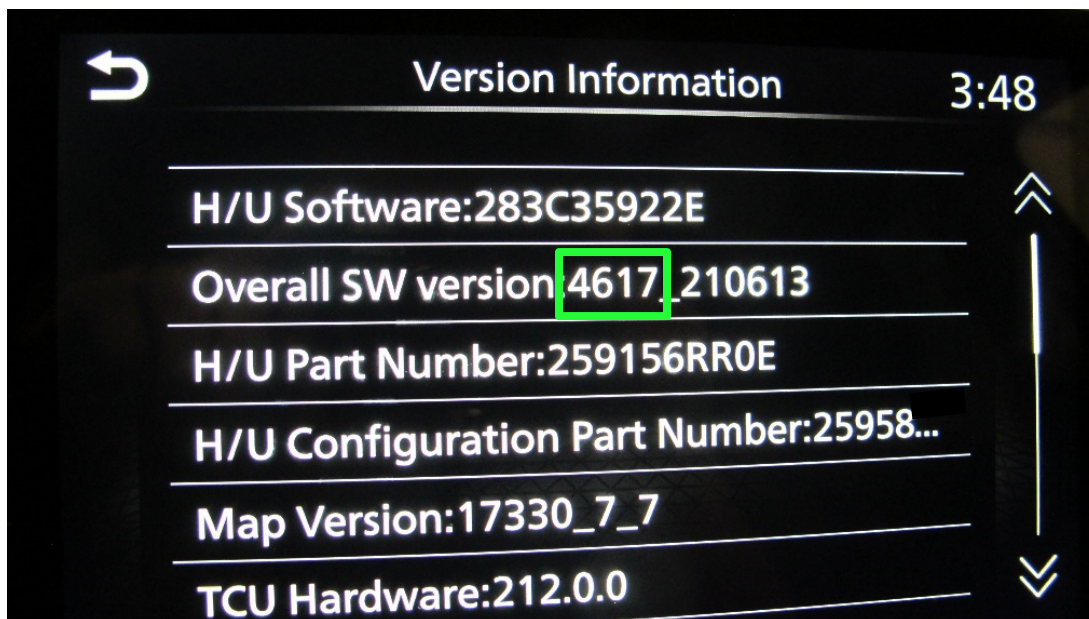
Figure 6

6. Write down the first four digits of **Overall SW version** on the Repair Order.

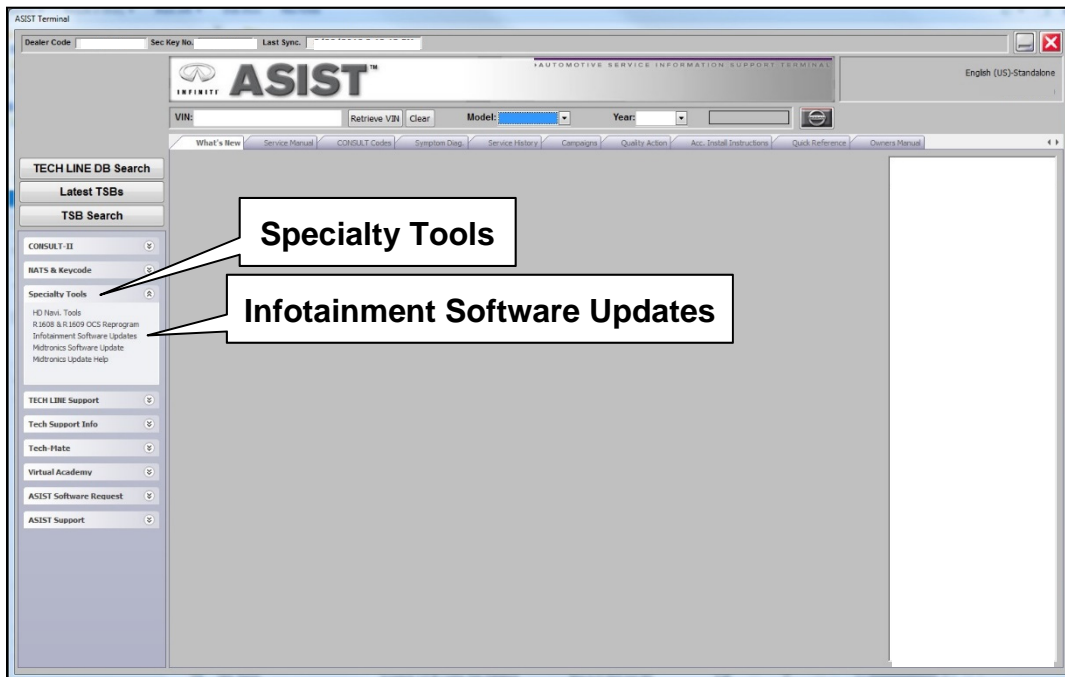
Figure 8

10. Select **Specialty Tools**, and then select **Infotainment Software Updates**.

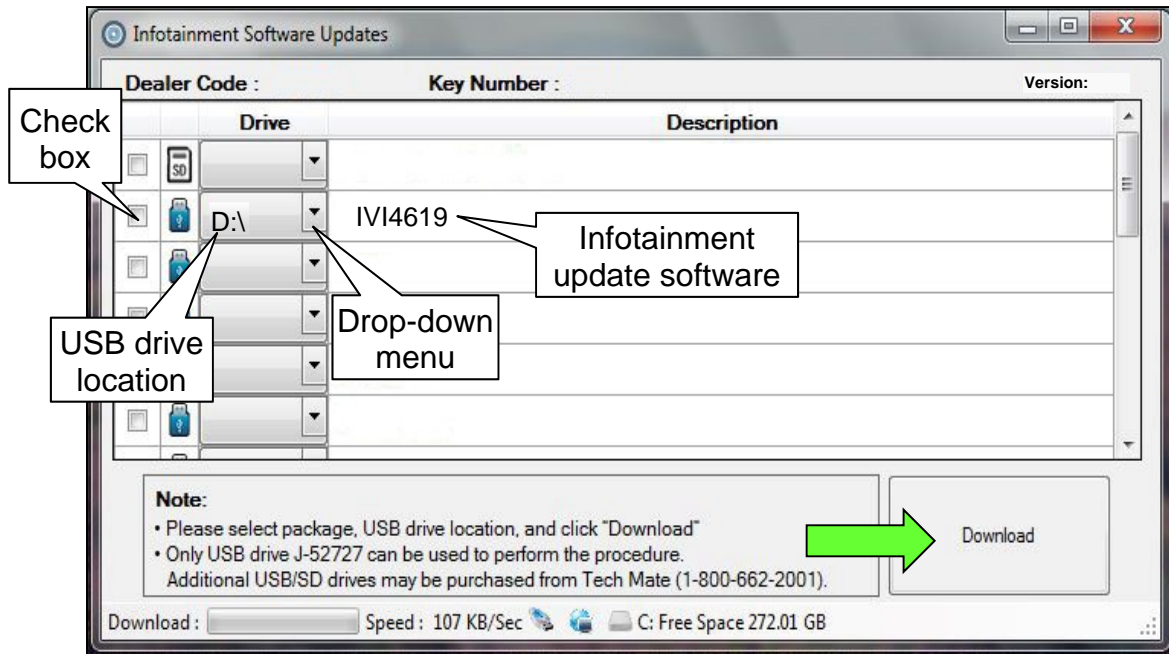
Figure 9

- Use the drop-down menu and select the location of the USB drive that was inserted in step 8 on page 7.

13. Select **Download** (Figure 9 on page 8), and then wait for the download to complete.

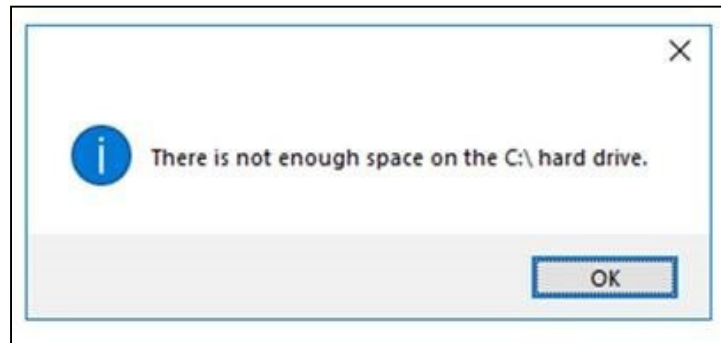
Figure 10

- The update software is estimated to take **4 hours** to download to the USB drive.
- If, while attempting to download the software to the CONSULT PC, you receive the message shown in Figure 10:
 - a. First attempt to clear space on the CONSULT PC hard drive.
 - b. If space cannot be cleared and a second CONSULT PC is available with space, use it and start over from step 8 on page 7.

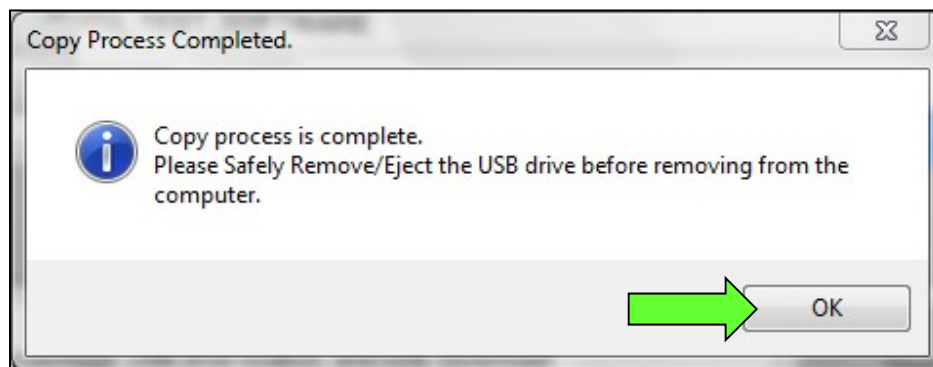
Figure 11

14. Select **OK**.

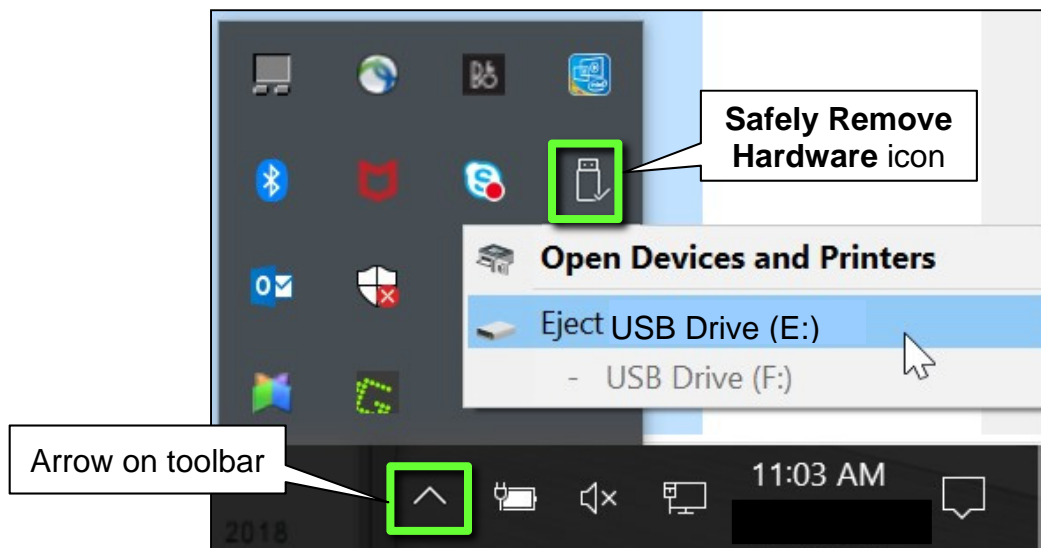
Figure 12

15. Once the transfer is complete, safely remove the USB drive from the CONSULT PC.
 - a. From the PC toolbar, select the **Safely Remove Hardware** icon.
 - o The icon is on the toolbar, or can be found after selecting the arrow.
 - b. Select the USB drive to be removed, and then remove the USB drive from the CONSULT PC.

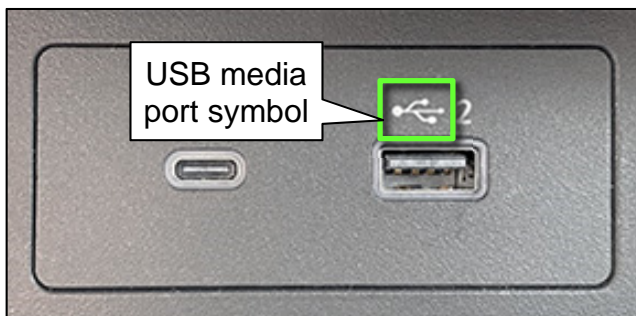
Figure 13

16. Close all ASIST **Infotainment Software Update** screens.
17. Set the parking brake.
18. Start the engine, and then wait 60 seconds for the system to load.
HINT: The engine needs to idle for the duration of the update to retain battery charge.
19. Insert the USB drive with the infotainment update software into the vehicle's USB media port (Figure 13).
 - Do not remove the USB drive during the update to the vehicle until instructed to.

HINT: Charging ports are marked in the vehicle with a “lightning bolt” symbol.

Do not insert the USB drive into a charging port. If used, the update software and/or USB drive may become damaged. Only insert the USB drive in a USB media port.

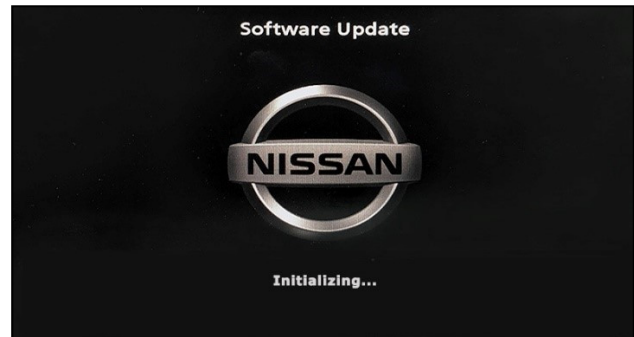
20. Wait approximately 10-30 seconds for the screen in Figure 15 to appear.

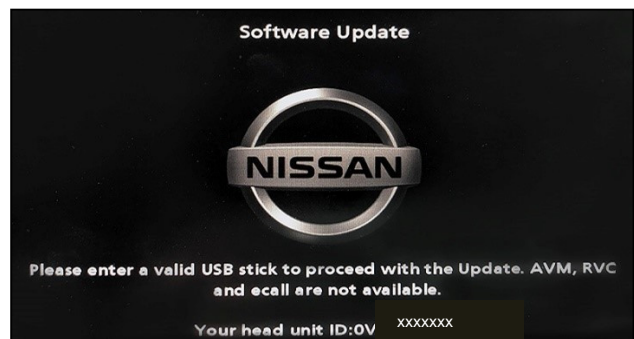
- The screen in Figure 16 may briefly appear. **Do not remove the USB drive.** The audio system will detect the USB drive and continue the update.

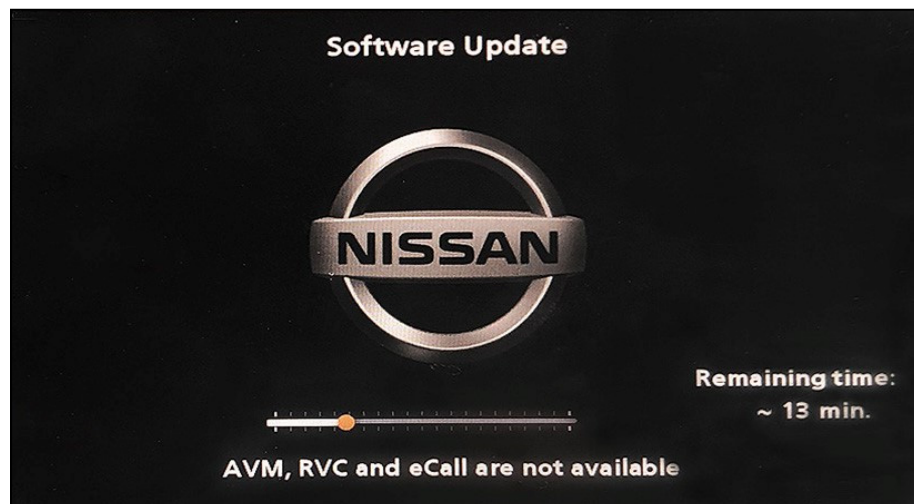
Figure 17

21. Wait for the update to complete.
 - Follow the on-screen instructions while waiting.
HINT: The update may take 15-25 minutes.

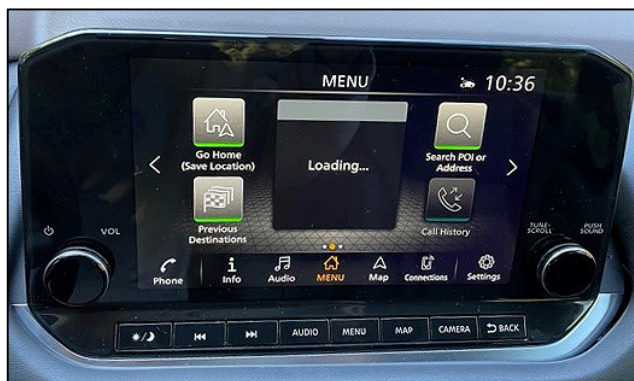
30. After the Nissan logo appears, wait about 1 minute.
 - The MENU (Home) screen in Figure 20 will be displayed.
