SERVICE BULLETIN

| REFERENCE: | Nova Bus Manuals | | |
|---|---|--|--|
| RS Nº: | MQR 7621-919 | | |

| SUBJECT: | Engine compartment ventilation |
| JUSTIFICATION: | Engine compartment may have high temperature issues due to inadequate heat dissipation. |

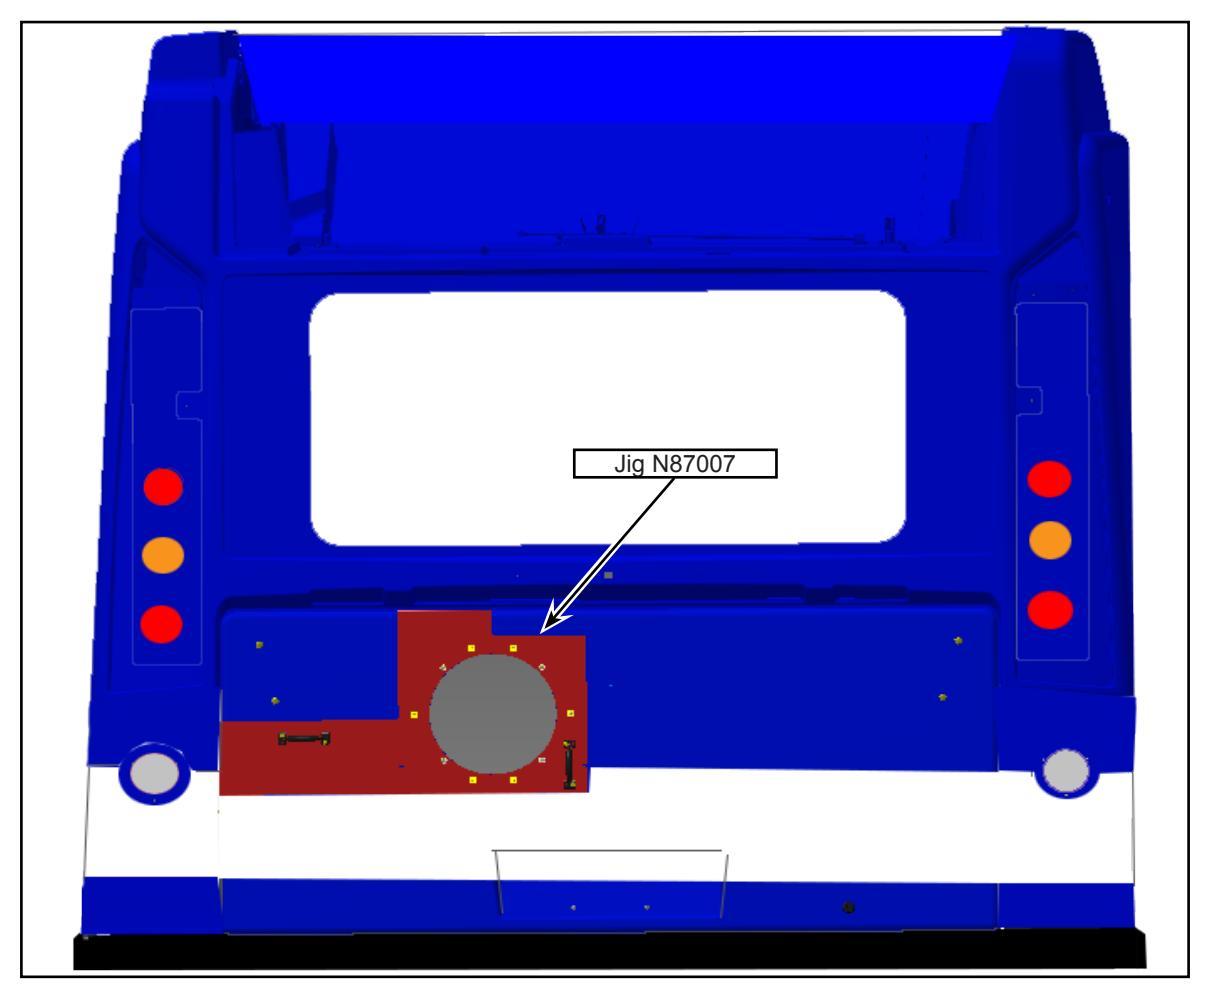
Figure 1 - Install the Jig on the Engine Compartment Access Door

- 1.1. Turn off power switch in battery compartment. Disconnect the negative battery cable.
- 1.2. Install a protection blanket in the engine compartment to collect debris.
- 1.3. Position jig N87007 on the engine door. Use the openings in the jig to line up with decal position. Adjust and reposition the jig as needed. See Figure 1.
- 1.4. Use the jig to mark the circle and drill the four 5/16 in. (7.94 mm) diameter holes and the six 3/16 in. (4.76 mm) diameter holes.
- 1.5. Drill a hole inside the marked area and cut the circular opening. The use of a jig saw is recommended.
- 1.6. Remove sharp edges with sandpaper or a file. Clean both sides.

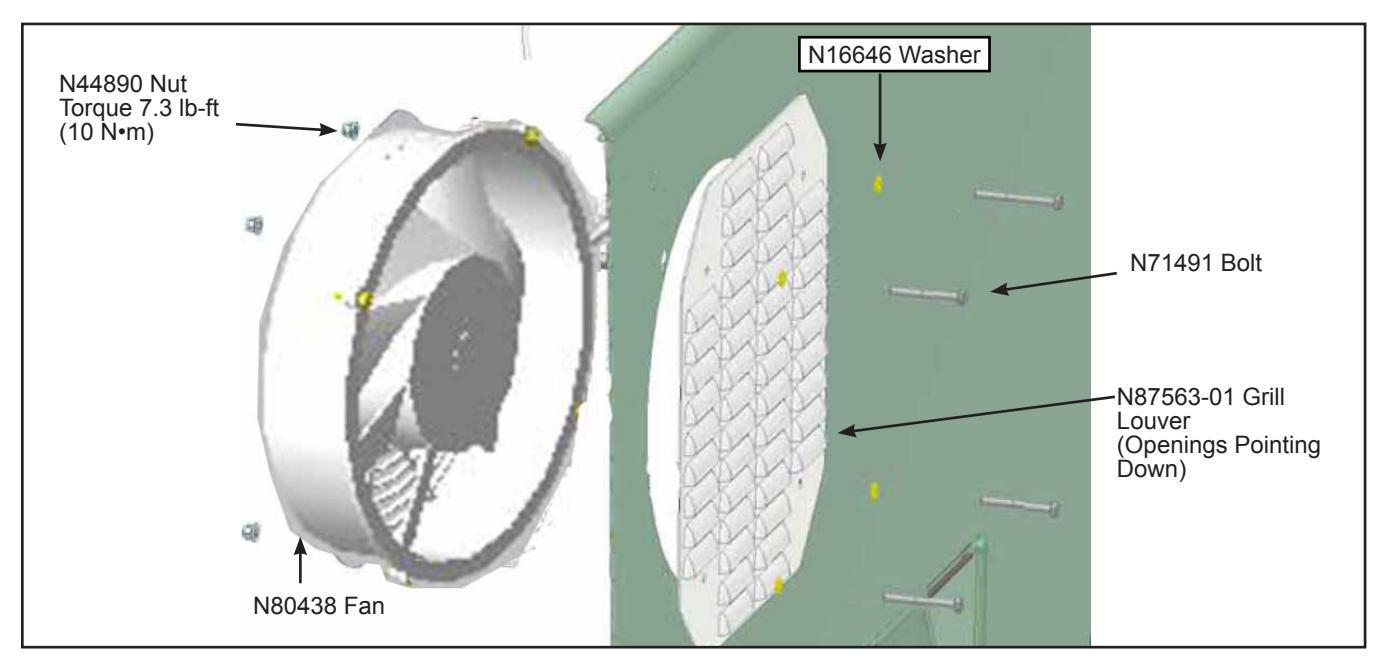
Figure 2 - Install Grill Louver and Electric Fan

- 1.7. Install temporarily grill louver N87563-01 onto the engine door. The openings must be pointing down on the outside.
- 1.8. Wash and degrease all surfaces prior to installing decal N90904-02 on the grill and aligning it with the decals on the vehicle.
- 1.9. Remove the grill and apply a clear coat after installation. Allow time to dry.
- 1.10. Install grill louver N87563-01 onto the engine door. Install the six rivets supplied.
- 1.11. Install electric fan N80438 on the inside with four N71491 bolts, N16646 washers and N44890 nuts. Install cable tie mount N57040 onto the upper curbside screw. See Figures 2 and 3.
- 1.12. Apply thread locker 9985283 or equivalent and torque the nuts to 7.3 lb-ft (10 N•m).

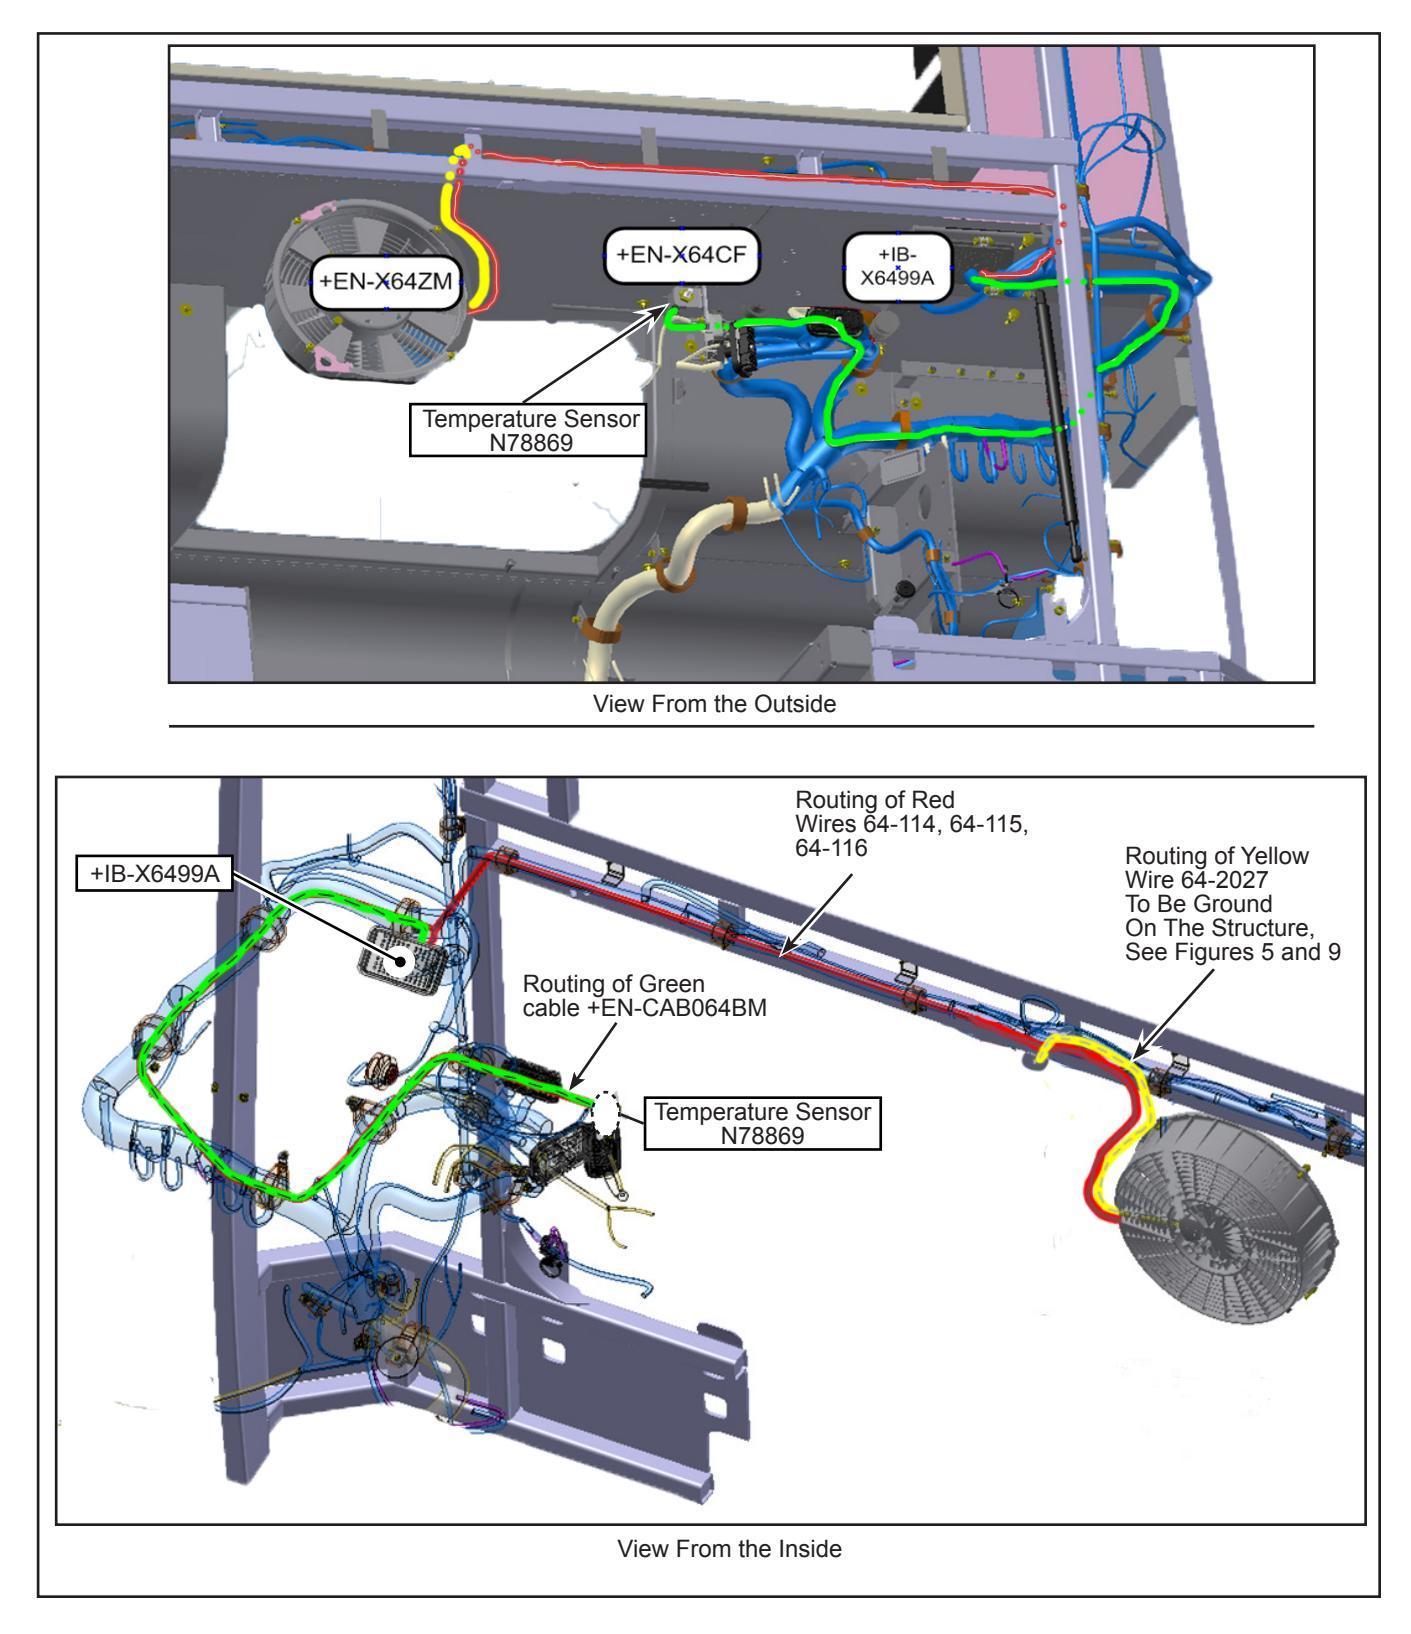
Figure 4 - Routing of New Harness N632000531

- 1.16. Route N632000531 harness by following existing license plate harness towards main engine harness 64 on the curbside and then up to the IB-X6499A connector. See Figure 4.
- 1.17. Secure harness N632000531 to the main harness with N56339 cable ties until temperature sensor location is reached.

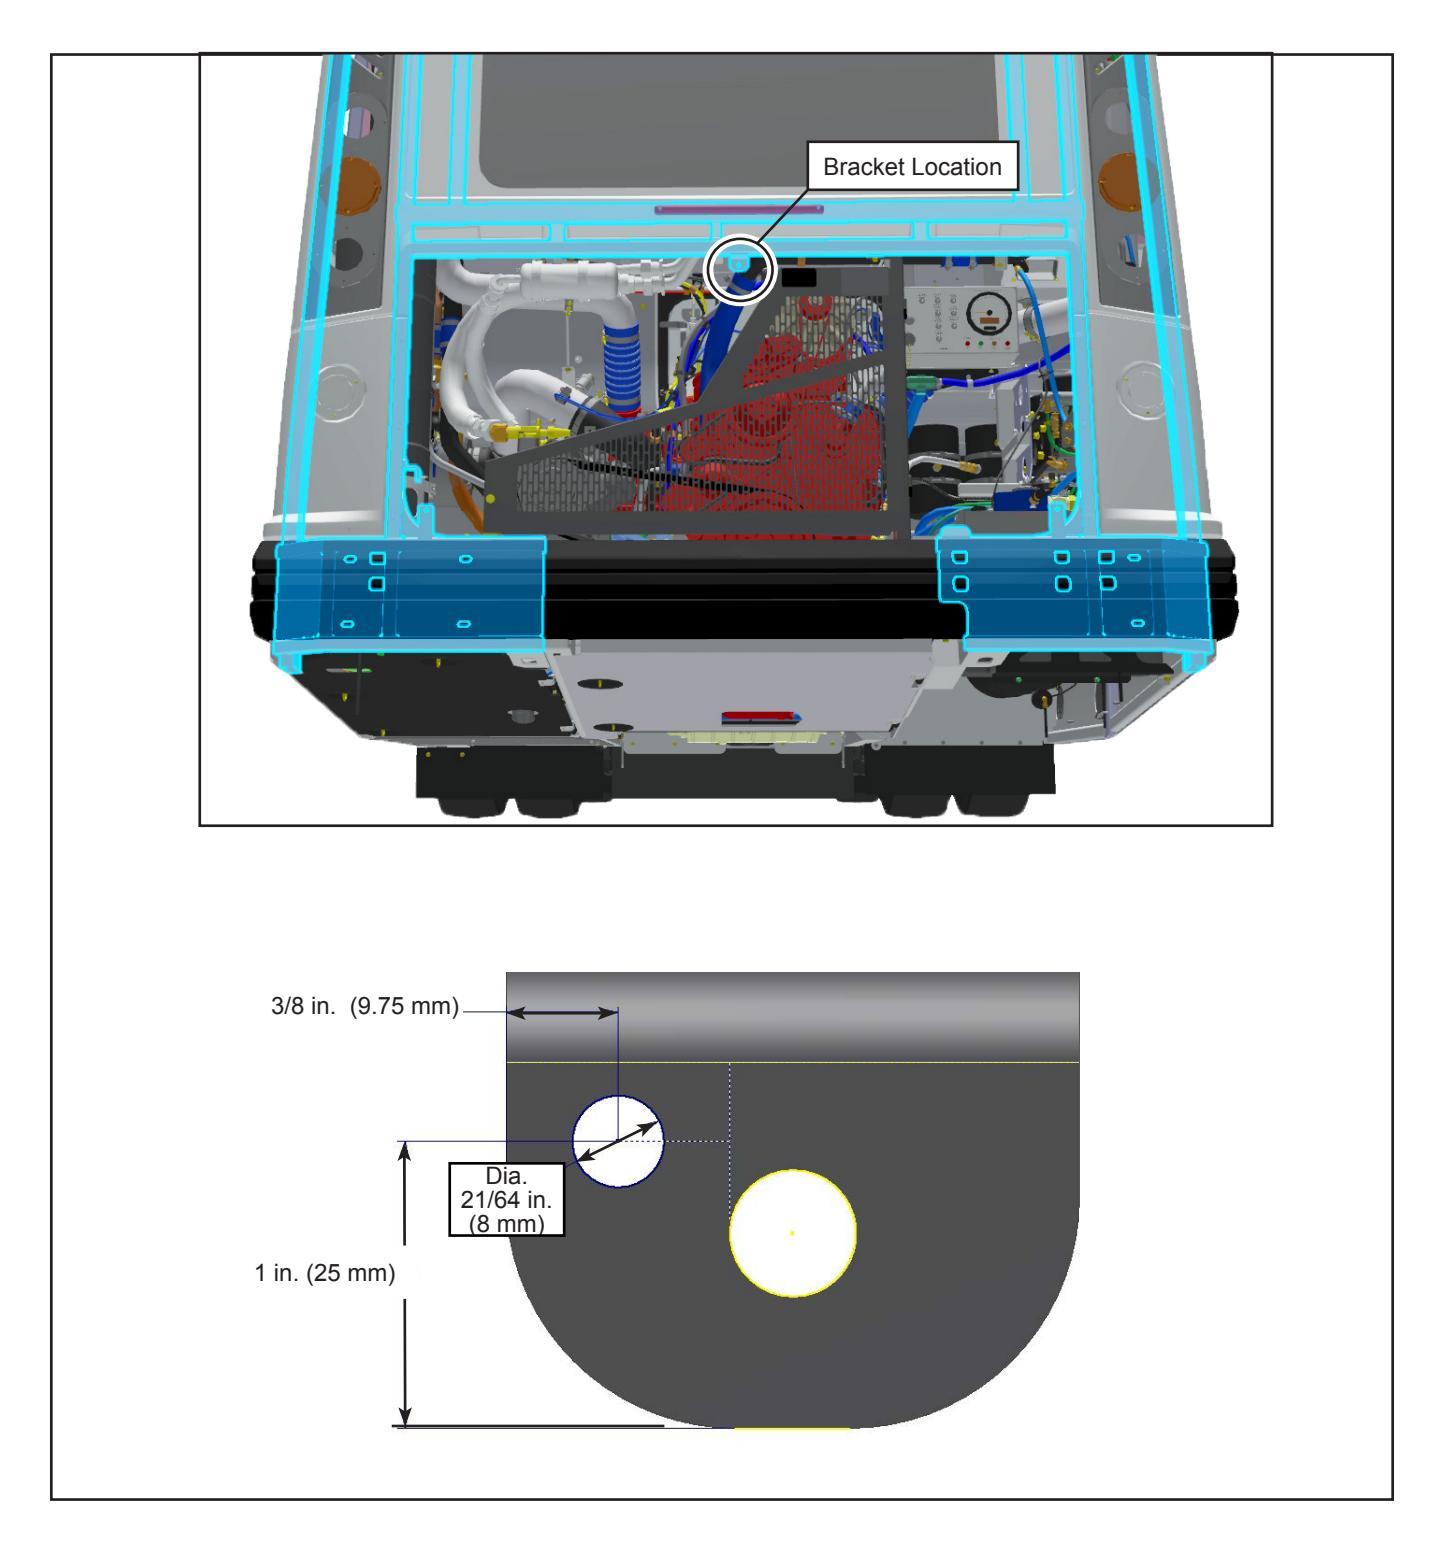
Figure 5 - Drill 21/64 in. (8 mm) hole for Ground

- 1.13. Drill 21/64 in. (8 mm) hole in the bracket of the structure for ground installation.
- 1.14. Remove the paint and clean the surface for proper ground contact. See Figures 5 and 9.

- NOVABUS
- 1.23. Connect wire 64-2027 (10 BK) to the vehicle structure. Make sure there is no paint between the ground and the structure. See Figures 5 and 9. Apply N35450 Maxi-Coat corrosion inhibitoror or equivalent to protect electric connection.

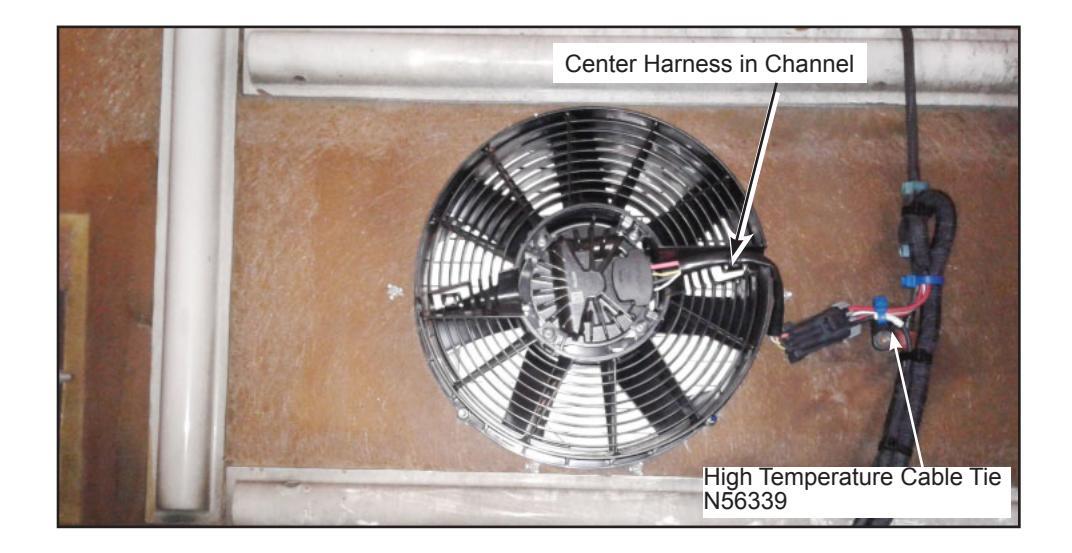
Figure 6 - Connect Harness to the Fan

an N56339 high temperature cable tie to the N57040 cable tie mount. Ensure that the harness is centered

1.15. Connect the electric fan connector to the N632000531 harness connector and attach the fan connector with

in the built-in fan channel and secure with cable tie N56339. See Figure 6.

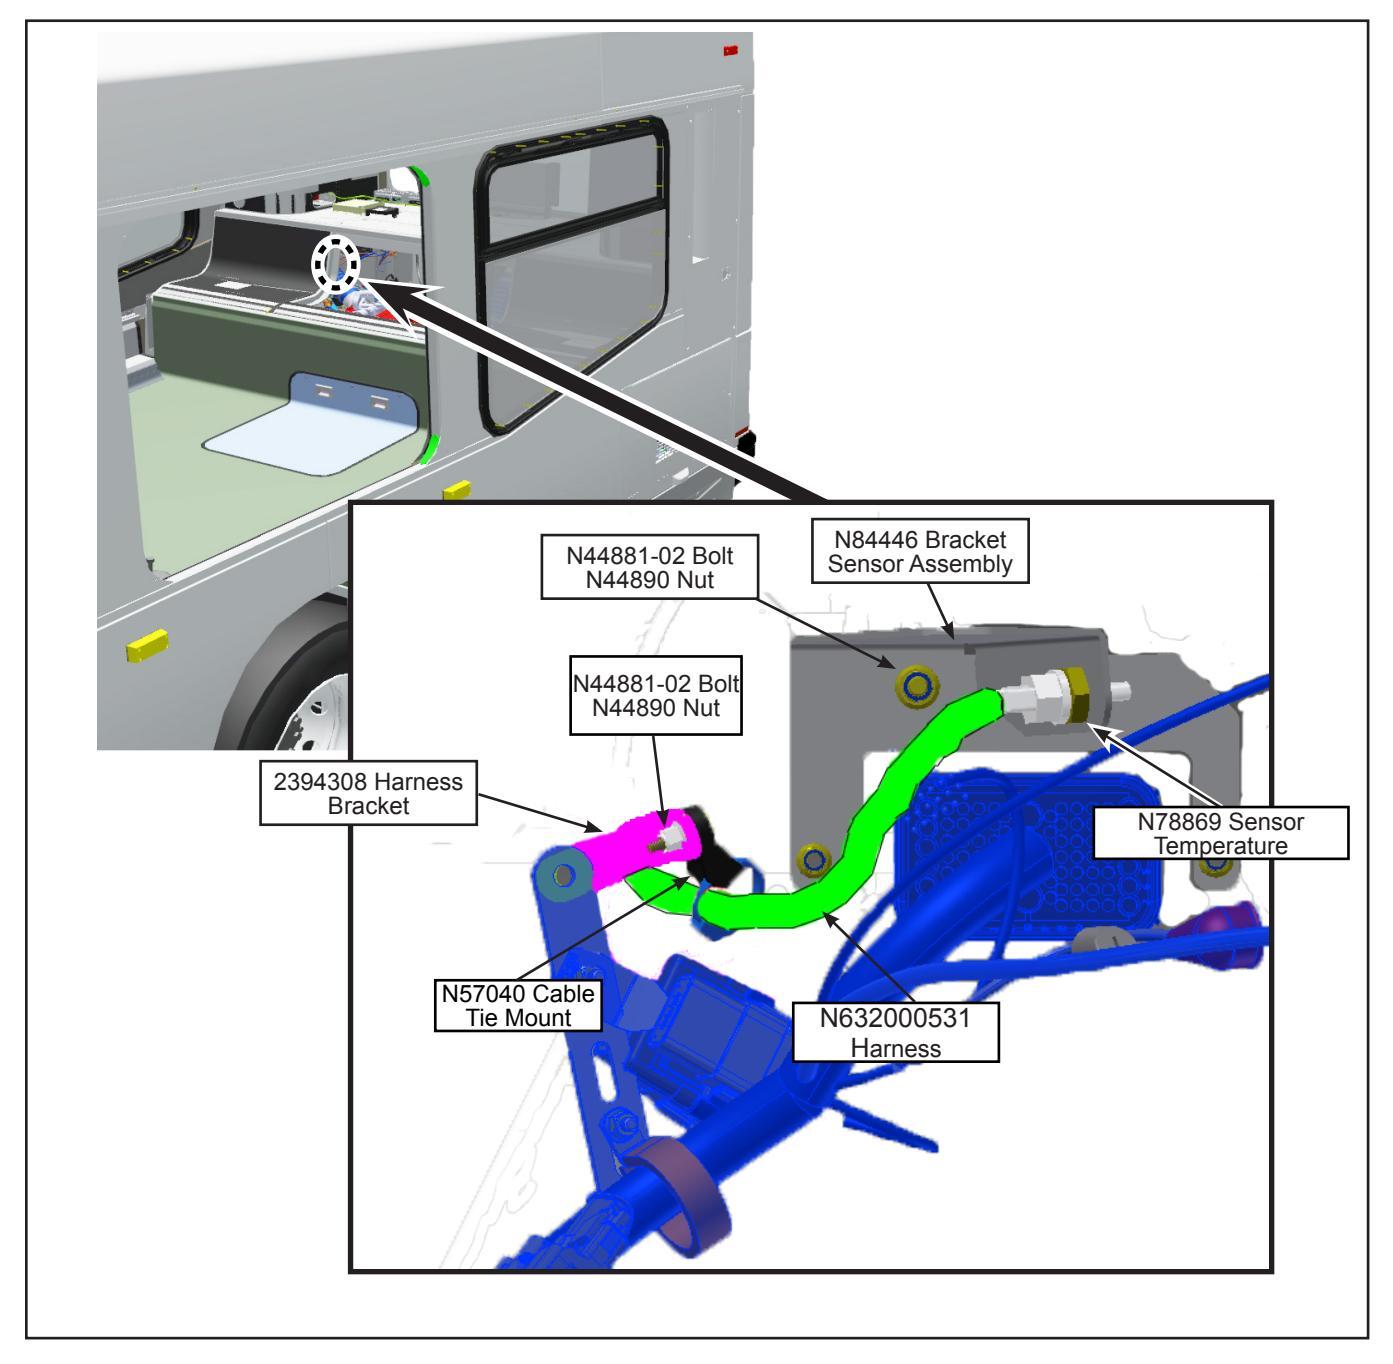
Figure 7 - Install and Connect Temperature Sensor

- 1.18. Install the N57040 cable tie mount onto the 2394308 harness bracket with an N44881-02 bolt and N44890 nut. See Figure 7.
- 1.19. Use the rear seat hatch to access the engine compartment. Install the 2394308 harness bracket with existing hardware. See Figure 7.
- 1.20. Install bracket sensor assembly N84446 over the +MT-X9564A connector bracket.

1.21. Connect the heat sensor to the harness as indicated in the electrical wiring diagram. See Figure 8. Install the sensor. See Figure 7.

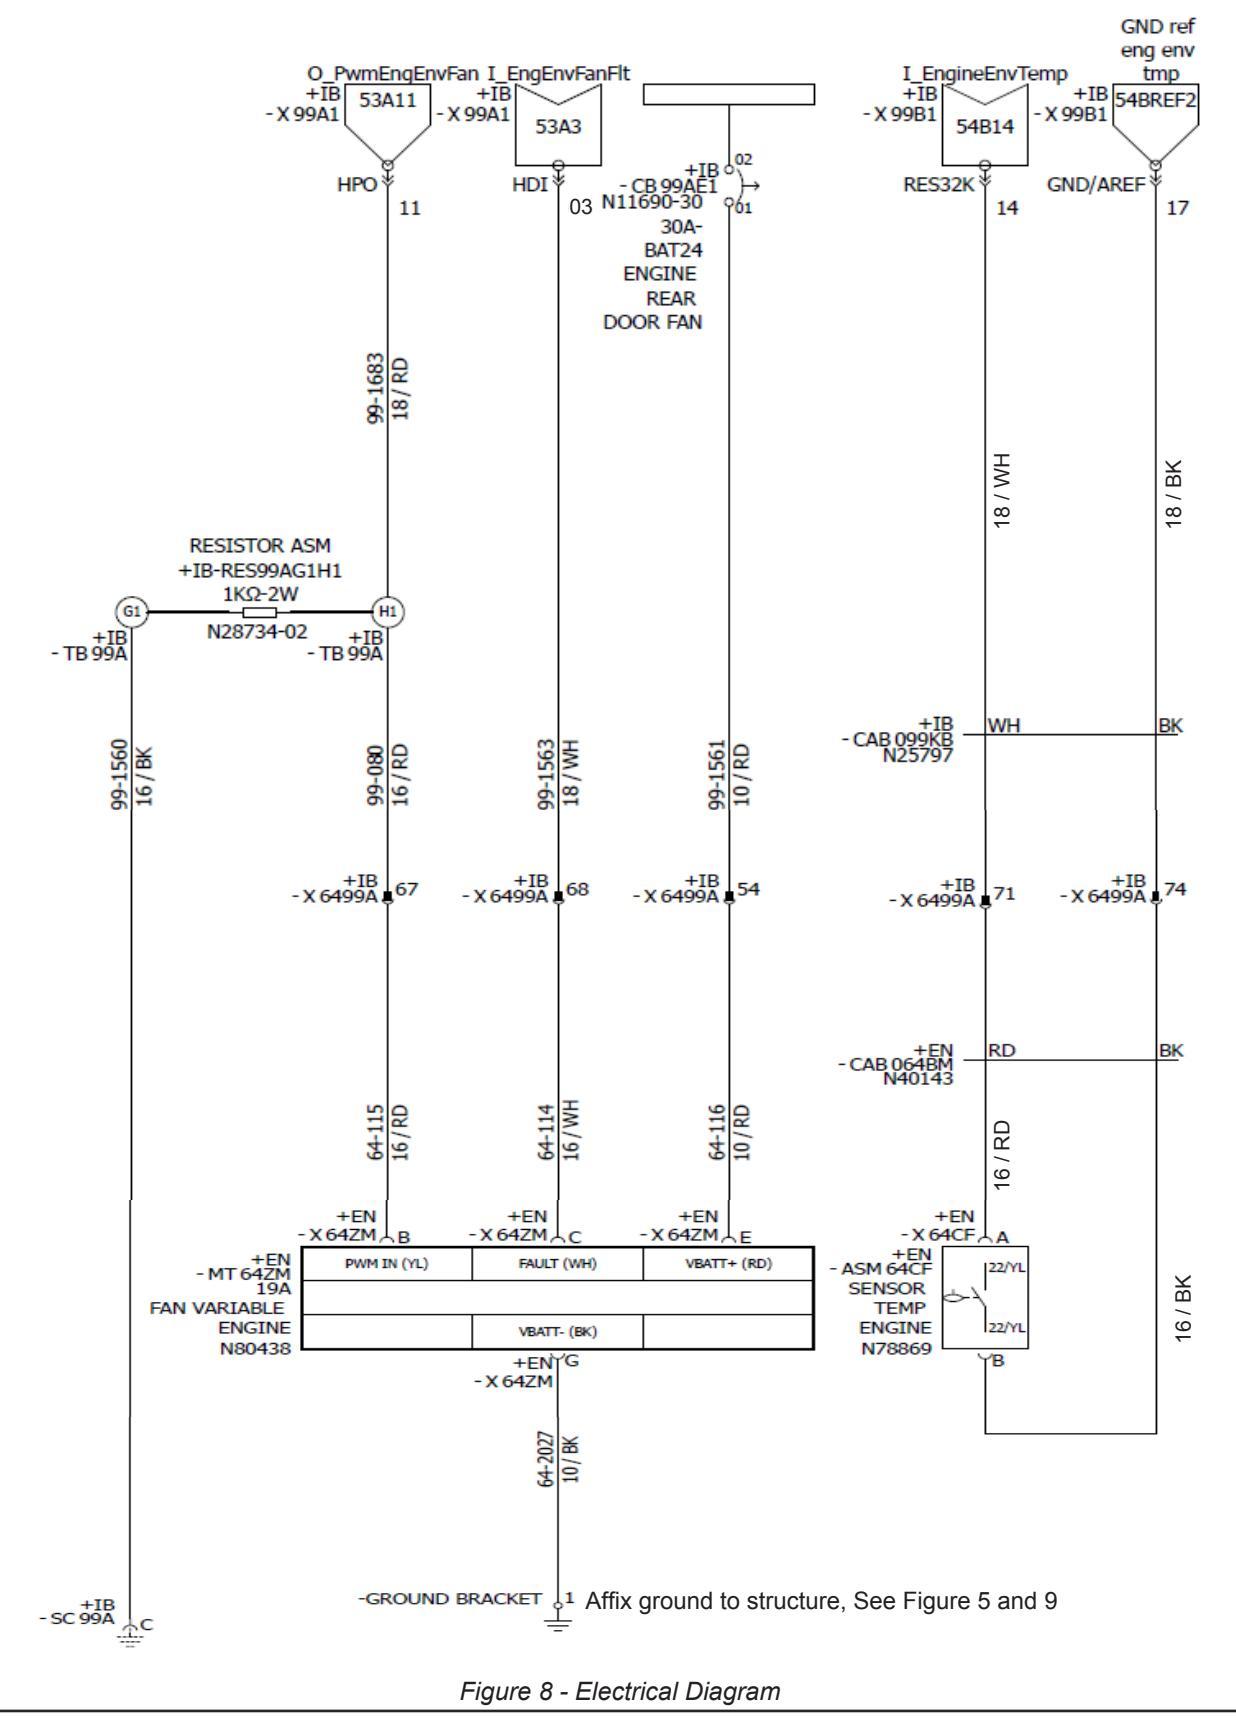
1.22. Install harness as shown in the electrical wiring diagram. See Figure 8.

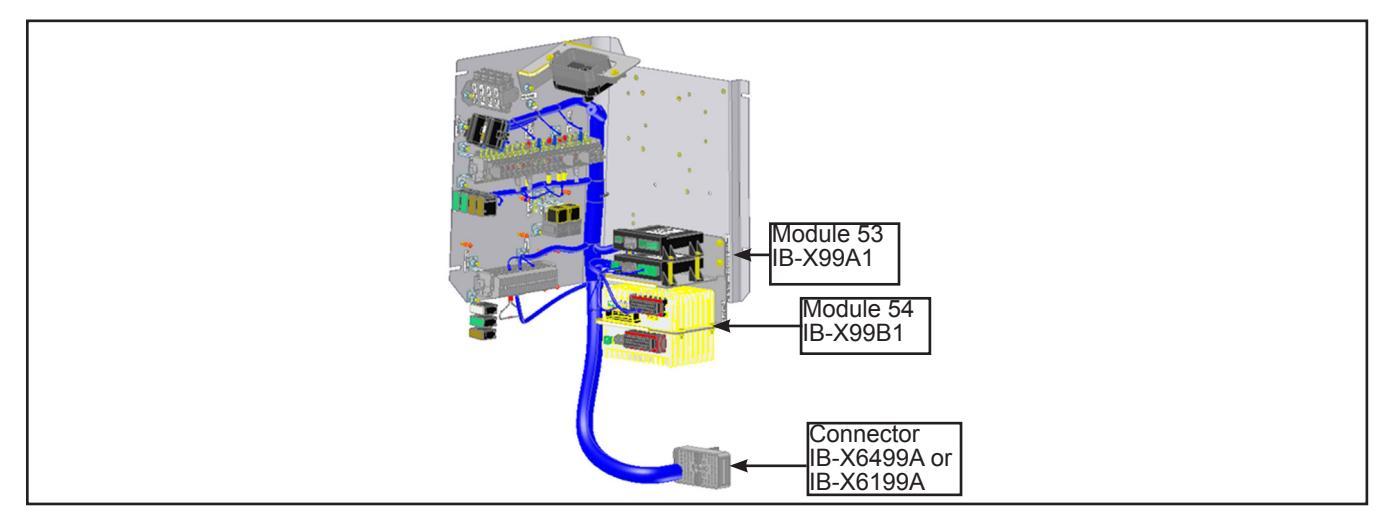
Figure 10 - IB Compartment

Connector IB-X6499A. Pinning wires. See Figure 10.

- 1.29. Connect wire 99-080 (16 RD) to connector +IB-X6499A at position 67.
- 1.30. Connect wire 99-1563 (18 WH) to connector +IB-X6499A at position 68.
- 1.31. Connect wire 99-1561 (10 RD) to connector +IB-X6499A at position 54.
- 1.32. Connect wire CAB099KB (18 BK) to connector +IB-X6499A at position 74.
- 1.33. Connect wire CAB099KB (18 WH) to connector +IB-X6499A at position 71.

1.34. Connect wire 99-1683 (18 RD) to IOB module 53 connector +IB-X99A1 (HPO) at position 11.

1.35. Connect wire 99-1563 (18 WH) to IOA module 53 connector +IB-X99A1 (HDI) at position 01.

1.36. Connect wire CAB099KB (18 WH) to IOB module 54 connector +IB-X99B1 at position 14.

1.37. Connect wire CAB099KB (18 BK) to IOB module 54 connector +IB-X99B1 at position 17.

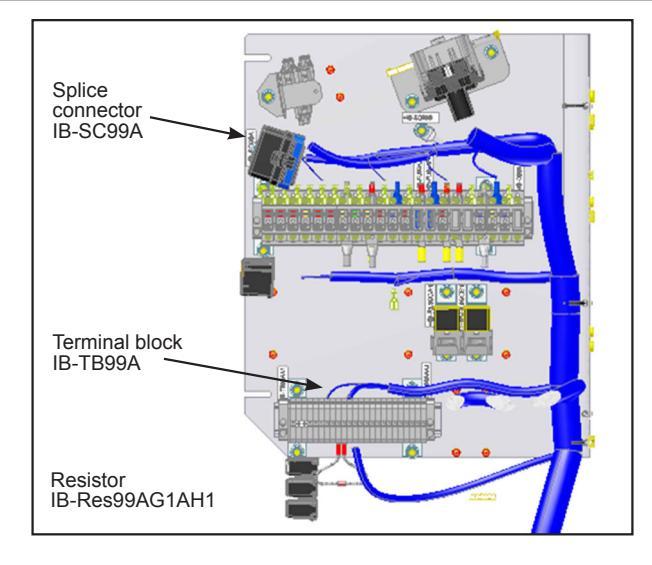
Figure 11 - IB Panel

- 1.38. Connect wire 99-1561 (10 RD) to +IB-CB99AE1.
- 1.39. Install the N11690-30 circuit breaker at location +IB-CB99AE.

- 1.40. Install the N28734-02 resistor across locations +IB-TB99A H1 and G1.
- 1.41. Connect wire 99-1683 (18 RD) to +IB-TB99A at position H1.
- 1.42. Connect wire 99-080 (16 RD) to +IB-TB99A at position H1.
- 1.43. Connect wire 99-1560 (16 BK) to +IB-TB99A at position G1.

1.44. Connect wire 99-1560 (16 BK) to splice connector +IB-SC99A at position C.

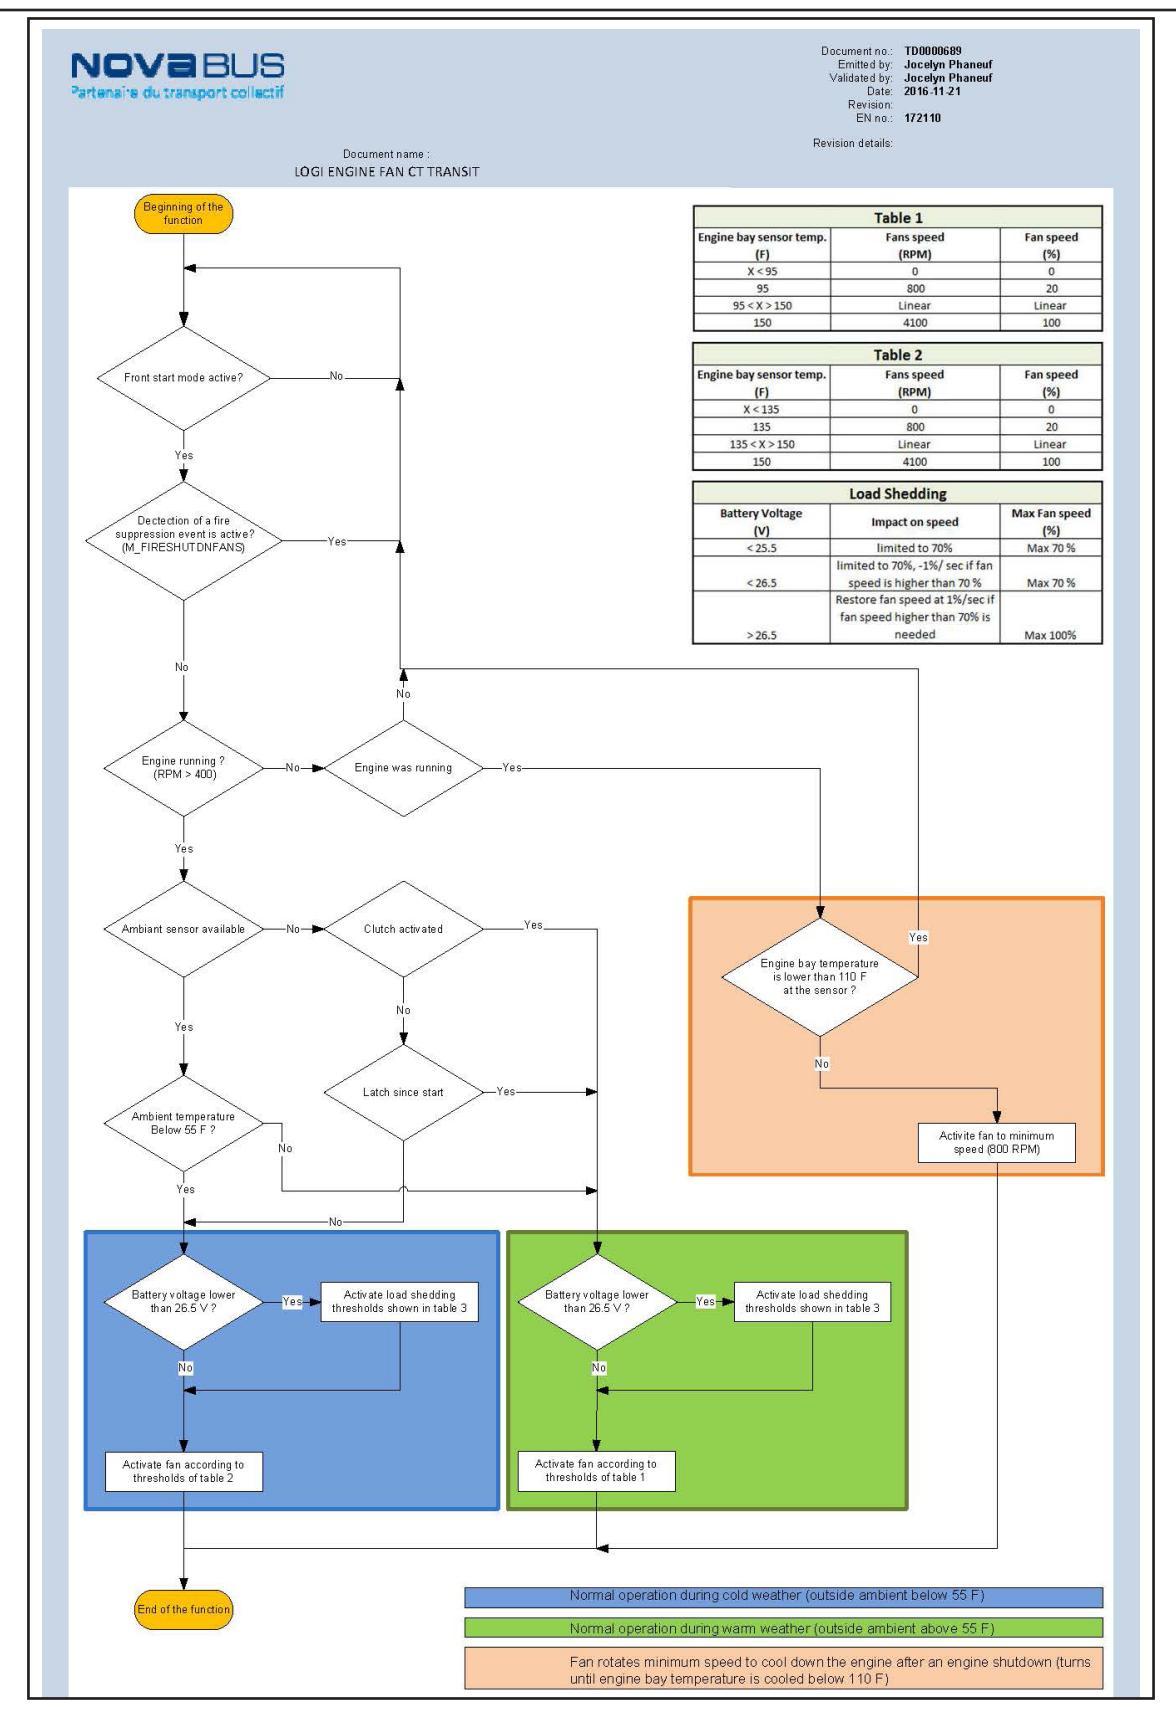
Figure 12 - Logic of Fan Operation

- 1.52. When engine compartment temperature is below 135 °F (57 °C), the fan does not operate.
- 1.53. When engine compartment temperature is 135 °F (57 °C), the fan operates at low speed (20%).
- 1.54. When engine compartment temperature is between 135 °F (57 °C) and 150 °F (65 °C), the speed of operation increases gradually.
- 1.55. When engine compartment temperature is 150 °F (65 °C) or above, the fan operates at maximum speed (100%).
- 1.56. Use cold air to lower the ambient sensor temperature below 55 °F (13 °C).
- 1.57. Use a heat gun on the engine compartment sensor to raise temperature from 135 °F (57 °C) to 150 °F (65 °C).

- 1.58. When engine compartment temperature is below 95 °F (35 °C), the fan does not operate.
- 1.59. When engine compartment temperature is 95 °F (35 °C), the fan operates at low speed (20%).
- 1.60. When engine compartment temperature is between 95 °F (35 °C) and 150 °F (65 °C), the speed of operation increases gradually.
- 1.61. When engine compartment temperature is 150 °F (65 °C) or above the fan oprates at maximum speed (100%).
- 1.62. Use a heat gun to raise temperature from 95 °F (35 °C) to 150 °F (65 °C).
- 1.63. Read % of fan speed on the multiplex at two temperatures. At a temperature of 95 °F (35 °C), the fan operates at low speed (20%). At 150 °F (65 °C), the fan operates at maximum speed (100%).

- 1.64. When engine compartment temperature is above 110 °F (43 °C), the fan operates at low speed (20%).
- 1.65. When engine compartment temperature is below 110 °F (43 °C), the fan does not operate.
- 1.66. Read % of fan speed on the multiplex at two temperatures.
