Bulletin No.: Pl0281E

# Service Bulletin

**Subject: Underbody Component Corrosion**

Models: 2017 and Prior GM Passenger Cars and Light Duty Trucks

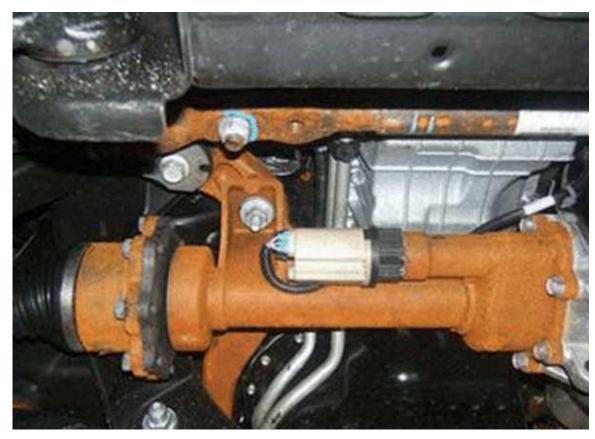
Front axle housing

No repair or consideration should be given for this condition. Surface corrosion on unprotected components will vary with age and exposure. Corrosion on these components has no detrimental impacts, either in short or long term durability.

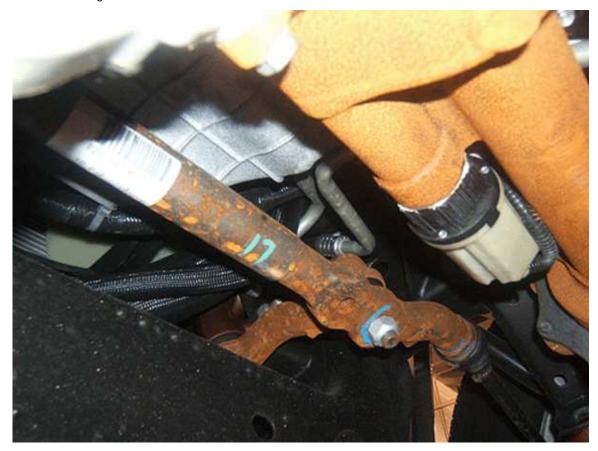
Steering linkage

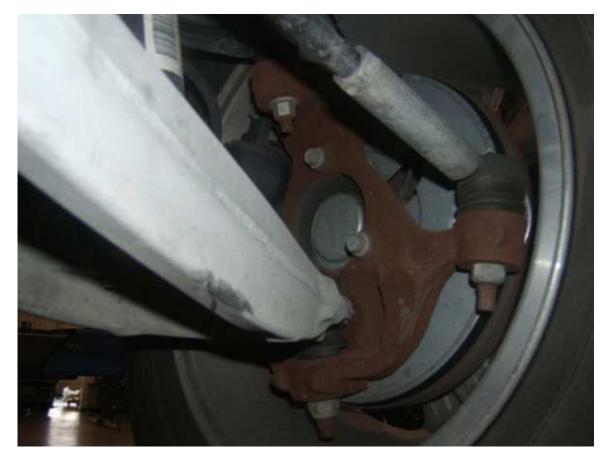
Steering knuckle

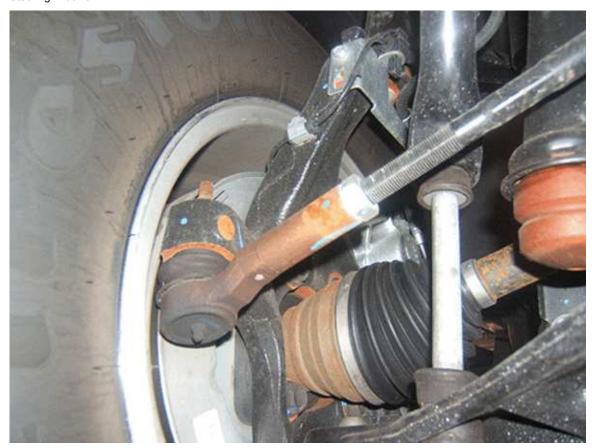
Tie rod end

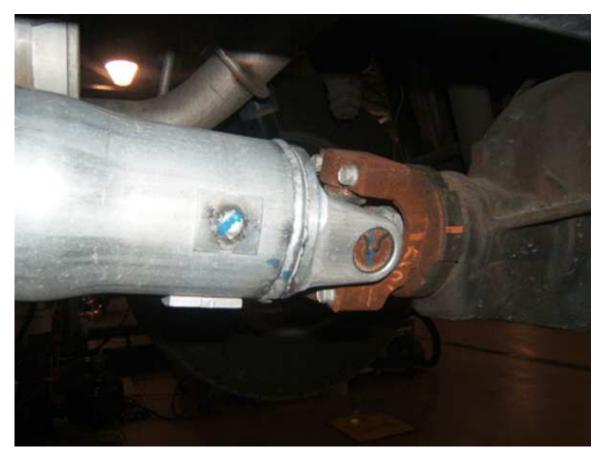
Propshaft yoke

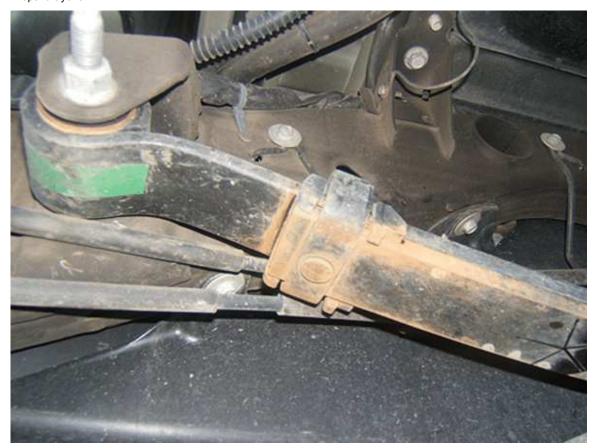
Leaf spring

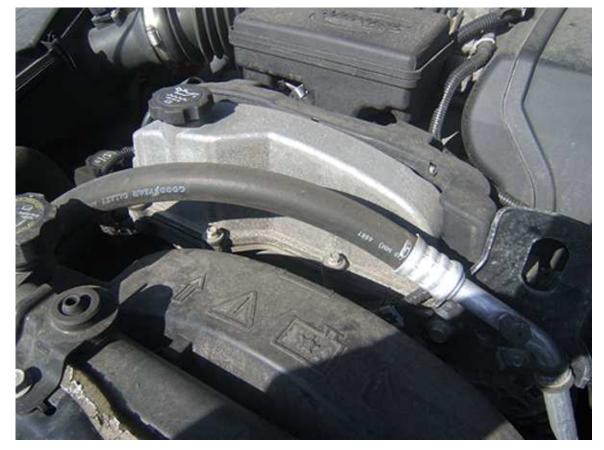
Under hood components

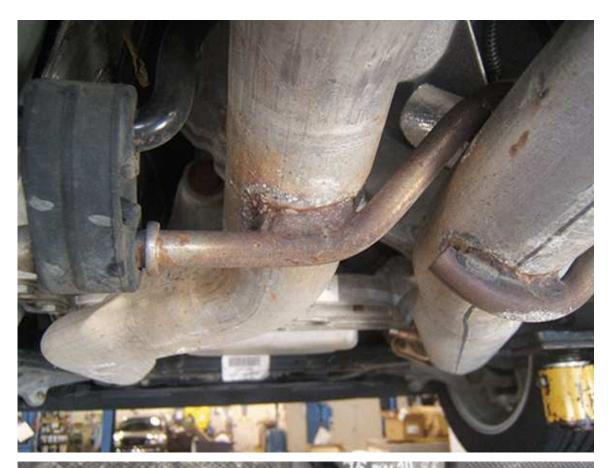
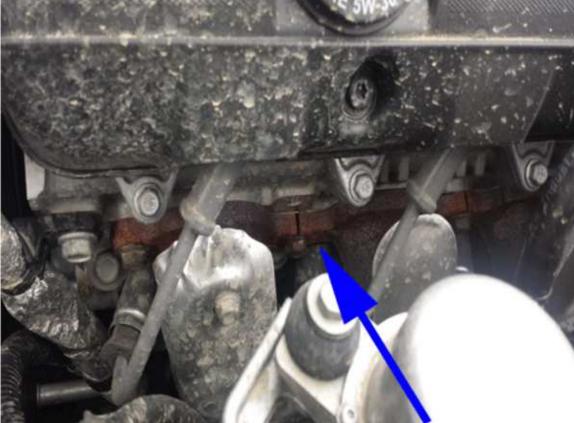
Exhaust system components

**Note:** During transit between the plant and the dealer, some of the exhaust system components may corrode as a result of salt exposure. These exhaust parts are made of a bare mild-grade stainless steel that will oxidize, or appear rusty. Over time, these components will have a uniform rust-like discoloration, which should be considered a normal condition.
