V-Stay Rod Cover, Replacement CHU, CXU, GU, TD, LEU, MRU, LR

PI0862, V-Stay Rod Cover, Replacement

Some MACK CHU, CXU, GU, TD, LEU, MRU, and LR trucks built from 03/19/2012 to 08/30/2015 and equipped with mRide suspensions may inadvertently lose the v-stay rod cover (part number 21896762) from the v-stay rod. The replacement v-stay rod cover will be installed and secured with a tack weld in two places (180 degrees apart). To secure a v-stay rod cap that is still in position, two tack welds (180 degrees apart) will be applied. Follow the repair procedure outlined in this Product Improvement (PI).

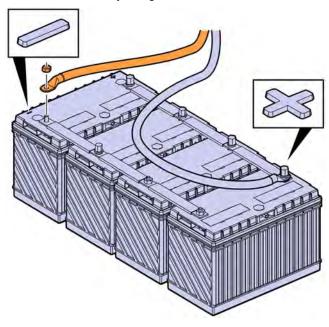
W3086747

5 Disconnect the cable from the battery's negative terminal.

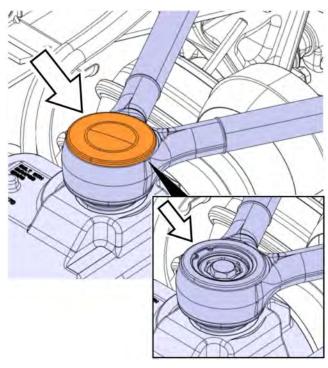
W6106241

- 1 Thoroughly clean and remove any grease from the v-stay rod pivot joint.
- 2 Inspect the v-stay pivot joint to ensure the v-stay rod cap is still in position and has not inadvertently fallen off the v-stay rod.

Note: If the v-stay rod cap is still in position, proceed to **(V-Stay Rod Cover, Tack Weld Existing Cover Only, Per Axle)** section, and tack weld the v-stay rod cap in 2 places (180 degrees apart).

Note: If the v-stay rod cap is missing, proceed to **(V-Stay Rod Cover, Replacement, Per Axle)** section, install and tack weld a new v-stay rod cap in 2 places (180 degrees apart).

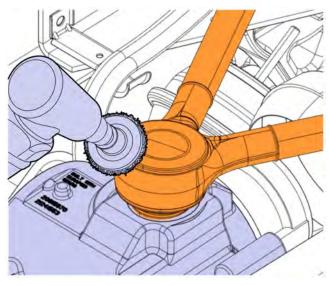
W6106244

1 Prep the v-stay rod cover and v-stay rod for tack welding by removing any paint from the weld mating areas.

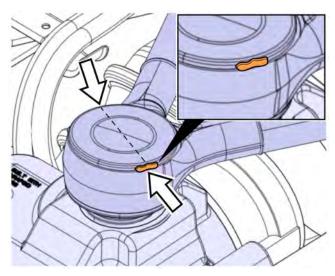
W6106245

2 Using safe welding practices, tack weld the v-stay rod cover in two places (180° apart). After the tack welds are complete, remove any welding slag.

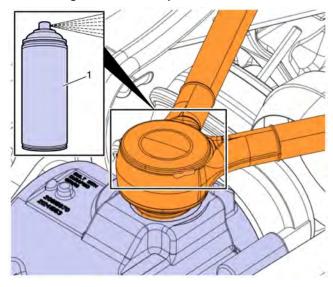
W6106246

- 3 Using suitable methods, prep and paint (1) the tack welds to prevent any rusting of the v-stay rod cover and v-stay rod.
- 4 Proceed to Commissioning the Truck for Operation.

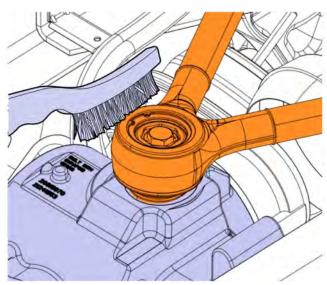
W6106242

1 Clean the mating surfaces of the V-Stay rod pivot joint, cover area, and ensure the center apex joint is clean and free of debris.

Note: After cleaning, inspect the apex joint for any excessive damage or play. If excessive wear is discovered in the v-stay rod apex joint, a pivot joint overhaul may be required.

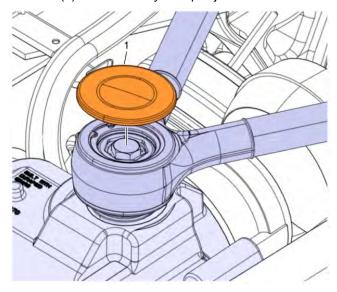
W6106240

- 2 Brush a liberal amount of lithium grease (XHP 222) onto all internal parts of the v-stay rod apex joint.
- 3 Position v-stay rod cover (1) onto the v-stay rod apex joint.

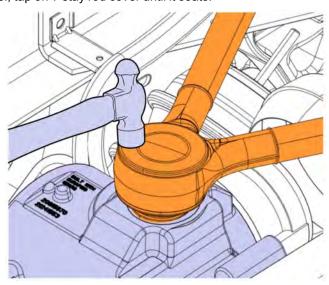
W6106243

4 Using a hammer, tap on v-stay rod cover until it seats.

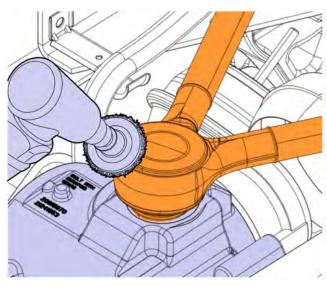
W6106244

6 Using safe welding practices, tack weld the v-stay rod cover in two places (180° apart). After the tack welds are complete, remove any welding slag.

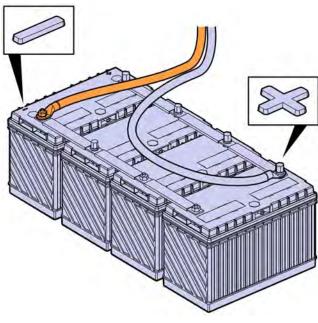
W3086758

1 Connect the cable to the battery's negative terminal.
