Campaign Number	Revision Level	Date	Group Number
C1516	A	14-OCT-2014	
Expiration Date (U.S. and Canada)		Expiration Date (International)	
01-JUN-2015		01-JUN-2015	
Engine Family	Fuel System	Plant	Build Date
			From To
ISX11.9	CM2250

ISX12 FDNY Air Compressor Campaign

This Campaign is being issued to address air compressors on ISX12 CM2250 and CM2350. The Campaign authorizes the replacement of air compressors if the compressor date code or the crankshaft date code is on or before 22/12.

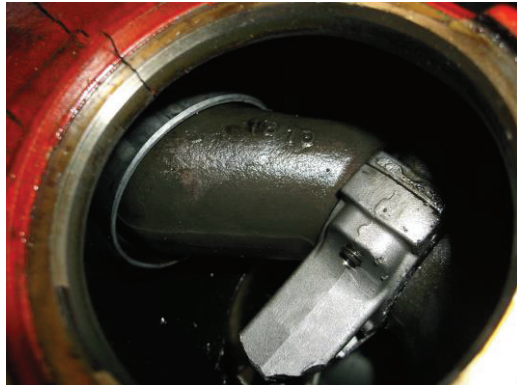
- 2) Rotate crankshaft so that the date code on the crankshaft is visible.

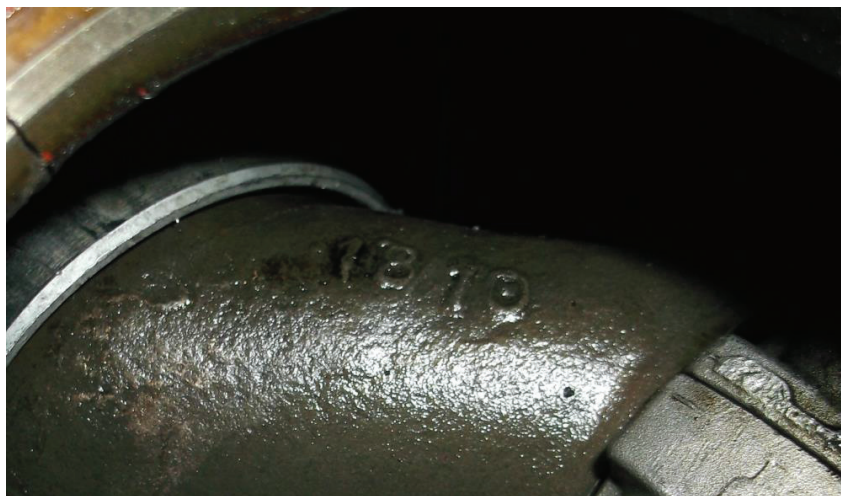
- 3) With a flashlight, review 4 digit casting on crankshaft. IF those digits are "22/12" or earlier, then compressor must be replaced. Otherwise, continue to next step. (Ex: The picture below has a crankshaft date code of "18/10" therefore, it would need replaced.)

- 4) IF those digits are "23/12" or later, then compressor is OKAY, and not subject to replacement. Procure Cummins Sump Plug Kit #4089675, and

follow the instructions (Attachment D) to clean, seal, and install a replacement cup plug. Write the crankshaft date code on the sump plug.

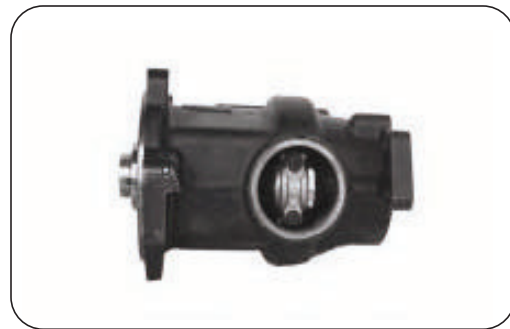
1. Inspect the sump plug bore for nicks and burrs, and wipe clean.

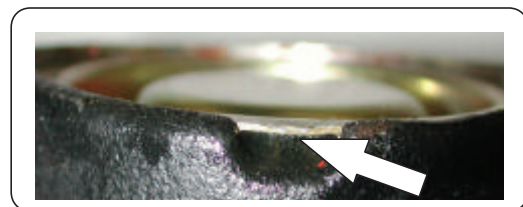
3. Press the plug in the crankcase until the flange of the plug seats to the crankcase shoulder.
