# Special Service Message

## SSM 72352 - L550 Headliner Modification for Fan Harness

**Models :** LC - Discovery Sport

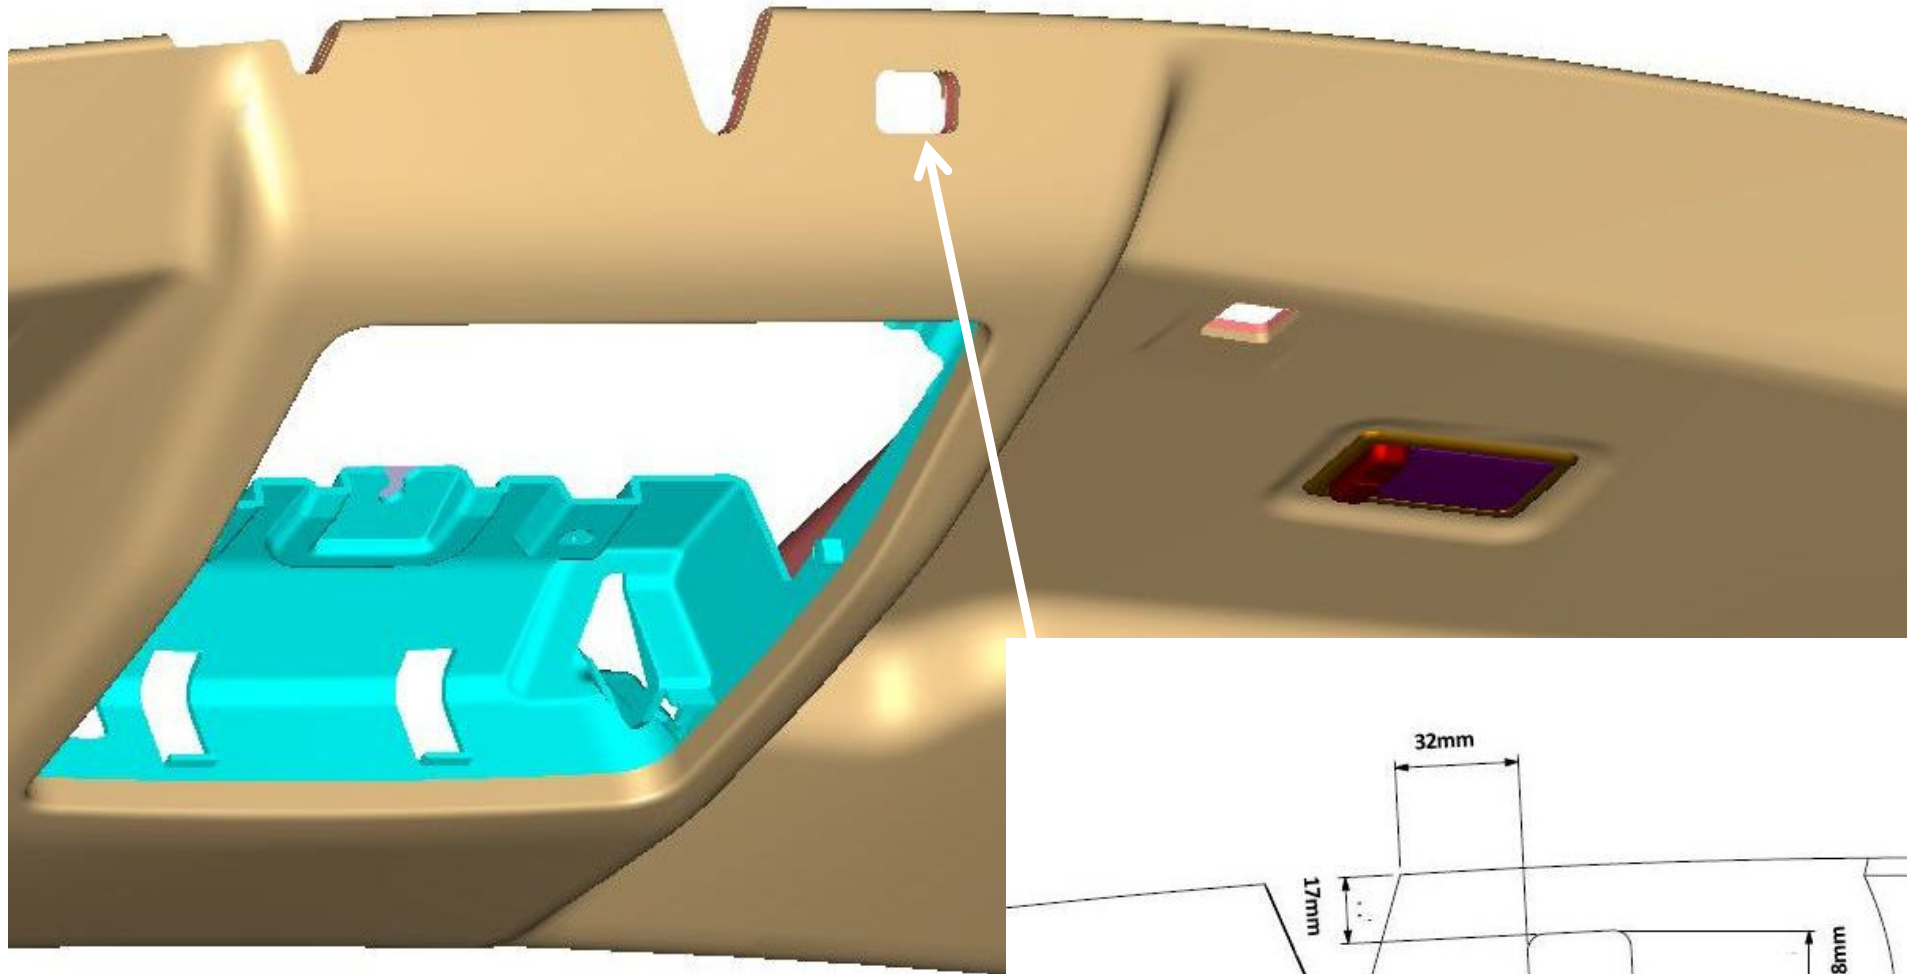
**Fig 1**

A number of L550 Discovery Sport headlining's have been supplied that may require modification to allow the fitment of the fan harness, by cutting out a square hole in the headlining.

A modification to the part specification after release.

A small square section of the headlining will need to be cut out with a suitable tool (eg. knife) to allow the fan harness to pass through.

- Please see attachment Figure 1, for details and dimensions of the modification required.
- Note: the area will be covered by the body of the rear view mirror when complete - Please see attachment fig 2.
