01816 Version 2

Timing Belt Chirps

Supersedes 14-025, dated December 18, 2014, to revise the information highlighted in **yellow**

Year	Model	Trim	VIN Range
2014–15	MDX	ALL	ALL
2014–15	RLX	ALL	ALL
2015	TLX	V6 only	ALL

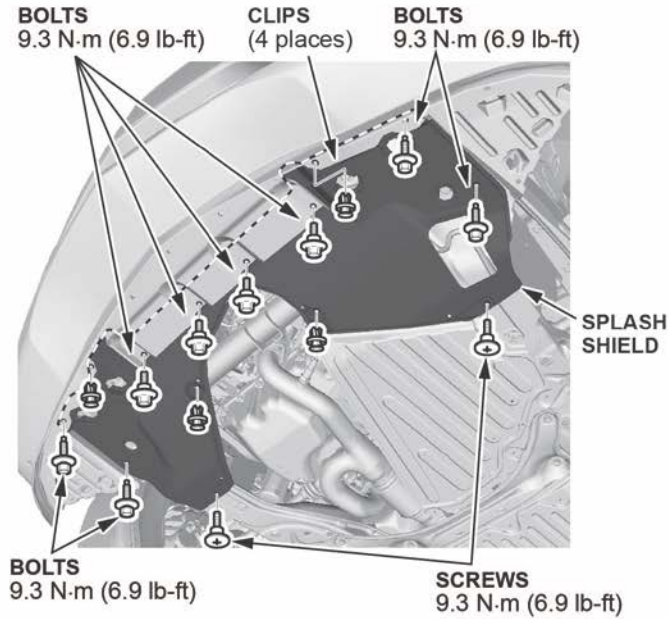
MDX:

- Remove the engine undercover.

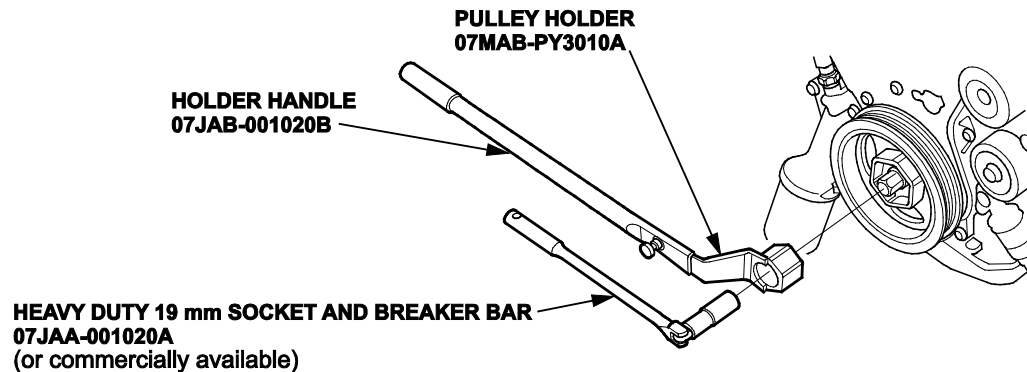
- Hold the crankshaft pulley with the holder handle and the pulley holder.

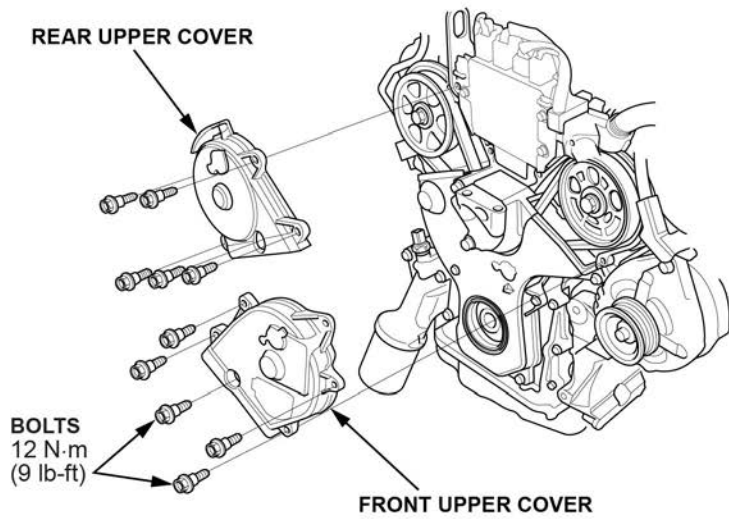
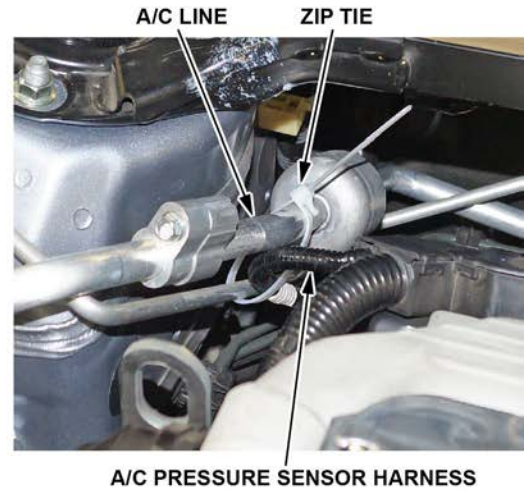
- Remove the crankshaft bolt with a heavy duty 19 mm socket and a breaker bar, then remove the crankshaft pulley and washer. Temporarily reinstall the crankshaft bolt.
- Remove the front and rear upper covers.

NOTE: Keep the A/C pressure sensor harness out of the way of moving parts by attaching it to the A/C line with a zip tie.

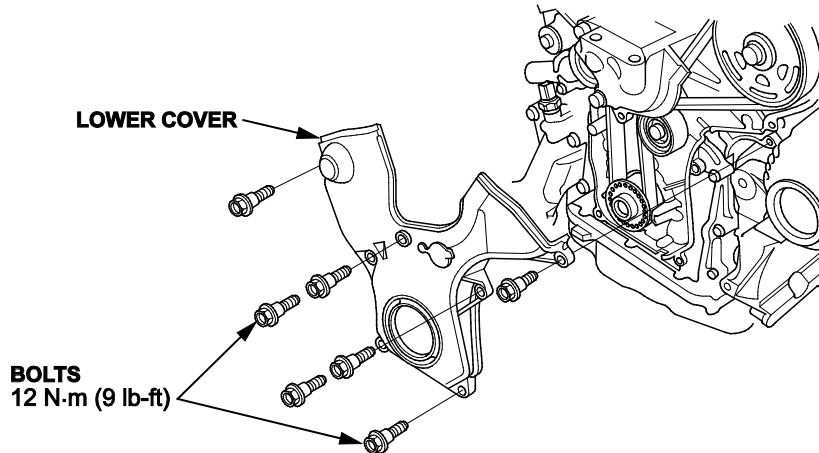
8. Remove the lower cover.

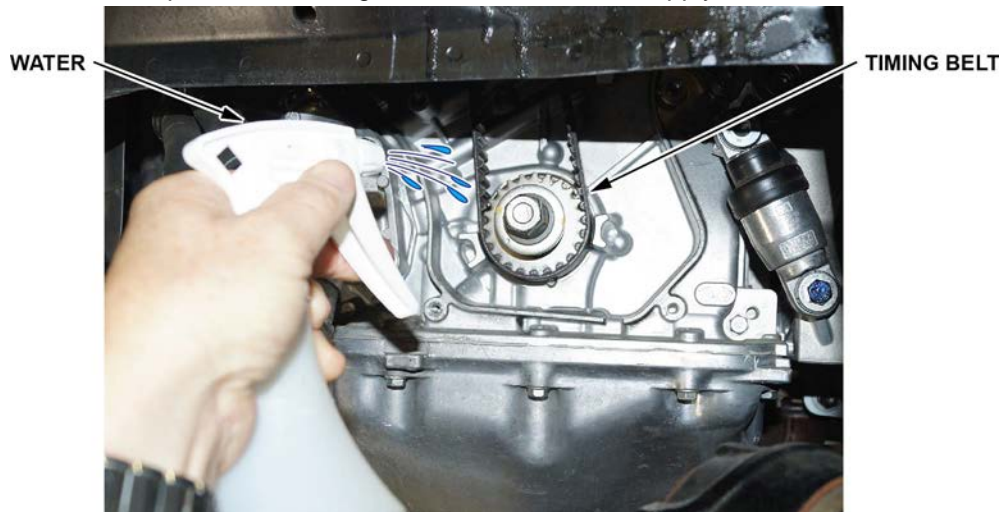
9. Start the engine while it is still hot, then spray the back edge of the timing belt with water while it is running.

Do you still hear a chirp?

- If the chirp lessens, changes pitch, or goes away, go to REPAIR PROCEDURE.
- If the chirp does not change, this bulletin does not apply. Continue with normal troubleshooting procedures.

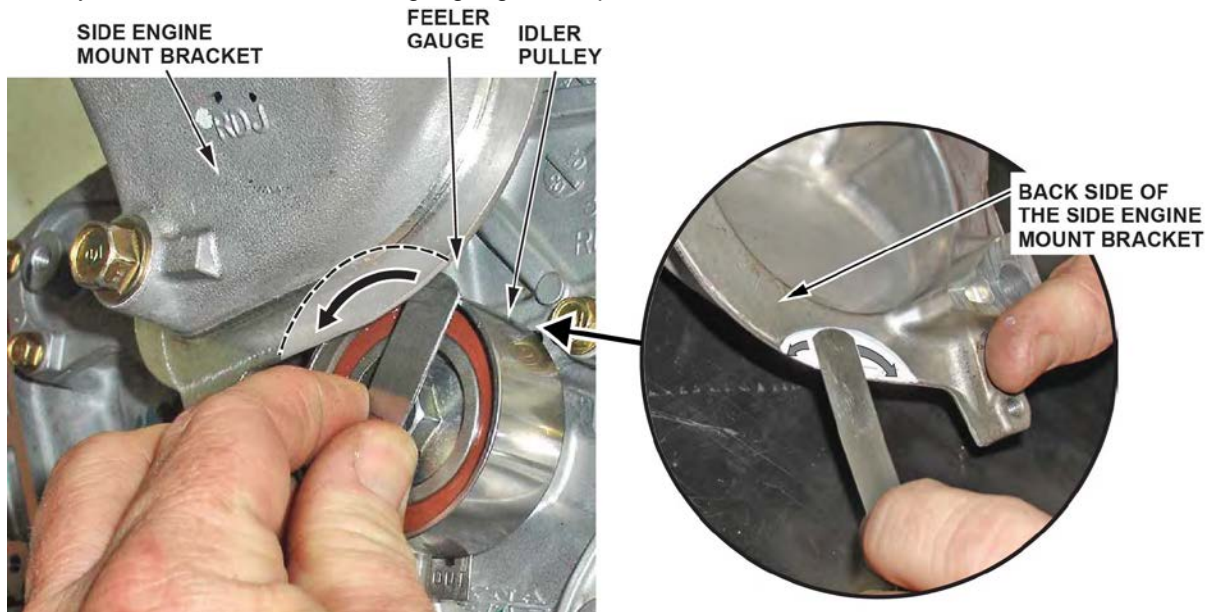
1. Try to insert a 0.95 mm feeler gauge between the top edge of the timing belt idler pulley and the back side of the side engine mount bracket that overhangs the pulley.

NOTE: Make sure you remove the feeler gauge from its holder to get a more accurate measurement.

- If you can insert the feeler gauge between the timing belt idler pulley and engine mount bracket, go to step 4.
- If you cannot insert the feeler gauge, go to step 2.

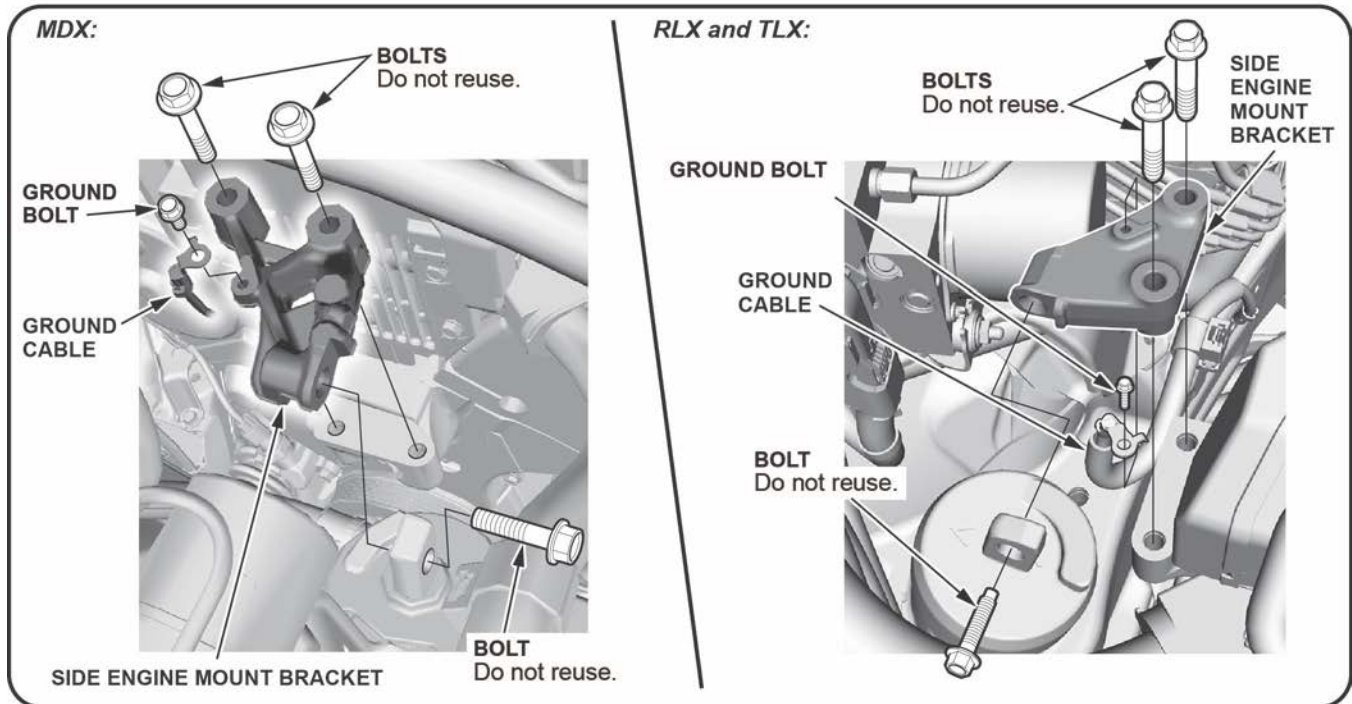
UPPER HALF OF SIDE ENGINE MOUNT

- Remove the side engine mount bracket.

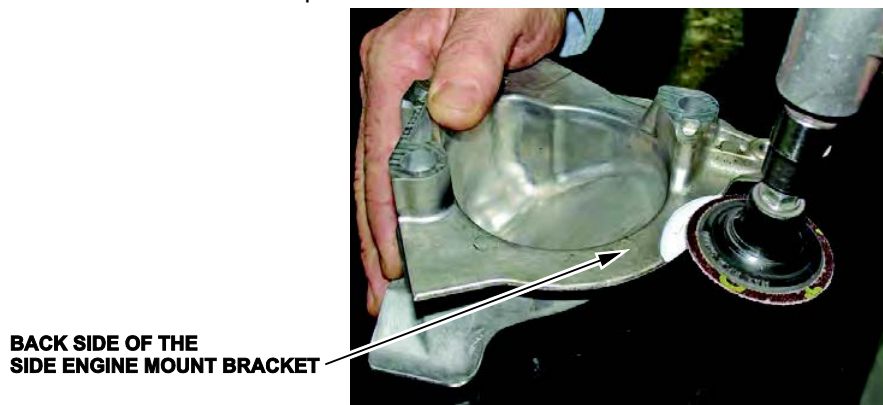
- Using a die grinder with a 2-inch grinding disc, use the circular casting offset as a guide to grind the side engine mount bracket until the lip measures 2 mm in thickness.

NOTE: Use a vernier caliper or micrometer to confirm the amount of material removed.

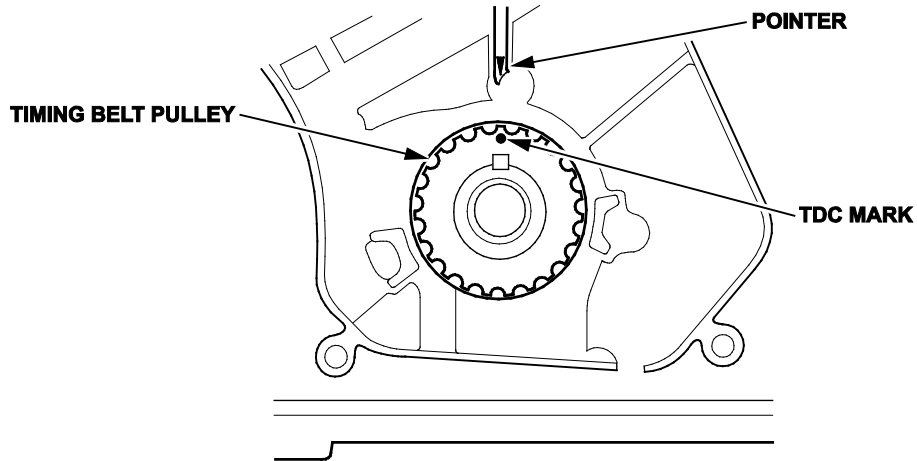
4. Set the engine to TDC (top dead center).
- Align the TDC mark on the tooth of the timing belt drive pulley with the pointer on the oil pump.

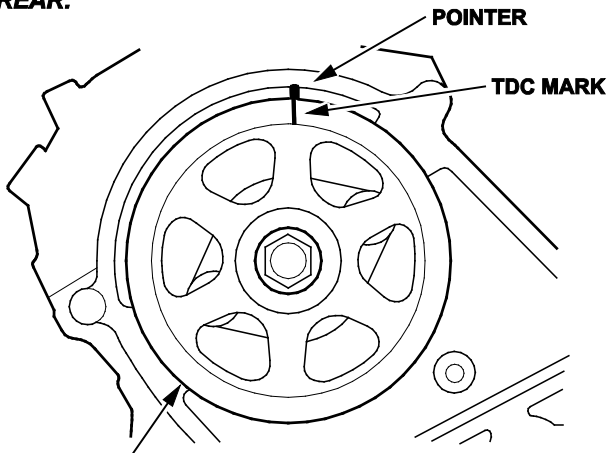
REAR:

- Align the TDC marks on the camshaft pulleys with the pointers on the back covers.

REAR CAMSHAFT PULLEY

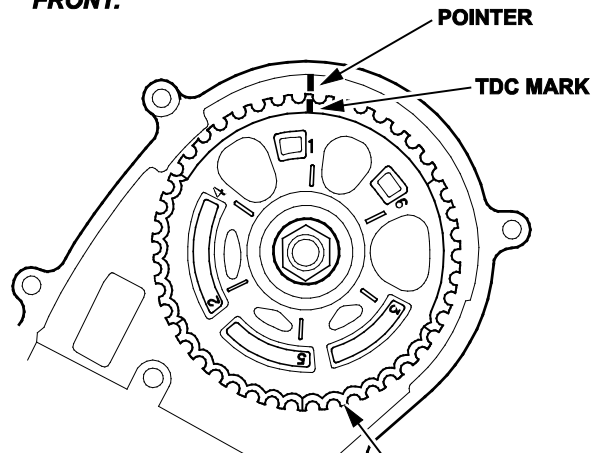
FRONT:

FRONT CAMSHAFT PULLEY

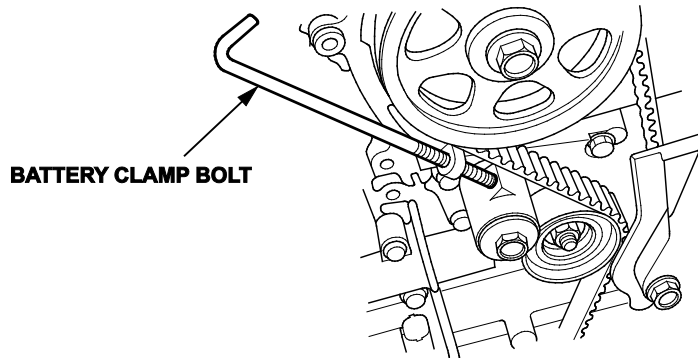
5. Thread and hand-tighten a battery clamp bolt as shown to hold the timing belt adjuster in its current position.

NOTE: Do not use a wrench to tighten the battery clamp bolt.

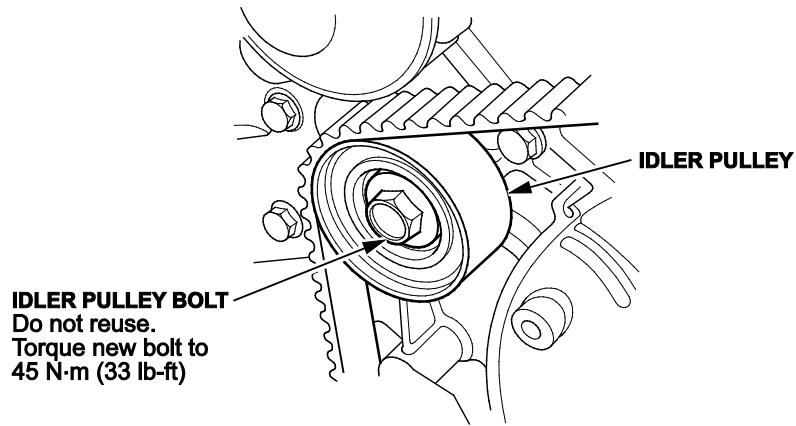
6. Remove the idler pulley.

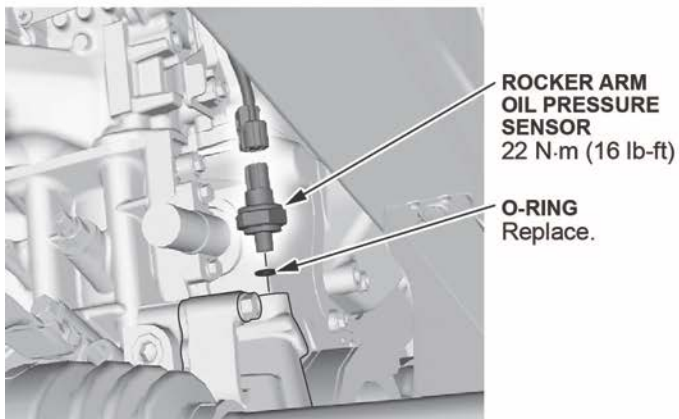
MDX:

8. Remove the rocker arm oil pressure sensor from the oil filter housing to access the timing belt auto-tensioner bolts.

- Disconnect the rocker arm oil pressure sensor connector.
- Remove the rocker arm oil pressure sensor.
- Remove any old liquid gasket from the switch and the switch mounting hole.

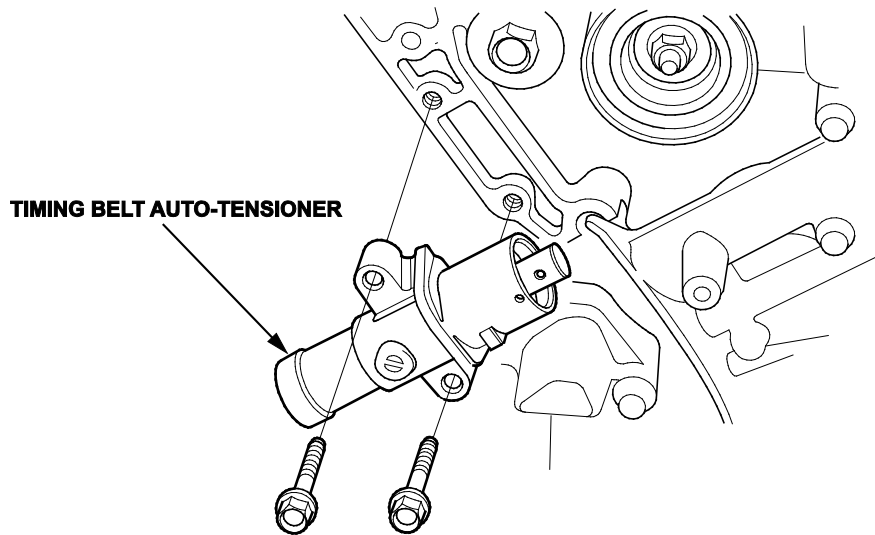
9. Remove the battery clamp bolt from the timing belt adjuster, then remove the timing belt auto-tensioner.

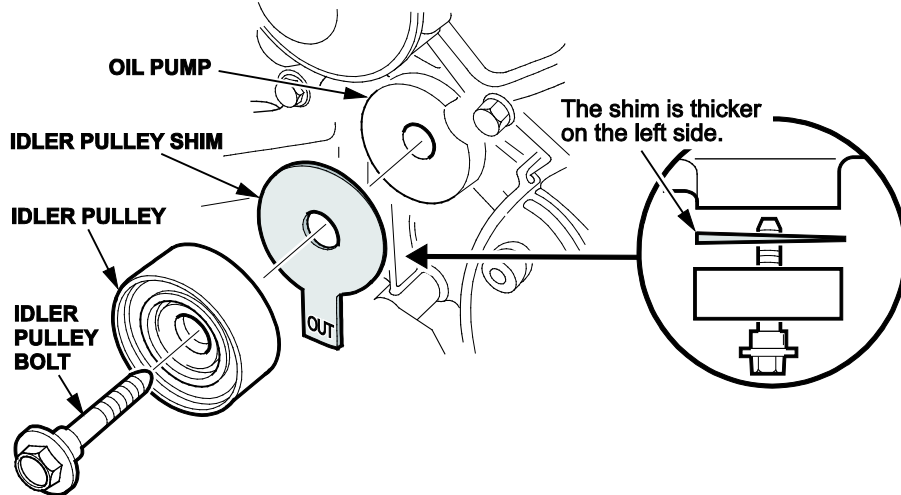
10. Place the idler pulley shim between the idler pulley and the oil pump housing; loosely install the new idler pulley bolt with Hondalock 1 applied to its threads. Make sure you follow the instructions on the Hondalock 1 container.

NOTE: The shim is tapered from left to right. The word **OUT** is stamped into the tang and painted white. It should be readable after the shim is installed.

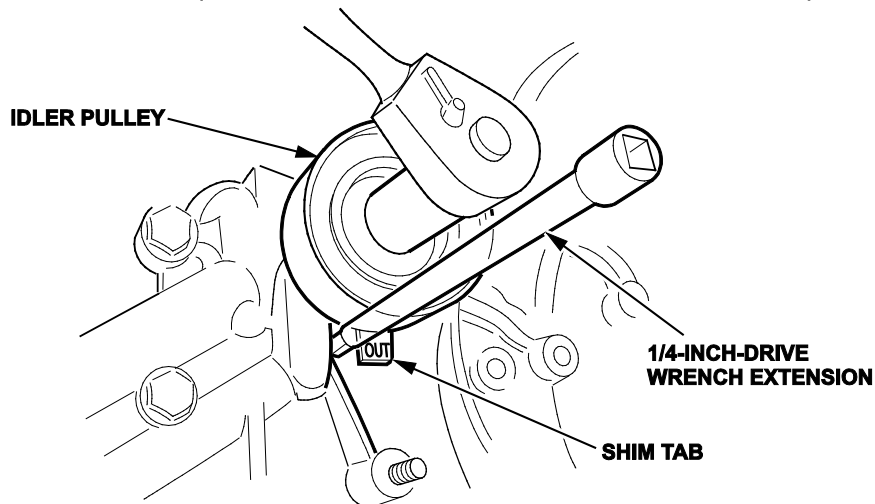
11. Install the new idler pulley bolt:

- Insert the square end of a 1/4-inch-drive ratchet extension to keep the shim's tang in the correct position.

- Tighten the idler pulley bolt to **44 N·m (33 lb-ft)**.
- Bend the shim's tang slightly towards the oil pump housing to keep it away from the idler pulley.

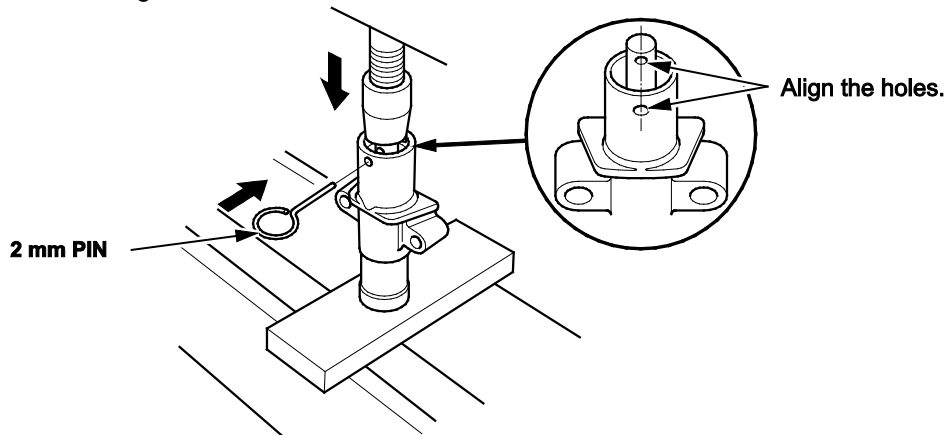
12. Compress the timing belt auto tensioner.

- Align the holes on the rod and timing belt auto-tensioner housing.
- Use a hydraulic press to slowly compress the timing belt auto-tensioner. Insert a 2 mm (5/64 in) pin through the housing and the rod.

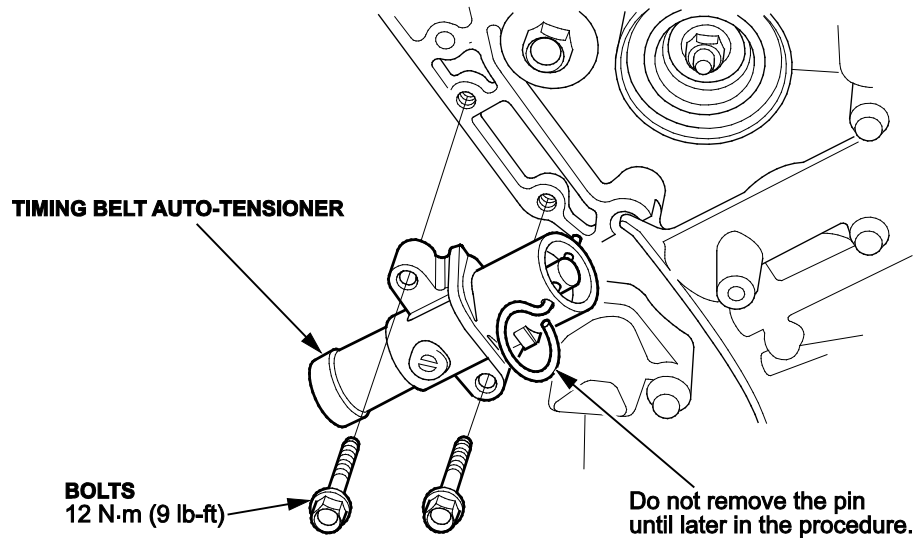
14. Reinstall the timing belt auto-tensioner. Do not remove the pin.

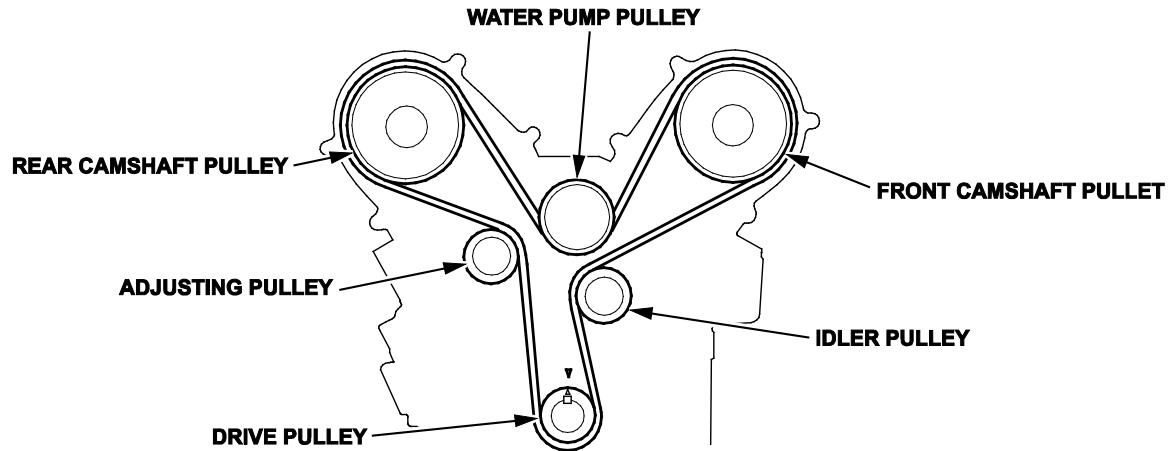
16. Reinstall the timing belt.

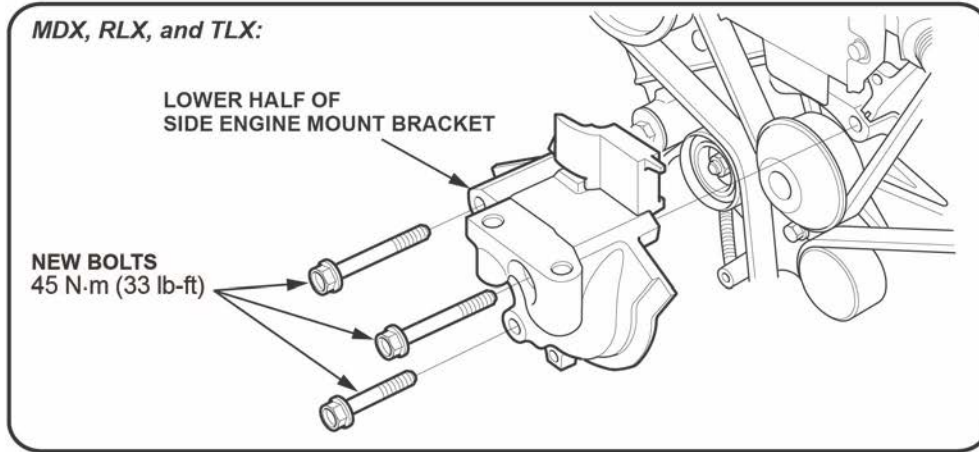
LOWER HALF OF SIDE ENGINE MOUNT

19. Reinstall the side engine mount with the new bolts and torque them as shown.

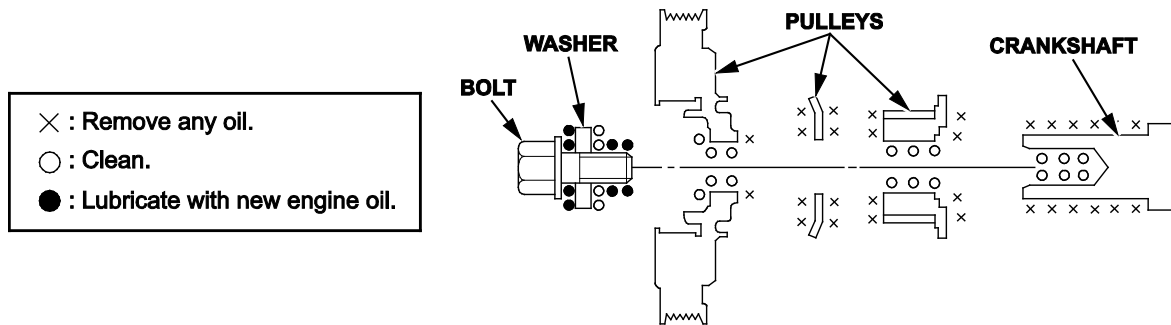
22. Remove any oil and clean the crankshaft pulley, washer, and bolt. Lubricate with new engine oil as shown.

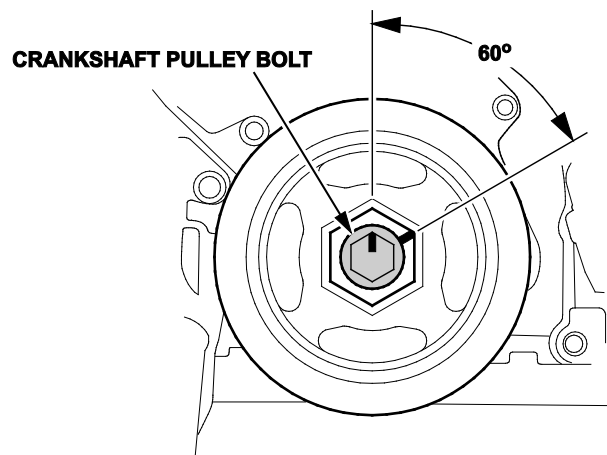
23. Install the crankshaft pulley and torque the bolt to **65 N·m (48 lb-ft)**.
24. Tighten the bolt an additional 60 degrees.
